RESPONSE OF RURAL DWELLINGS
TO RECENT DESTRUCTIVE EARTHQUAKES
IN TURKEY (1973-1975)

SYNOPSIS

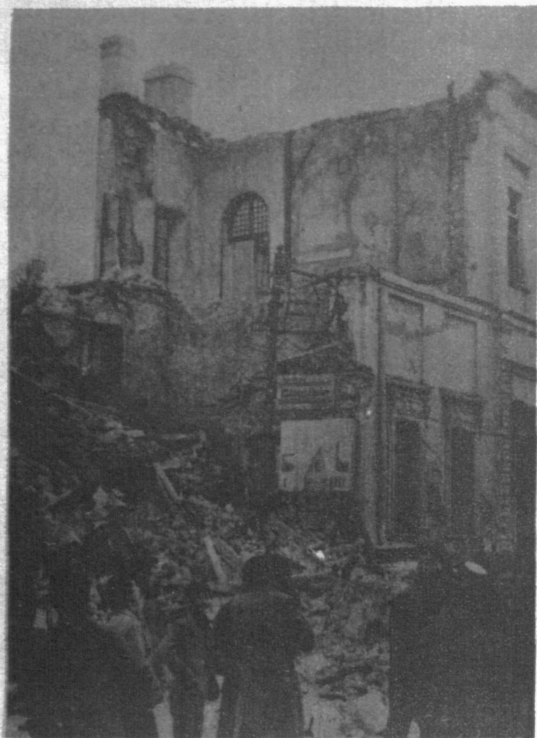
Since there are no low-cost rural dwellings in the region their damages could not be observed. From other types, 15 masonry dwellings were demolished. (fig.1), the conical roof of the historic clock tower fell off (fig.2), and wall cracks, column and chimney damages, and plaster peel offs were observed in roughly 200 masonry and reinforced concrete buildings.

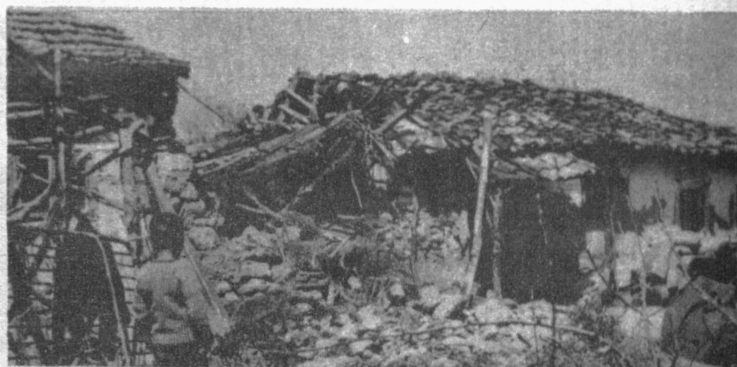
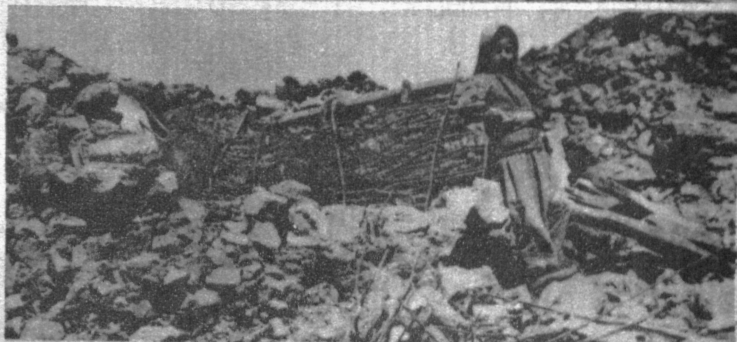
In the region 75 % of the houses are low-cost rural dwellings. The predominant prototype rural dwelling of the region has a heavy roof, thick masonry walls, and one story. The epoxy material of the walls is mud. The earthquake responses are shown in figures 4 and 5.

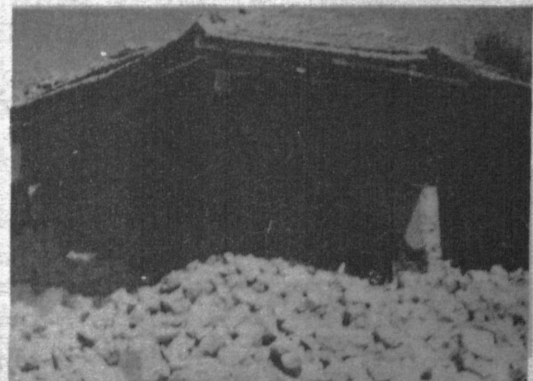
Figure 6 shows a reinforced concrete school. Figure 7 shows a low-cost rural dwelling district after the earthquake. Figure 8 displays the wooden roof beam and wall connection detail. Figure 9 shows the damage on a masonry

building. Figure 10 is a view of slightly damaged prototype low-cost rural dwellings and Figure 11 shows a detail from one of the rare buildings which was not damaged.
