THE FRIULI (ITALY) MAY AND SEPT. 1976 EARTHQUAKE

A BRIEF SURVEY OF THE DAMAGES

An overview is presented of the damages caused to the principal types of constructions of the Friuli region by the sequence of shocks that lasted from May to September, 1976.

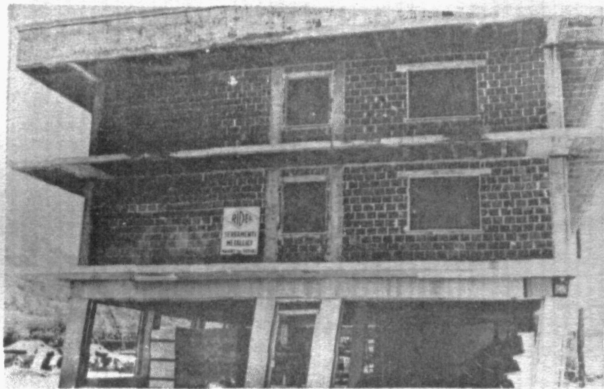
Fig.1 Damages to buildings

DAMAGE TOWN	N I L			SMALL			GREAT			TOTAL		
	I	II	III	I	II	III	I	II	III	I	II	III
BUIA	0	20	0	5	36	50	5	20	40	90	24	10
GEMONA	0	0	13	2	28	50	15	43	10	83	29	27
FORGARIA	0	16	50	5	17	50	15	50	0	80	17	0
OSOPPO	7	17	80	7	33	20	13	33	0	73	17	0
TRASAGHIS	0	11	--	0	33	--	42	23	--	58	33	--
MAJANO	8	16	60	17	32	20	25	26	0	50	26	20
TARCENTO	17	30	25	25	10	75	33	40	0	25	20	0
SAN DANIELE	50	45	60	35	37	40	9	18	0	6	0	0

Three ample categories can be recognized, a synoptical table of the damages suffered by each of them in 8 major towns appearing in fig.1. Type 1 - Masonry houses, one or two stories high, built with irregular alluvional stones, having wooden floors and roofs, lacking of connections between orthogonal walls. Widely diffused in rural as well as in older parts of the towns. Most of them seriously damaged or collapsed (fig.2) .

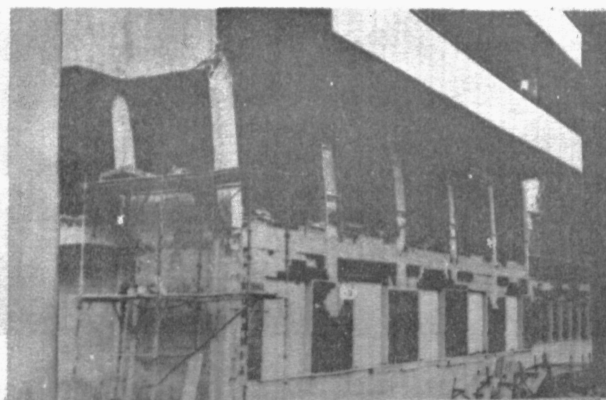
Fig.3 Yielding of first floor columns

Type 3 - Reinforced concrete buildings, from three to eight stories high. Degree of damage influenced both from the structural layout and the presence of non structural elements. Partially or totally free first stories caused the majority of the failures (figs 3 and 4); asymmetry of the first story columns height caused unrecoverable damage of the G section of the Gemona hospital, the main building of the region (figs 5 and 6), while asymmetry of the first floor perimetral walls caused rotation and subsequent collapse (on September shock) of the B section of the building in figs 7 and 8.

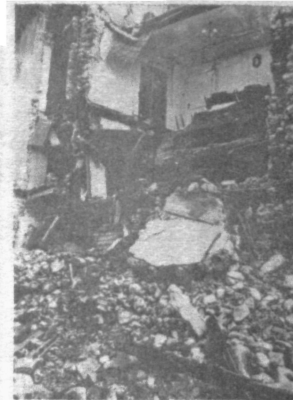
Fig.6 Gemona Hospital - G Section -
Free second floor with collapsed
columns

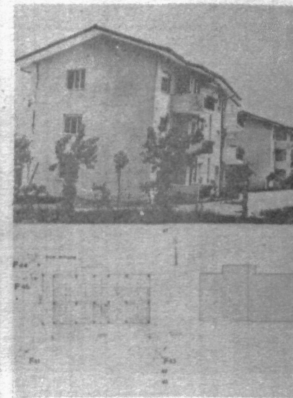
Fig.2 Typical masonry
house.

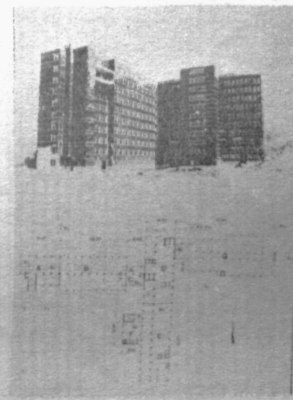
Fig.4 Base pilotis
destruction

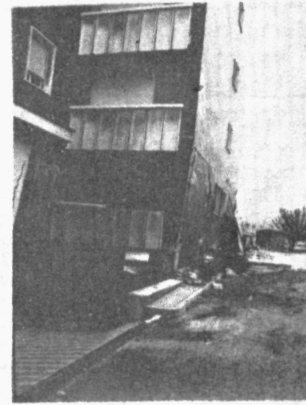
Fig.7 Seven stories building after the quake.

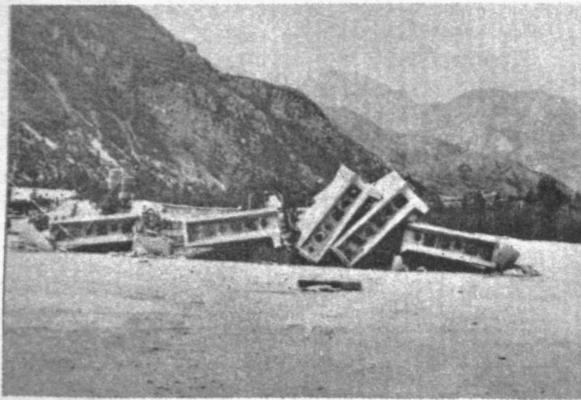
Fig.8 B section of building in fig.7

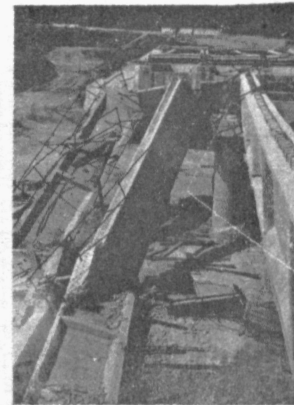
Fig. 9 Prefabricated beams waiting for use

A highway crossing the region from Udine to Tarvisio, at the border with Austria, is under construction. The structural schemes of the bridges consist mostly of simply supported spans, made of prestressed prefabricated beams connected by cast-in-situ slabs, or of hollow multicellular decks. Prefabricated beams 33 to 40 meters long, waiting for use in stock areas were lost in great number due to overturning and reciprocal shocks (fig.9). Beams already in place over the piers were separated each other and fell down (fig.10). Damages to completed structures were mainly caused by the mobility of the decks, not sufficiently restrained by the supports. This is exemplified in fig.11 showing a hollow deck fall down after a displacement relative to the pier of more than 50 cm, and also in fig.12, showing the residual offset of a deck relative to the pier. Where concrete stoppers were provided over the piers, repeated collisions with the beams led to their destruction (fig.13). As another example of insufficient restraint, an elevated pipeline, carrying methane from Trieste to the north, fell down due to insufficient depth of the supporting saddles (fig. 14)

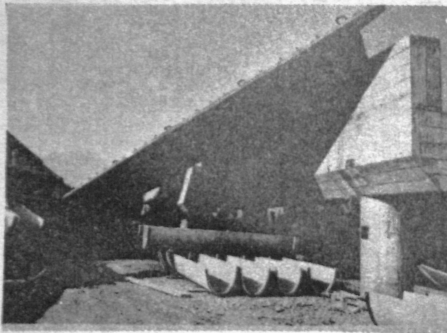
Fig.10 Bridge deck under construction

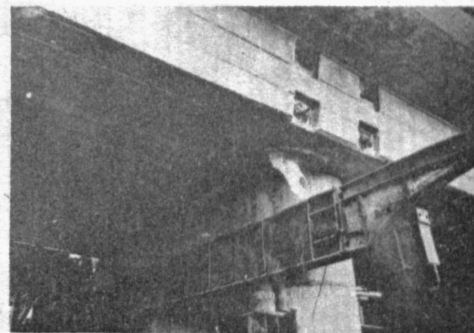
Fig.11 Collapse of a deck from the pier

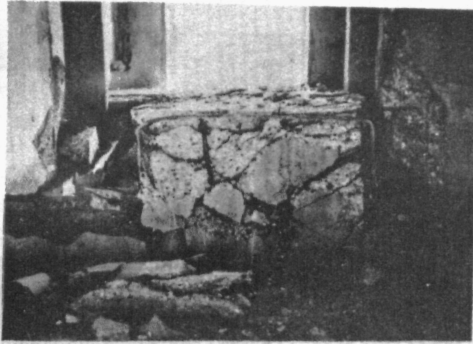
Fig. 12 Residual offset of a deck

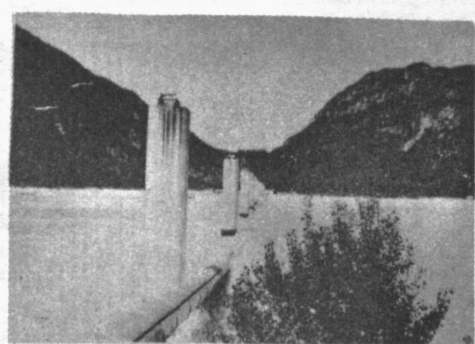
Fig.13 Destroyed concrete stoppers

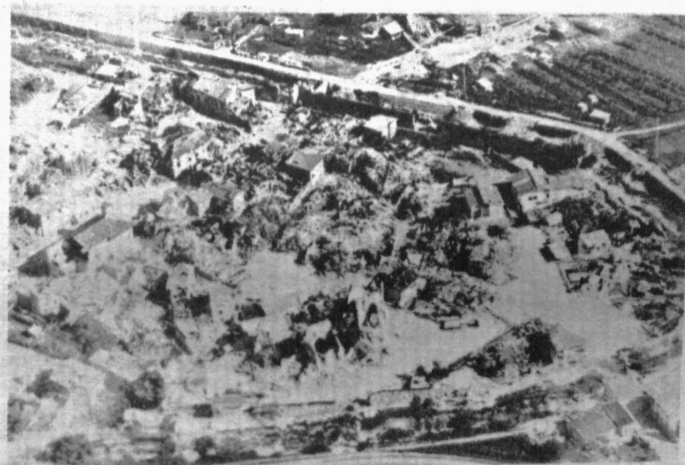
Fig.15 View of Venzone after May

In at least 100 towns the major buildings have been seriously affected: 20 bell towers and 50 churches have collapsed, and five castles are in ruins. Two hundred bell towers, 500 churches and about 30 castles suffered significant damages. Two medioeval walled towns, Venzona and Gemona were of preminent artistic value. Fig.15 shows an aerial view of Venzona after May, with the cathedral (13th century) still standing except for one bell tower; the same view appears in fig.16 after September, with the Cathedral completely destroyed. The old town center of Gemona after September is shown in fig.17 note the Town Hall in the center and the Cathedral on the far right. The first one, a 15th century building, appears in fig.18 while the second one, built in 13th century, with the bell tower dating back to 1330, is shown in fig.19.

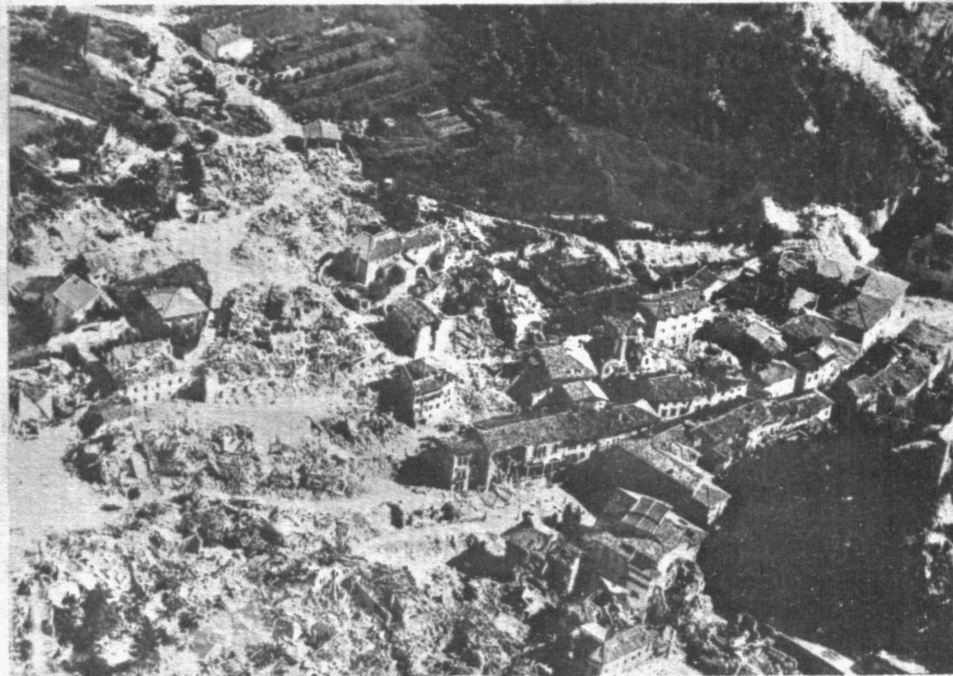
Fig.16 View of Venzone after September

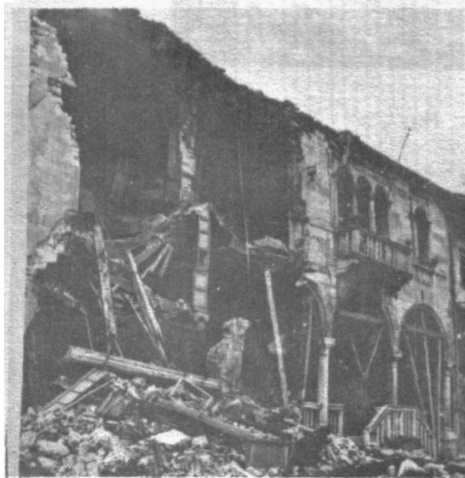
Fig.17 View of Gemona after September

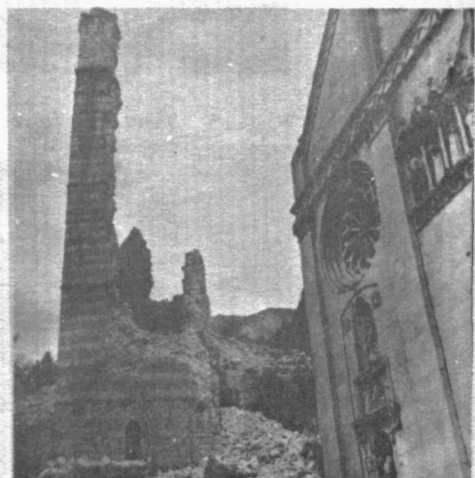
Fig.18 Town Hall of Gemona
(15th cent.)
