EFFECTS OF VRANCHEA EARTHQUAKE, MARCH 1977

ON THE TERRITORY OF BULGARIA

G. Brankov^I S. Sachanski^{II}

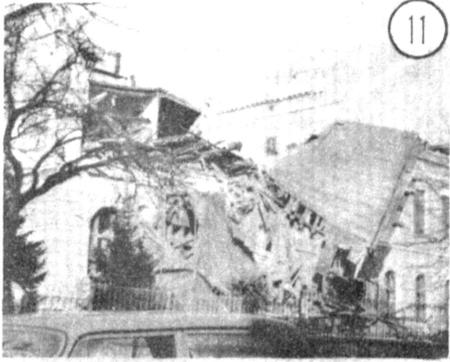
Many two-storey school brick buildings got damages in the corners (Fig.10). Another school building was damaged in the conference room (Fig.11) and also at the connections between masonry walls and timber roof structure.

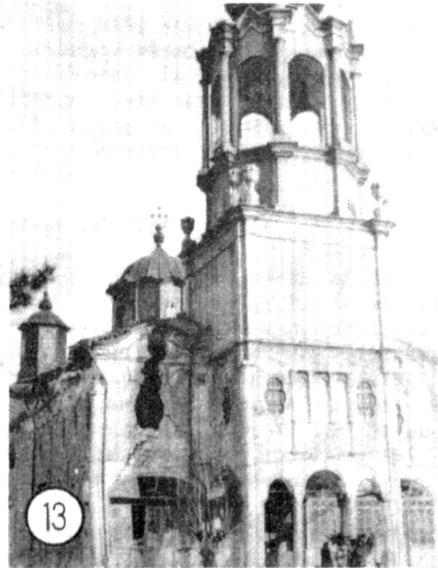
In some places like Svishtov one-storey brick buildings did not get any damages although some tall buildings (Figs.5-7) were destroyed. In some other places only small buildings were damaged (Fig.12). A few old churches were seriously damaged (Fig.13). Many damages occurred in some industrial buildings of the cause of the bad connection between the roof trusses and columns (Fig.14) and also between the walls and columns (Fig.15).

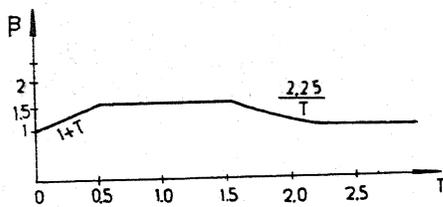
fig. 16

- The earthquake resistance design of buildings located in northern parts of Bulgaria, near to Danub river, has to take into consideration the long distance effect of Vrancea earthquake by a respective spectrum (Fig.16).
