Seismic Retrofit Of RC Columns With Inadequate Lap-Splice Length By External Post-Tensioned High-Strength Strips

15 WCEE
LISBOA 2012

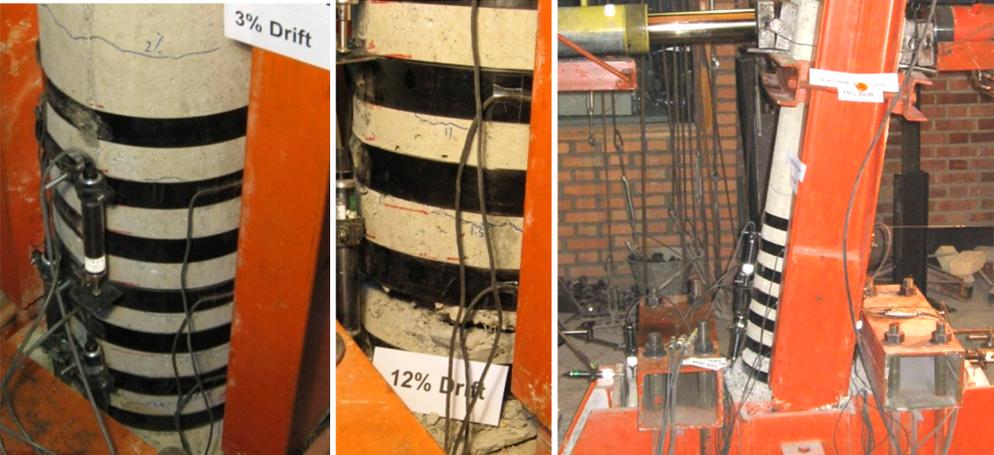
Figure 8. The observed behaviour of the column specimen CS-S64-A at various levels of lateral displacement

The second column specimen, i.e. CS-S64-A was actively confined with external strips. As depicted in figure8, this specimen could have suffered great lateral displacements with minor damages. None of the strips have ruptured even at the end of the tests. The damage at the 3% drift ratio is just some hair cracks between the strips. At 12% lateral drift ratio the cracks are really widened and some crushing between downer strips is observed. At this great level of lateral displacement, although the concrete crushing is observed but due to the effective lateral pressure applied by the external strips, the slippage of the longitudinal reinforcements along the short lap-splice has been prevented or at least controlled.

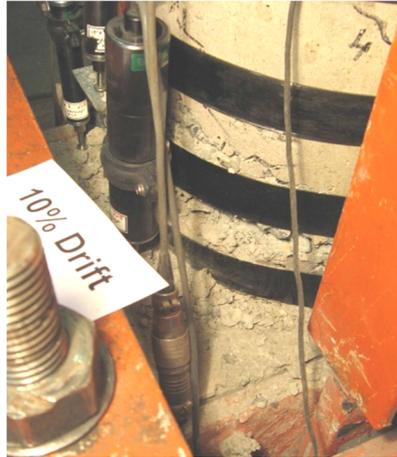
Figure 11. The state of damage to the column specimen CS-S64-P at 10% drift ratio

The third specimen, i.e. CS-S64-P was retrofitted with the same retrofit layout as the second specimen but with negligible post-tensioning force in the strips. The damage pattern observed in this column was very similar to that of its actively confined counterpart. The cracks formed between the strips and under 7% drift ratio, the only observable damage to the column was cracks between the strip on the tensile side and crushing along the edges of these cracks on the compressive side, as shown in figure11. None of the strips ruptured by the end of the test, that means a drift ratio level in excess of 12%. The gravitational load carrying capacity of the column was maintained by the end of the test.

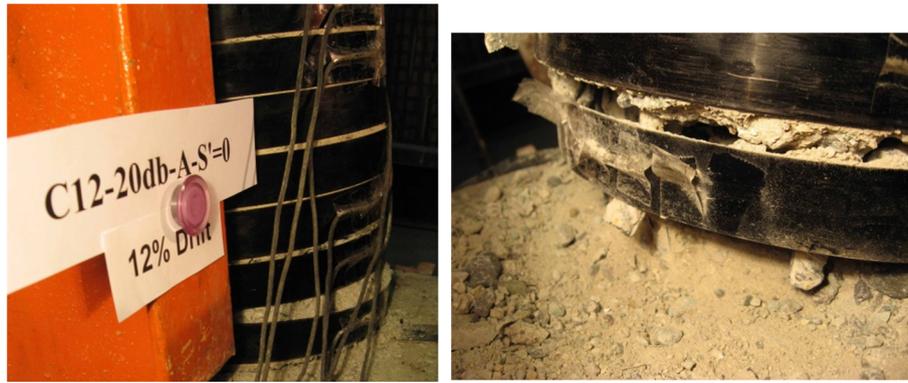
(a) (b)
Figure 13. The state of damage observed in the column specimen CS-S32-A at a) 12% drift ratio and b) the end of the test

The last column specimen, i.e. CS-S32-A, was retrofitted by higher volumetric ratio of confining strips. As shown in table 1, along the height of the lap-splice, the column was fully jacketed with strips at zero spacings. At low levels of the lateral displacement, up to 6 % of drift ratio, the only observable damage to the columns is the completely horizontal cracks between the strips. At 7% drift ratio, the edges of these cracks are crushed in each half-cycle on the compressive sides. At very high levels of the lateral drift ratio (12%), the crushed concrete was observed to fall out from the strip jacketing as shown in figure 13. This must result in the loss of the bond between the spliced rebars due to the removal of their surrounding concrete. However, the effective lateral pressure applied by the strips at these stages of the lateral displacement (that severe damage has been imposed to the concrete of the column), successfully prevented the slippage of the spliced reinforcements. None of the strips ruptured by the end of the test and the column was able to maintain the gravitational load by the end of the test.
