Discussion of the protection retrofit principle of the earthquake damaged building site and introduction of an example

Zhang Haoyu, Sun Baitao, Huang Quansheng, Chen Hongfu

Institute of Engineering Mechanics, China Earthquake Administration

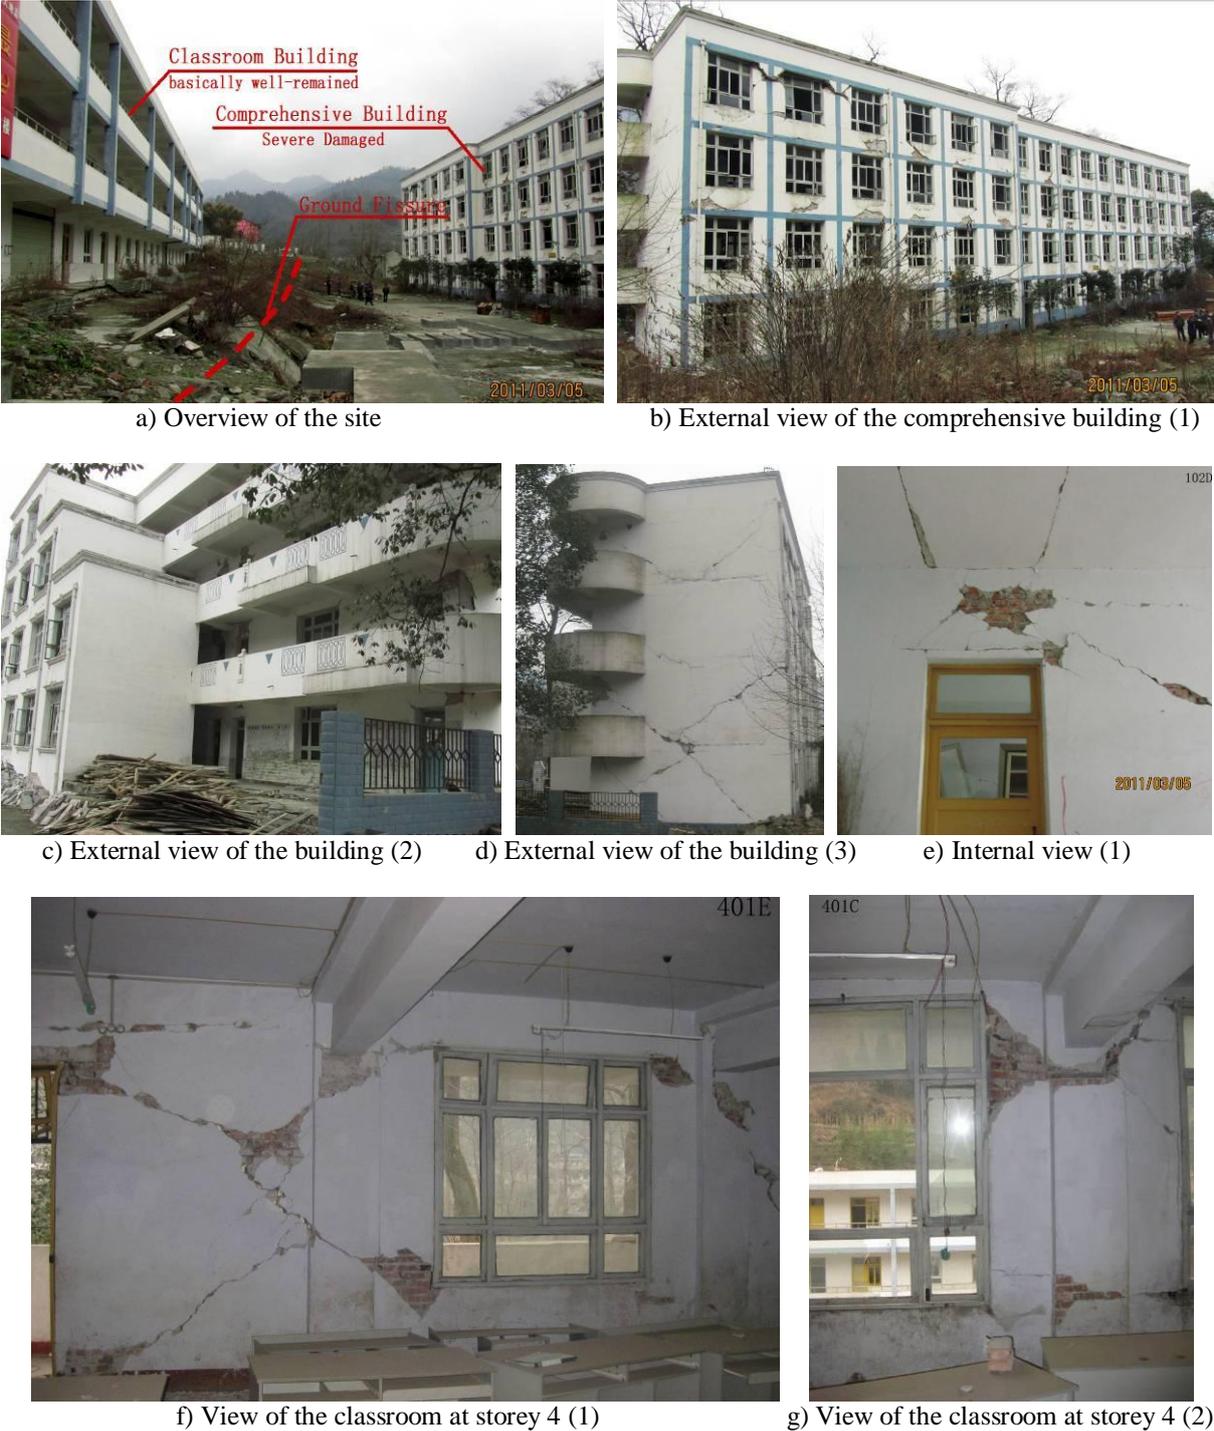
Fig.1 Overview of White Deer Middle school earthquake damaged site and typical damage appearances of the comprehensive building

Comprehensive building of White Deer middle school, White Deer town, Pengzhou, Sichuan Province, China, is a 4 storey brick-concrete structure, which was designed and built in 1985. The thickness of the longitudinal wall is 370mm in storey 1 and storey2, 240mm in storey 3 and storey 4 respectively; the thickness of the cross wall is 240mm in all the stories. The floors and the roof were formed by the precast prestressed hollow slab. The basis of the building was also masonry brick strip foundation. Fig.1 shows several aspects of the sight for the building, and Fig.2a) shows the plan of the first storey.

In the Wenchuan earthquake occurred on May 12th. 2008, a ground fissure passed through the middle ground between the comprehensive building and the classroom building (a 3 storey brick-concrete structure), which was built in 2005. The height difference between the two buildings was changed due to the strong ground motion from 0 to about 3m high. The comprehensive building was severely damaged, locally near-collapse, while the classroom building survived with its structure basically well-remained, as shown in Fig.1.

Structural elements between C-axis and E-axis in Fig.2a) were severely damaged, while the elements between A-axis and B-axis were slightly damaged. The cross walls of the lower storey were damaged more severely than that of upper storey; longitudinal walls of storey 3 and storey 4 were damaged severely, parts of the walls at storey 4 were nearly collapse (Fig.1g)), while the longitudinal walls of storey 1 and storey 2 were damaged slighter than that of the upper storey. Most of reinforced concrete stairs, reinforced beams and precast prestressed concrete slabs survive basically well-remained, except

All the retrofit components, except the longitudinal braces which were not adhere to the masonry walls, were connected to the adjacent masonry walls by expansion bolts, which ensures the retrofit components and the masonry walls working together and making the walls as the anti-buckling support of the steel retrofit components. For several most severely damaged walls, particular constructions are designed to connect them with the retrofit components adjacently. Fig.6 shows the connection constructions of the walls in Fig.1f) and Fig.1g).
