Aseismic Capacity of Telecommunication Conduit Repaired with Linings

NTT Access Network Service Systems Laboratories, Japan

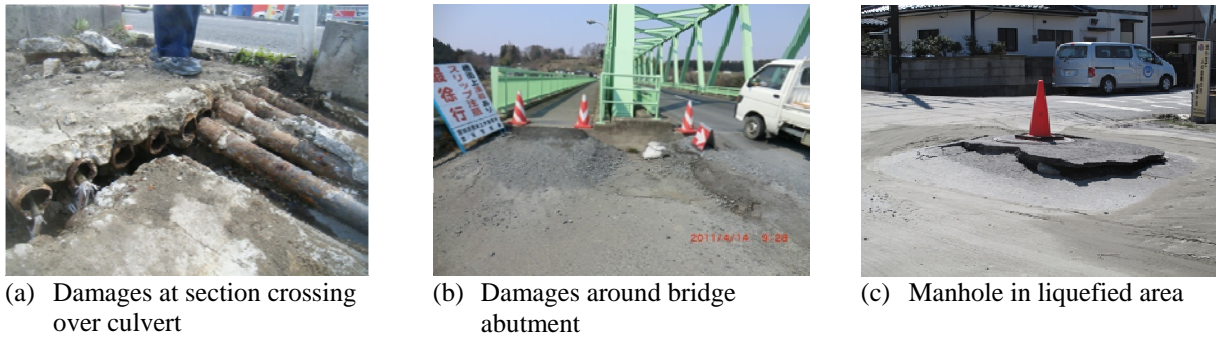
Figure 2.1. Damages due to the Great East Japan Earthquake

The damage investigation of telecommunication infrastructure facilities regarding the Great East Japan Earthquake (11th, March, 2011) showed that damages are likely to occur around the boundary of bridge abutment and at sections crossing over culverts in liquefied ground, soft ground or reclaimed land (Fig. 2.1). These damages are similar to those of previous earthquake disasters.

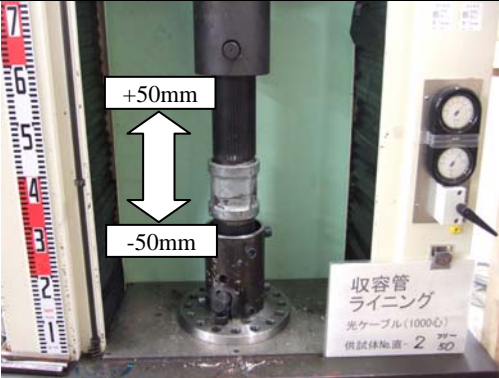
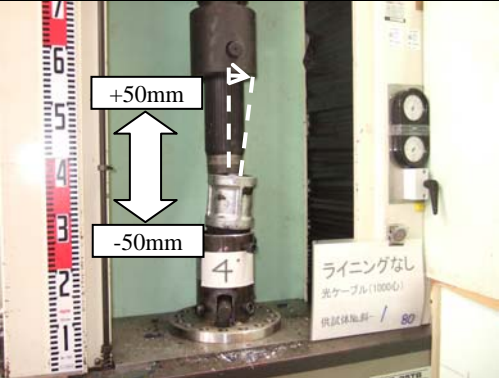
Table 5.2. Result of Collision Experiment

Without lining	With lining	Without lining	With lining

When there is no lining, a screw joint was damaged greatly due to collision, and it may damage a cable. On the other hand, when there is a lining, the continuity and the section of inner space are held and a cable can be protected. When there was crookedness, the behaviour of the pipe end, after joint breaks away, became unstable. Therefore, when there was no lining pipe, the cable damage grade became large. On the other hand, when there was a lining pipe, it acts as a guide. As a result, behaviour of outer pipe was stabilized comparatively and the cable was able to be protected.

Safety against the collisions repeated after joint breaks away was also confirmed by experiment. Specimens without lining and specimens with lining were both created. A specimen was installed in the testing machine and three cycles of periodic compression and tension with amplitude of 50 mm were loaded. Not only straight specimens, but also crooked specimens were tested.
