MECHANICAL PROPERTIES OF EXTERNALLY STRENGTHENED MASONRY

15 WCEE
LISBOA 2012

Sachin B. Kadam & Yogendra Singh

Department of Earthquake Engineering, Indian Institute of Technology Roorkee (India)

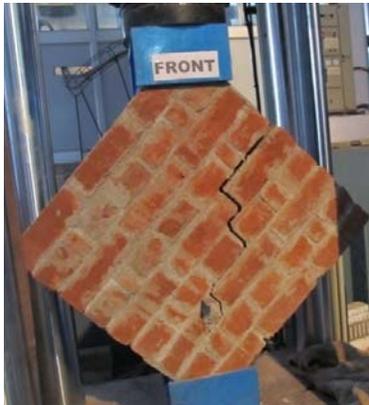
(a) URM one - wythe thick masonry panel

The failure of URM specimens was sudden and brittle. These panels failed by the formation of diagonal cracks. The failure was more sudden for one-wythe thick specimen, where the total collapses of specimen followed by the formation of a toothed crack. After development of first crack, the specimen was not able to sustain any further force. After the appearance of cracks, strain measuring devices had been removed to avoid damage to the instrument due to the sudden collapse of specimen. The response of these specimens can be considered as a combined diagonal shear and sliding failure as shown in Fig. 3.1(a) and Fig. 3.1(b)

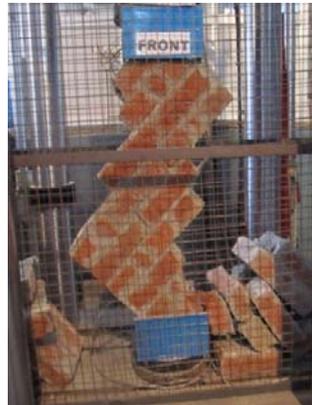
(b) URM two - wythe thick masonry panel

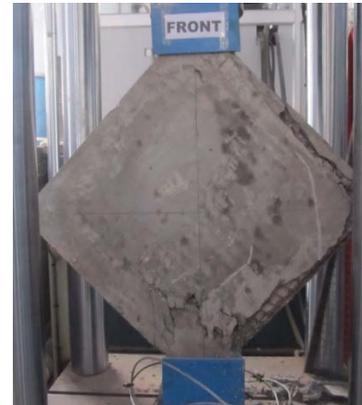
(c) Unidirectionally retrofitted two - wythe thick masonry panel

The behaviour of retrofitted specimens was governed by the thickness of sample, reinforcement ratio and method of reinforcement. Initial failure was started in the form of diagonal crack which was restrained by the reinforcement, resulting in more ductile failure than that observed in the URM specimens. For unidirectionally reinforced specimens, failure was observed in terms of cracks originating from the edges of the specimen. These cracks changed into major cracks at the later stage as shown in Fig. 3.1(c) and Fig. 3.1(e). At large displacements, there was considerable local crushing of the micro concrete adjacent to the WMM. It was observed that at some locations mesh had

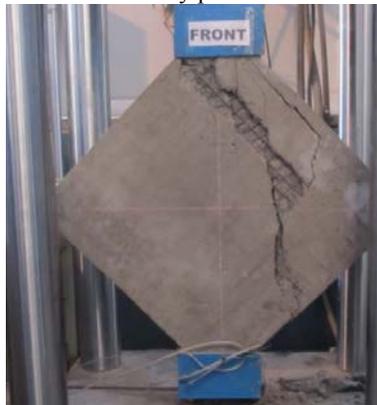
(d) Bidirectionally retrofitted two - wythe thick masonry panel

ruptured. For bidirectionally reinforced specimens failure in terms of crack was distributed along the compressed diagonal of the specimens as shown in Fig. 3.1(d) and Fig. 3.1(f). These diagonal cracks were changed into major cracks and at the later stage, local crushing of masonry along with micro concrete took place near to loading and supporting shoes. It was observed that this cracked masonry together with restrain reinforcement, develops shear induced dilation mechanisms resulting in increased load and displacement capacity. In Table 3.1 Maximum shear stress (τ_{max}) is listed and also ratio of the shear strength of the retrofitted to corresponding URM specimen (τ/τ_0) is expressed. All the four reinforcement patterns (Series 3 to 6) resulted in an increase in shear strength. The maximum ratio of the shear strength of the retrofitted to corresponding URM specimen (τ/τ_0) was achieved in case of bidirectionally retrofitted one - wythe thick masonry panel which was 7.06. The observed increase in shear strength of the retrofitted to corresponding URM specimen was in the range of 0.57–1.48 MPa in experimental program.

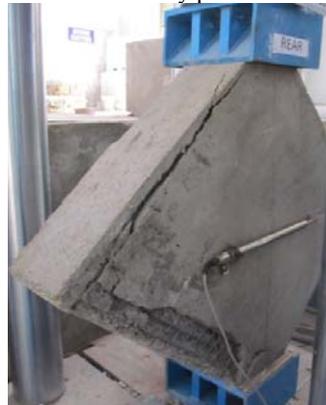
(e) Unidirectionally retrofitted one - wythe thick masonry panel

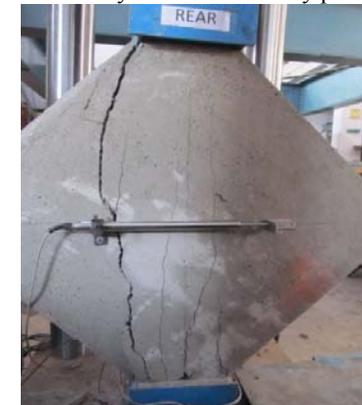
(f) Bidirectionally retrofitted one - wythe thick masonry panel
