Seismic Strengthening of Boundary Columns in R/C Shear Walls

This paper proposes and describes a new method for seismically strengthening vulnerable existing reinforced concrete shear walls, which do not satisfy current Japanese structural provisions. The proposed method improves the seismic performance of shear walls by confining only boundary columns using steel shapes and high-strength steel rods. A series of structural tests was conducted using four shear wall specimens: two normal specimens with different failure modes and two strengthened specimens applying the proposed method to normal specimens. As a result, the unstrengthened specimens failed in a brittle manner and lost their axial resistance after shear failure. Large compressive deformations after shear failures of unstrengthened specimens were caused by slip behaviour along diagonal shear cracks, which was modelled by a simple trigonometric equation. On the other hand, the strengthened specimens exhibited stable behaviour, and confining the boundary columns successfully prevented shear failure.

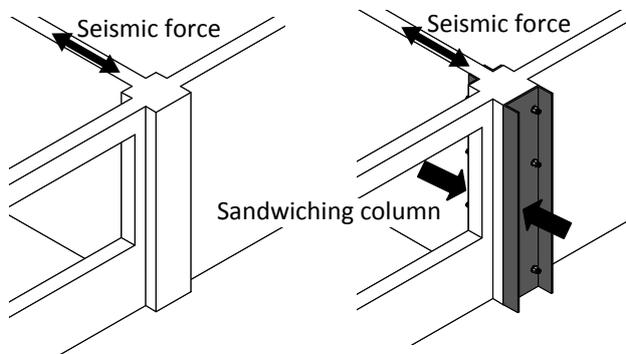
Figure 1. Retrofit scheme

This study proposes a new method for seismically strengthening vulnerable existing R/C shear walls. The proposed method improves the seismic performance of shear walls by partially confining only boundary columns using steel shapes and high-strength steel rods. Figure 1 illustrates the retrofit scheme. The application procedure, which is illustrated with the shear wall specimen described below, is as follows:

Step 1: A C-shaped steel channel and L-shaped steel angles are attached to the exterior and interior surfaces of boundary column, respectively, as shown in Fig. 1. A slit of 10 mm is designed at the top of each steel shape, which is not subjected a direct compression from a beam above. Mortar is applied between the boundary column and channel/angles.

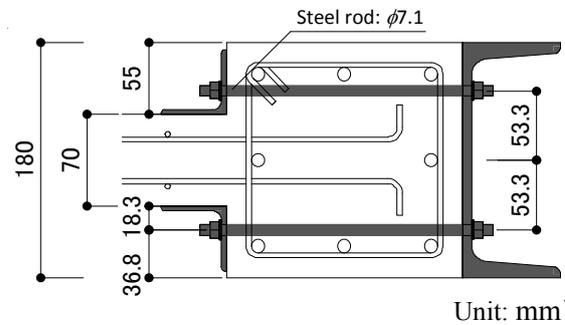
Figure 2. Cross-section of boundary column

Step 2: High-strength steel rods are inserted penetrating the column and steel shapes, as shown in Fig. 2. The diameter of a steel rod is 7.1 mm.

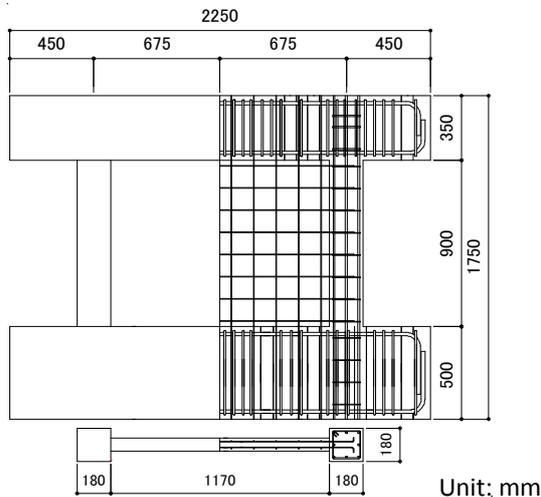
Figure 3. Details of unstrengthened specimens

Four 3/10 scale specimens were prepared representing typical existing R/C shear walls in Japan, which do not satisfy the current Japanese structural provisions (AIJ 2010). All specimens had the same structural details, as shown in Fig. 3 and Table 1, whereas two types of failure mechanism were

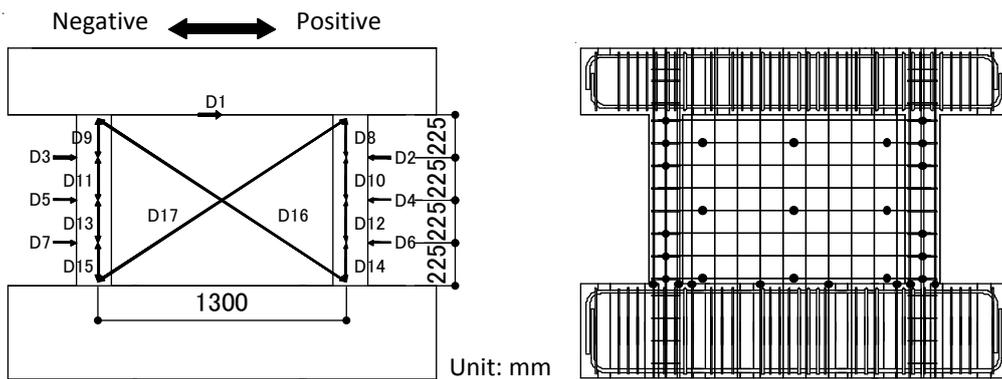
Figure 4. Arrangements of displacement transducers and strain gauges

Figure 4 shows the transducers set-up to measure the horizontal, vertical and diagonal relative displacements of specimens. D1 in the figure is a transducer that measures the horizontal relative displacement used for controlling lateral loads. Strains of reinforcements were measured using several strain gauges adhered to longitudinal and shear reinforcements in the boundary columns and wall panel. Moreover, at the peak and residual drifts in each loading cycle described below, initiated cracks, crack propagation, and crack widths measured by visual inspection were marked on the specimens to identify the failure mechanisms of specimens.

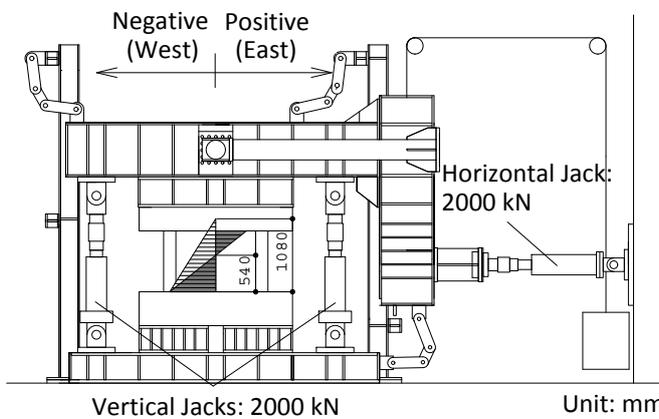
Figure 5. Schematic view of test set-up

A schematic representation of the experimental set-up is shown in Fig. 5. Each specimen was fixed at its upper and lower stubs to the loading frames. Reversed cyclic lateral loads were applied to the specimens under a constant axial load of 300 kN. Shear span-to-depth ratios of 0.8 and 0.4 were maintained by controlling vertical jacks for SW0.8 and RW0.8, and SW0.4 and RW0.4, respectively. Incremental lateral loads were controlled by top drift ratio, R , which was measured with the transducer D1 in Fig. 4. The lateral loading program had an initial cycle to $R=1/800$, followed by two cycles to $R=1/400$, $1/200$, $1/100$, $1/50$, and $1/25$, and a pushover to $R=1/12.5$, as shown in Fig. 6.

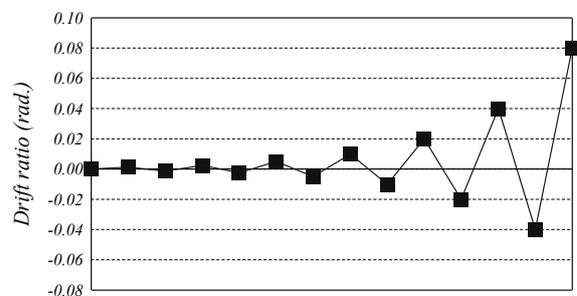
Figure 6. Loading history in the horizontal direction

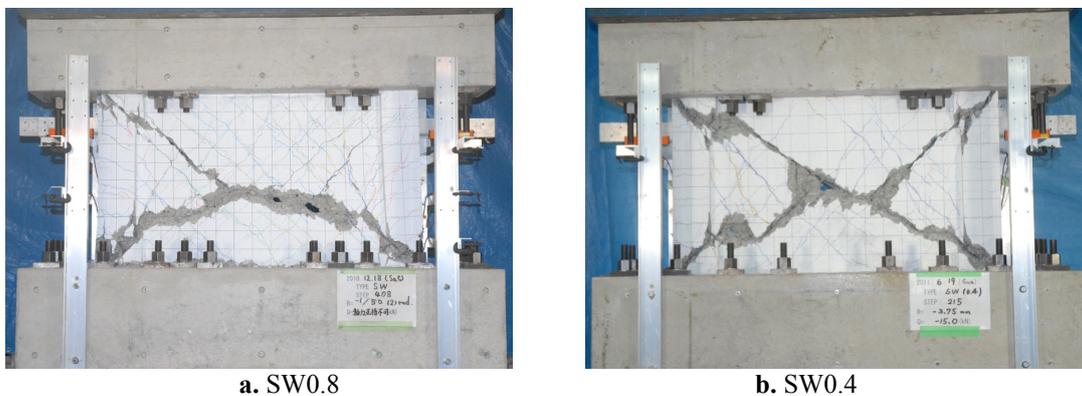
Figure 7. Damage to unstrengthened specimens after testing

Initial flexural and shear cracks were observed at the bottom of the boundary column and the wall panel, respectively, in the first cycle to $R=1/800$. Initial shear cracks at the ends of columns occurred in the following cycle to $R=1/400$. The specimen began to yield in bending during the cycle to $R=1/200$, where longitudinal rebars in the column and wall initially yielded. Spalling of concrete cover was observed on the wall panel in the cycle to $R=1/100$. The specimen failed in shear during the first cycle to $R=1/50$, then it completely lost the axial resistance during the second cycle. Figure 7a shows the damage to the specimen after the test.

Similar behaviour to SW0.8 was observed until the cycle to $R=1/400$. In this specimen, however, significant shear cracks occurred at the top of the tensile column and developed diagonally to the bottom of the compressive column during the cycle to $R=1/200$. As a result, the lateral strength rapidly deteriorated during this cycle. Diagonal cracks developed as shown in Fig. 7b.

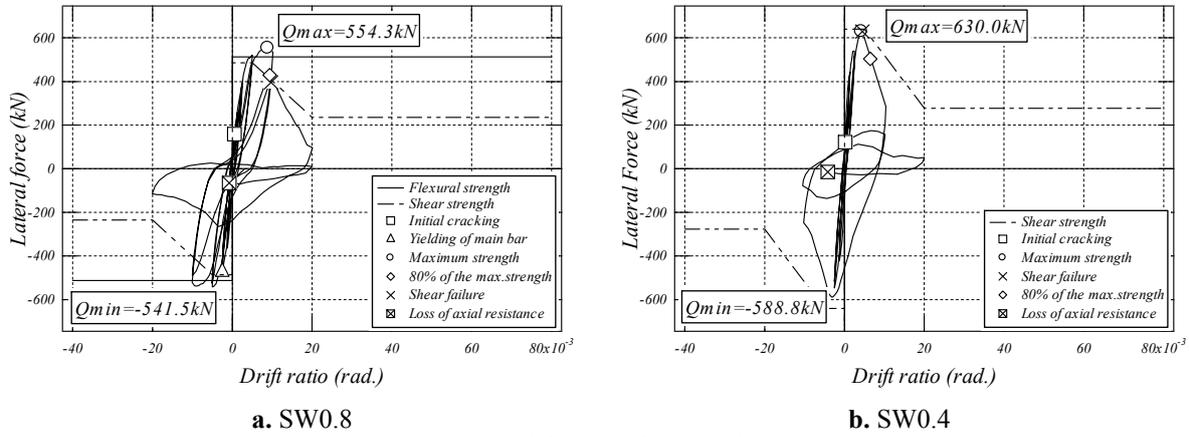
Figure 8. Lateral force-drift ratio relationships

Figure 8a shows the lateral force-drift ratio relationship of SW0.8. Stiffness was initially degraded with initial flexural and shear cracks at the tensile column and wall, respectively. The maximum lateral strength of 554 kN was recorded during the cycle to $R=1/100$, which exceeded the theoretical flexural strength. Then, the lateral resistance dropped rapidly to about 20% of the maximum strength after shear failure around $R=1/100$ during the cycle to $R=1/50$. It also lost axial resistance during this cycle.

The specimen exhibited similar behaviour to SW0.8 at small drift levels. As shown in Fig. 8b, however, it failed in shear prior to flexural yielding. The maximum lateral strength was 630 kN which was recorded during the cycle to $R=1/200$. Then, the lateral drift jumped to $R=1/100$ with rapid strength deterioration, and the shear resistance dropped to about 50% of the maximum strength. The specimen completely lost its horizontal and axial load carrying capacities during the cycle to $R=1/50$.

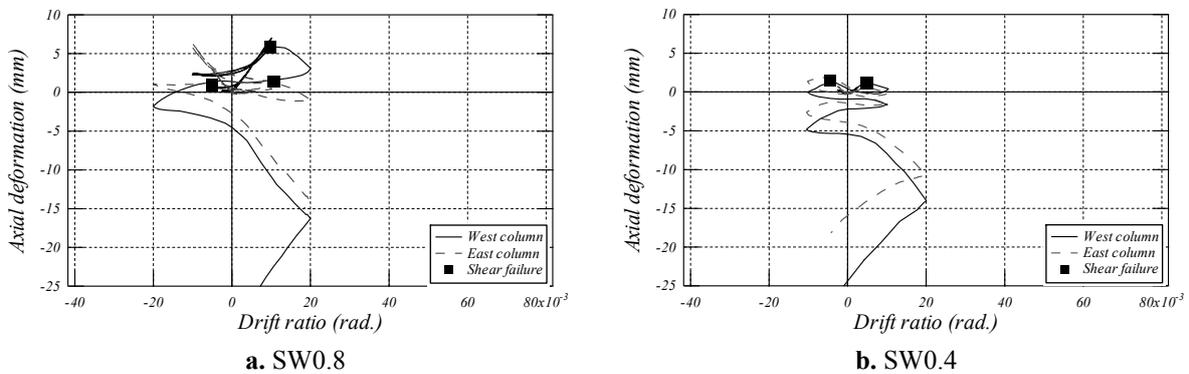
Figure 9. Axial deformation-lateral drift ratio relationships

Figure 9 shows the axial deformation-lateral drift ratio relationships of both specimens, which indicate that compressive deformations increased significantly after the specimens failed in shear. Sliding behaviour was also observed along the diagonal shear cracks, which are shown in Fig. 7, after the shear failure. Therefore, the relationship between axial deformation and lateral drift seems to be represented by a simple trigonometric equation (Eq. 1), as illustrated in Fig. 10.

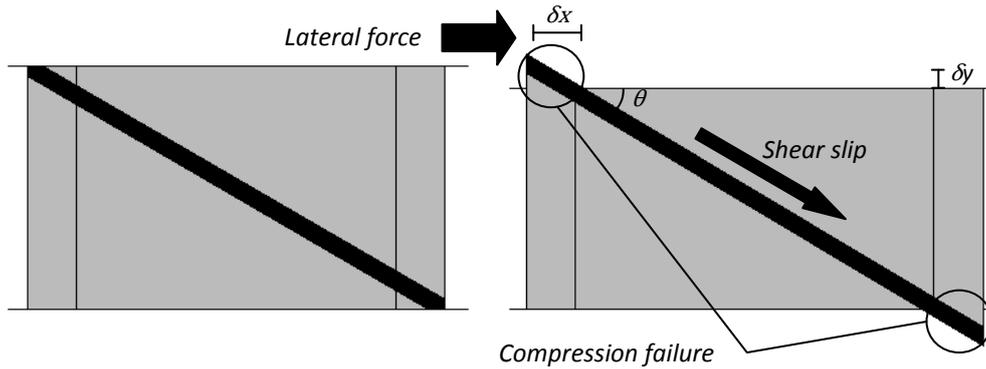
Figure 10. Shear slip behaviour

$$\delta_y = \delta_x \cdot \tan \theta \quad (1)$$

where, δ_y , δ_x , θ : refer to Fig. 10.

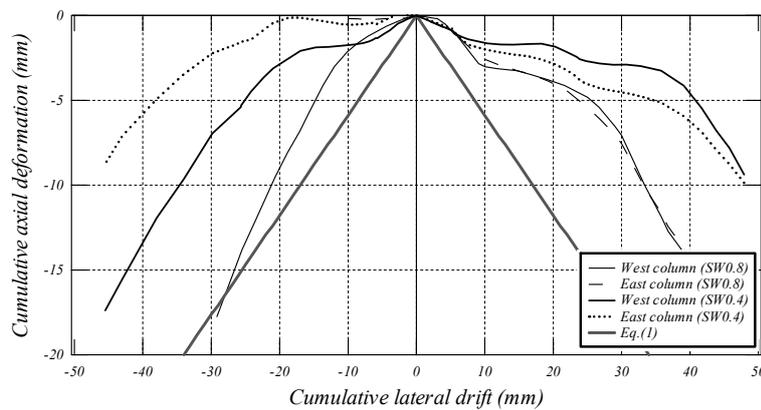
Figure 11. Cumulative axial deformation-cumulative lateral drift relationships after shear failure

Figure 11 shows the relationships between cumulative axial deformation and cumulative lateral drift for both specimens. However, the cumulative axial deformation of each column was obtained with a coordinate relative to the point of shear failure in each loading direction, as explained in Fig. 12. Comparing with the calculation by Eq. 1, it was found that the inclinations obtained with Eq. 1 agreed well with the experimental results in the ultimate state.

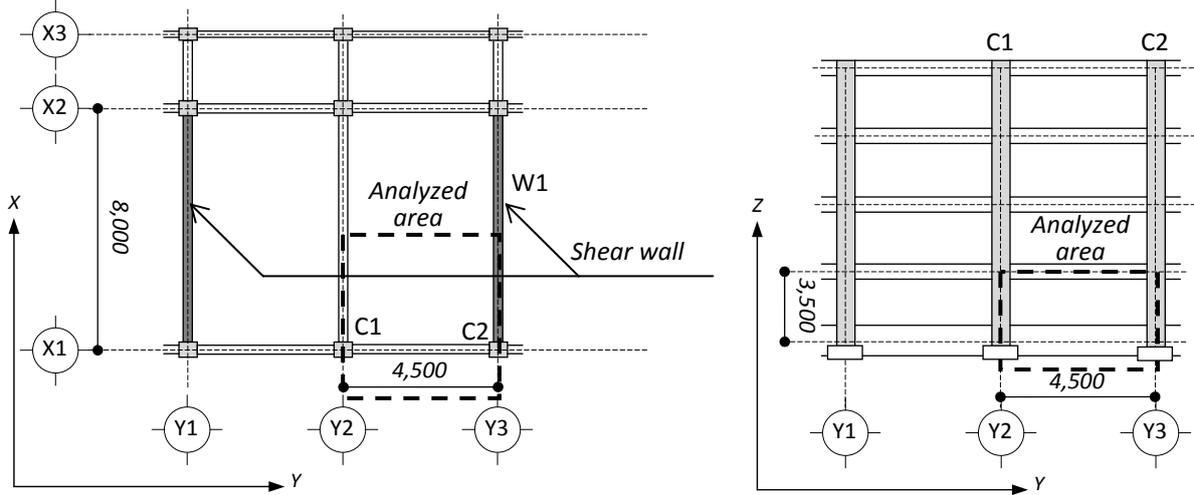
Figure 13. Analytical structure

The structure analyzed was a single-story frame partially extracted from a typical four-story R/C school building in Japan (JBDPA 2005), as shown in Fig. 13. Figure 14 shows the modelling of the structure. In the following analysis, however, responses of the structure were evaluated only along the X axis in Fig. 13.

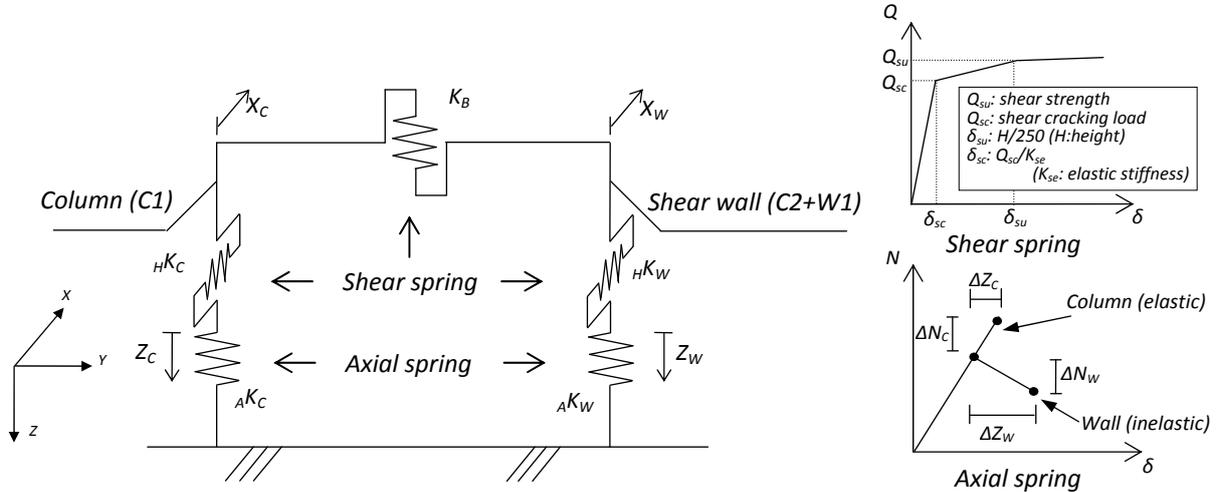
Figure 14. Modelling

where, ΔZ_W : incremental axial deformation of shear wall, ΔX_W : incremental lateral drift of shear wall (refer to Fig. 14).

where, ΔN_C : incremental axial force of column, ΔN_W : incremental axial force of shear wall, K_B : shear stiffness of beam, ΔZ_C : incremental axial deformation of column (refer to Fig. 14).

where, ${}_A K_C$: axial stiffness of column (refer to Fig. 14).

where, ${}_A K_W$: axial stiffness of shear wall (refer to Fig. 14).

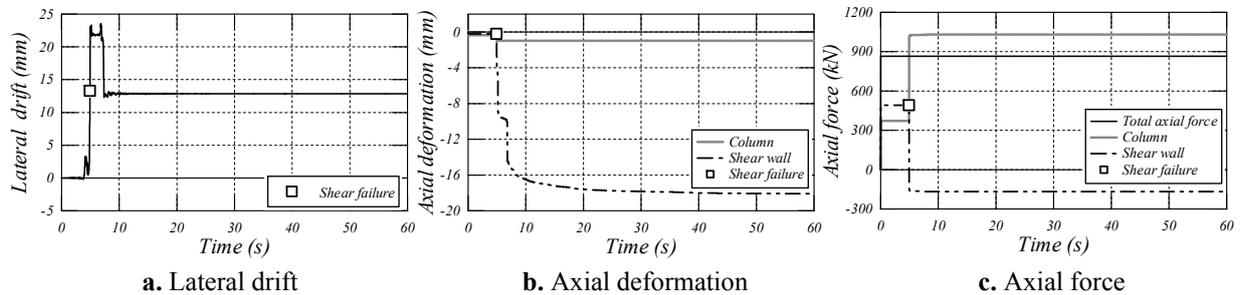
Figure 15. Analytical results

The 1995 JMA Kobe acceleration record (NS) was used for the earthquake response analysis. Damping was assumed to be proportional to initial stiffness with a damping ratio of 5%. Figure 15 shows the time histories of lateral drifts, axial deformations and axial forces of column and wall. The shear wall failed in shear at about 4 sec. from Fig. 15a, then exhibited large compressive deformation from Fig. 15b. As a result, the column adjacent to shear wall carried a larger axial load, which was 2.7 times before the shear failure of the wall. This result indicates the potential risk of a progressive collapse of this kind of structure.

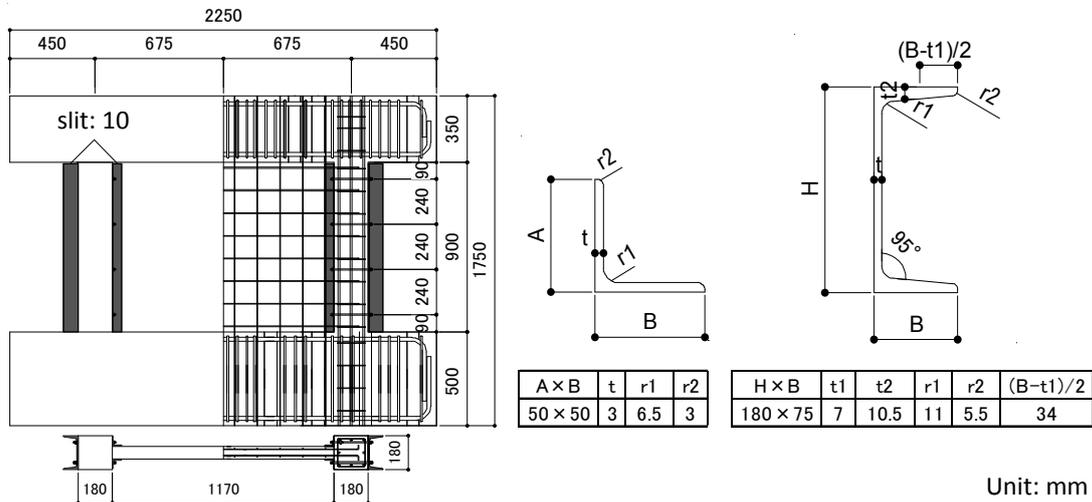
Figure 16. Details of strengthened specimens

The strengthening method proposed in Section 2 was applied to two of the specimens described in Section 3.1. Figure 16 illustrates details of strengthened specimens and steel shapes used for strengthening. Yield stresses of strengthening materials were 1092 N/mm^2 and 332 N/mm^2 for high-strength steel rods of $\phi 7$ and steel shapes, respectively. The tests were conducted in the same manner as described in Sections 3.2 and 3.3. Experimental results are compared between unstrengthened and strengthened specimens in the following.

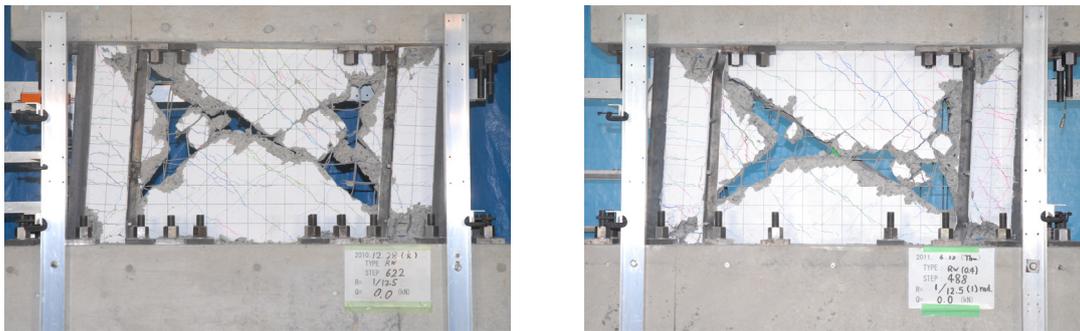
a. RW0.8

b. RW0.4

Figure 17. Damage to strengthened specimens after testing

cycles to $R=1/100$ and $R=1/400$, respectively. Then, in the cases of strengthened specimens, concrete crushing occurred particularly between the column and wall during the cycles to $1/50$ and $1/200$ for SW0.8 and SW0.4, respectively. Shear failure occurred only at the wall panels in the cycles to $1/50$ and $1/100$ for SW0.8 and SW0.4, whereas the boundary columns avoided shear failure at the ends. Therefore, they could still support the axial loads. Figure 17 shows the damage to strengthened specimens after the tests.

In the cases of strengthened specimens, the columns did not lose their axial resistances, which differed from the test results for unstrengthened specimens. The columns were finally separated from the wall panel with severe damage to concrete at the boundaries, as shown in Fig. 17. They behaved like an independent column in the ultimate state. Consequently, the columns were prevented from suffering shear and axial failure, as shown in Fig. 19, because they were not subjected to high punching shear forces from the wall panels.

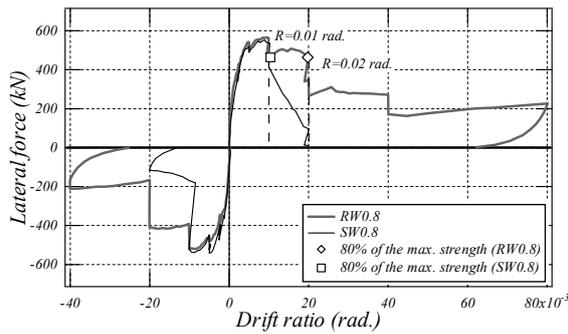
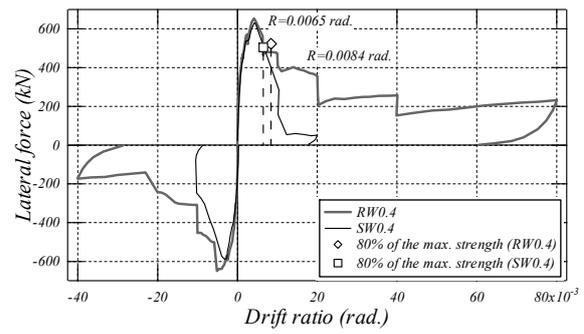
a. RW0.8 and SW0.8

b. RW0.4 and SW0.4

Figure 18. Comparisons between lateral force-drift ratio relationships

Figure 18 compares the envelope curves of lateral force-drift ratio relationships between the strengthened and unstrengthened specimens. Strengthened specimens exhibited similar envelope curves until the unstrengthened specimens failed in shear. Although neither of the strengthened specimens significantly exceeded the maximum strengths of unstrengthened specimens (even in the case of shear-critical wall, RW0.4), the deformation capacities, which were obtained at 80% of the maximum strengths, were improved by about 100% and 30% for RW0.8 and RW0.4, respectively. Horizontal strengths were not completely lost throughout the tests because the columns did not lose their axial load-carrying capacities.

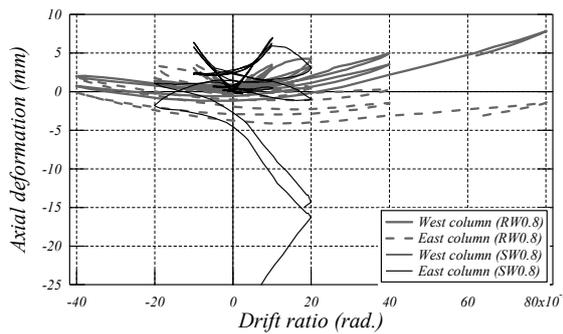
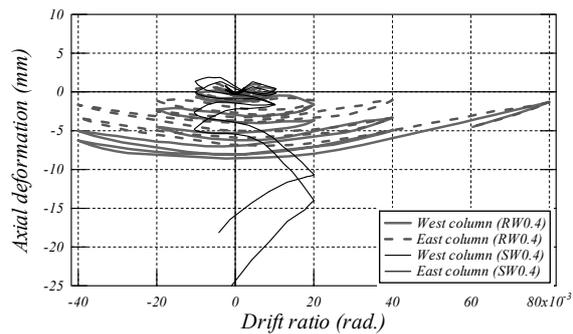
a. RW0.8 and SW0.8

b. RW0.4 and SW0.4

Figure 19. Comparisons between axial deformation-lateral drift ratio relationships
