# Need for action in earthquake mitigation of nonstructural elements in Switzerland – Regulations, responsibilities & implementation

**F. Braune**

*Coordination Center for Earthquake Mitigation  
Swiss Federal Office for the Environment FOEN*

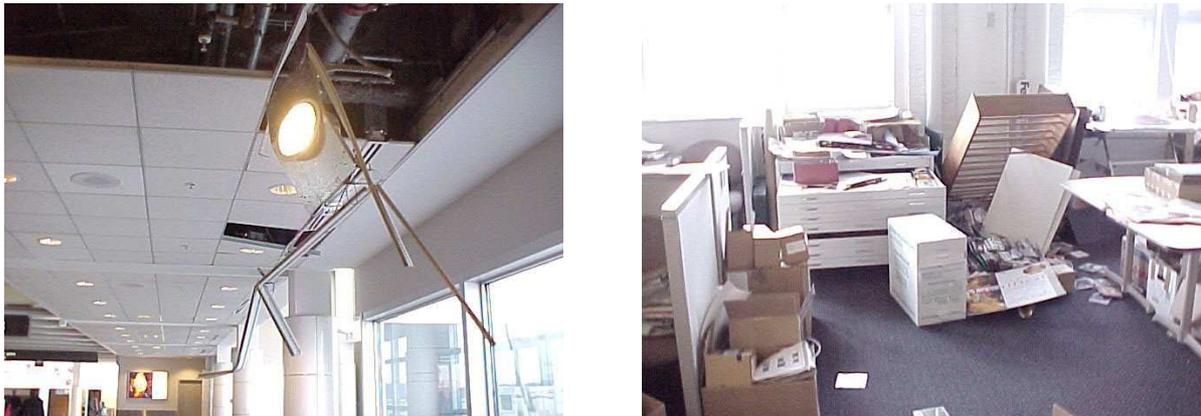
**Figure 3.** Typical nonstructural damage (Source: FEMA)
