# Tsunami Evacuation Process and Human Loss Distribution in the 2011 Great East Japan Earthquake - A Case Study of Natori City, Miyagi Prefecture -

15 WCEE  
LISBOA 2012

H. Murakami, K. Takimoto

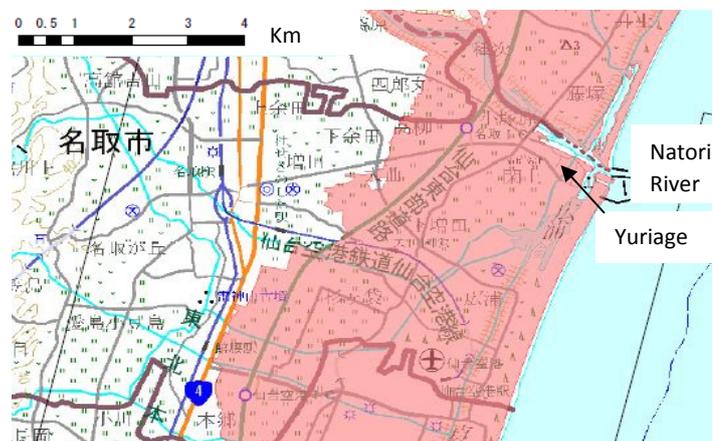
**Figure 1.** Tsunami inundation map of Natori city prepared by the Geographical Survey Institute (GSI) of Japan (pink zone) with notation added by the authors. Source: GSI

Natori city is located in flat alluvium plain in the south of Sendai city in Miyagi prefecture facing the Pacific Ocean along sandy coast (Fig. 1). When the 2011 off the Pacific Coast of Tohoku (hereafter the 2011 Great East Japan) earthquake ( $M_w=9.0$ ) occurred on Friday, March 11, at 14h46m (JST), the Yuriage fishing port and residential area as well as the Shimomasuda and Kitakama farming areas were totally devastated by the tsunami that followed. Tsunami inundation height at Yuriage port was 8.81m as reported by Mikami et al. (2012). Due to the flat low-lying topography the tsunami inundation zone extended to approximately 4 km inland from the coast, making evacuation conditions hard and dangerous. Out of 71,134 people resident in Natori city, number of human loss and missing reached 911 and 55 respectively. Extensive field observation on tsunami damage in Yuriage area are contained in EEFIT (2011) that was co-authored by this paper's authors. Table 1.1. indicates population and casualty statistics comparison of Natori city and other coastal cities and towns in Miyagi and Iwate prefectures. In Natori city, the fatality rate among the population estimated by Miyazawa (2011) to reside in the inundated area reached 9.26% and is among the highest in the flat coastline region of Miyagi prefecture.

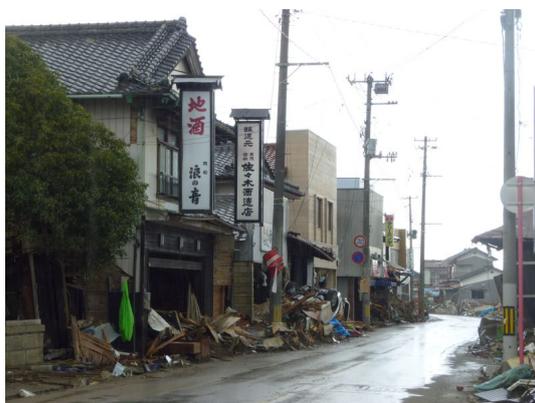
**Photo 1.** Yuriage 1-chome, a shopping street with remaining houses

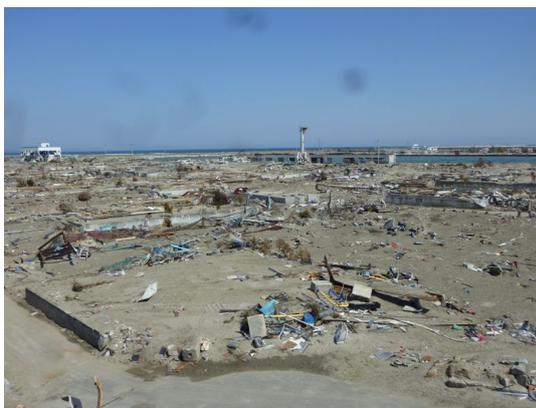
**Photo 2.** In Yuriage 4-chome near the fishing port, houses were totally lost, only foundations of wooden houses remain

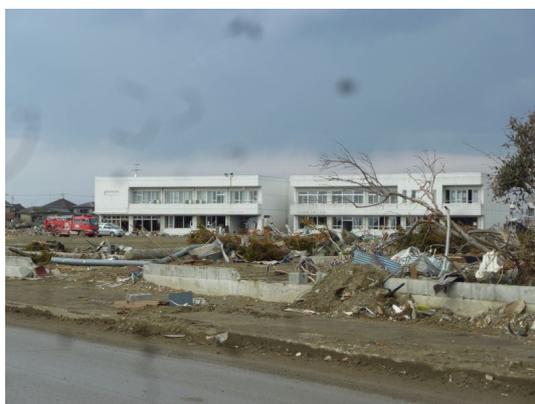
**Photo 3.** Yuriage community center in which 43 people evacuated 2<sup>nd</sup> floor and survived

in the rias coastline of Miyagi and Iwate prefectures (e.g. Ofunato) is not possible. Yuriage community center (2 storeys), Yuriage junior high school (3 storeys), and Yuriage elementary school (3 storeys) are all reinforced concrete (RC) buildings designated as evacuation shelters in the hazard map (Fig. 2), but were not meant to be vertical tsunami evacuation buildings (Murakami, et al., 2012).

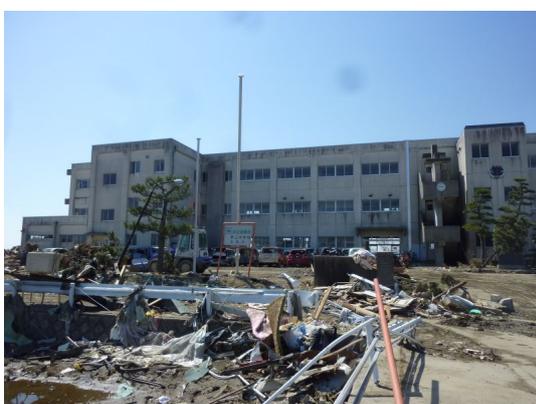
**Photo 4.** Yuriage junior high school where 800 people took refuge and survived

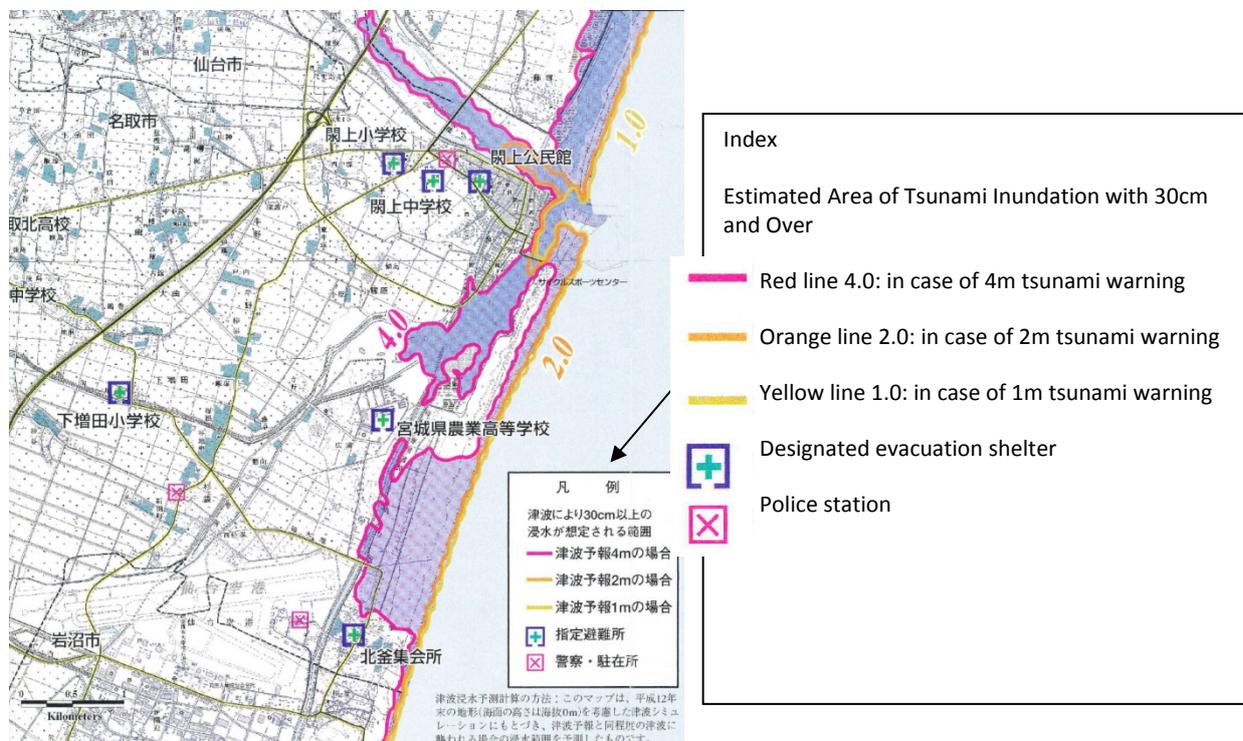
**Figure 2.** Natori City Tsunami Inundation Estimation Map published and distributed to households in 2001 (source: Miyagi prefectural government)

Residents in alluvium plain in Sendai coast had little experience of tsunami damage in the 1896 Meiji Sanriku, the 1933 Showa Sanriku earthquakes, nor in the 1960 Chile tsunami. Miyagi prefecture government (2004) published the third comprehensive report on estimated damage from a most-likely scenario earthquake expected to occur in the Pacific Ocean (M7.8). The tsunami hazard map for Natori city (Fig. 2) was prepared prior to this report in 2001 with estimated inundation zone under 3 tsunami height scenarios (4, 2 and 1 metres respectively). The estimated inundation zone under all 3 scenarios was constrained near the Yuriage port and in rice paddies, but not in the densely populated residential area.

- 1) Natori city's 2001 tsunami hazard map was based on tsunami of 1, 2 and 4 metres, but the tsunami of 2011 exceeded 8 metres.
- 2) The municipal wireless system for broadcasting emergency information was unfortunately disabled during strong shaking, and as a result tsunami warning and evacuation order was not broadcast through loudspeakers. People got information via radio, TV, neighbours, police, firemen, and official PR vehicles

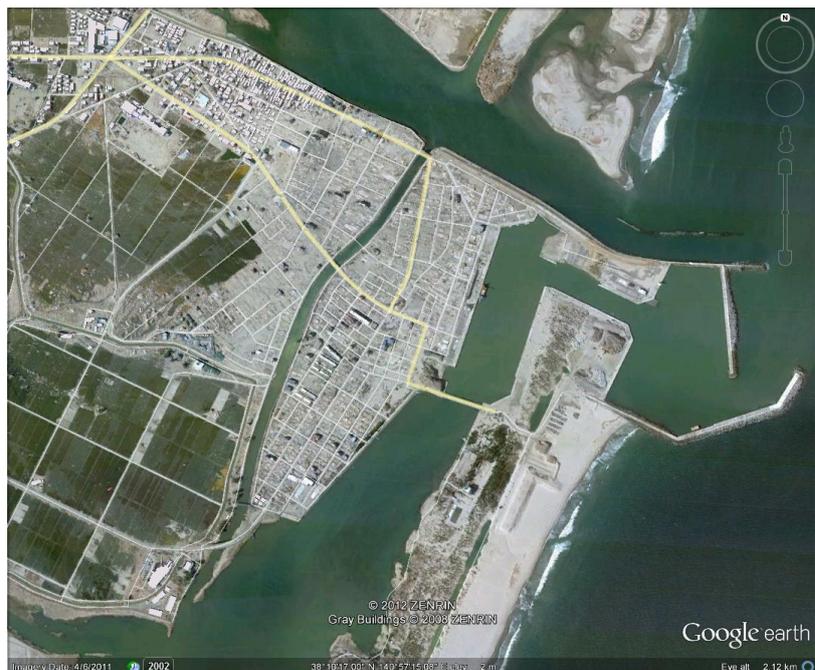
**Figure 5.** Aerial view of Yuriage district, Natori city after tsunami disaster by Google Earth

Fig. 5 is aerial view of Yuriage district, which indicates post-tsunami damage conditions. Yuriage district is subdivided into 7 neighbourhoods (akin to postcode areas) called “*chome*” and the boundaries can be seen in Fig. 6. The confirmed fatalities were classified by address divisions and compared with rate of elderly population, ratio of houses destroyed/washed-away (Table 2.1.). Life loss rate and ratio of totally lost houses for each chome are shown in the map with inundation levels and major evacuation places (Fig. 6). The topography of Yuriage area is flat coastal plain with most elevation less than 5m, thus prompt evacuation to nearby natural hills like in some towns

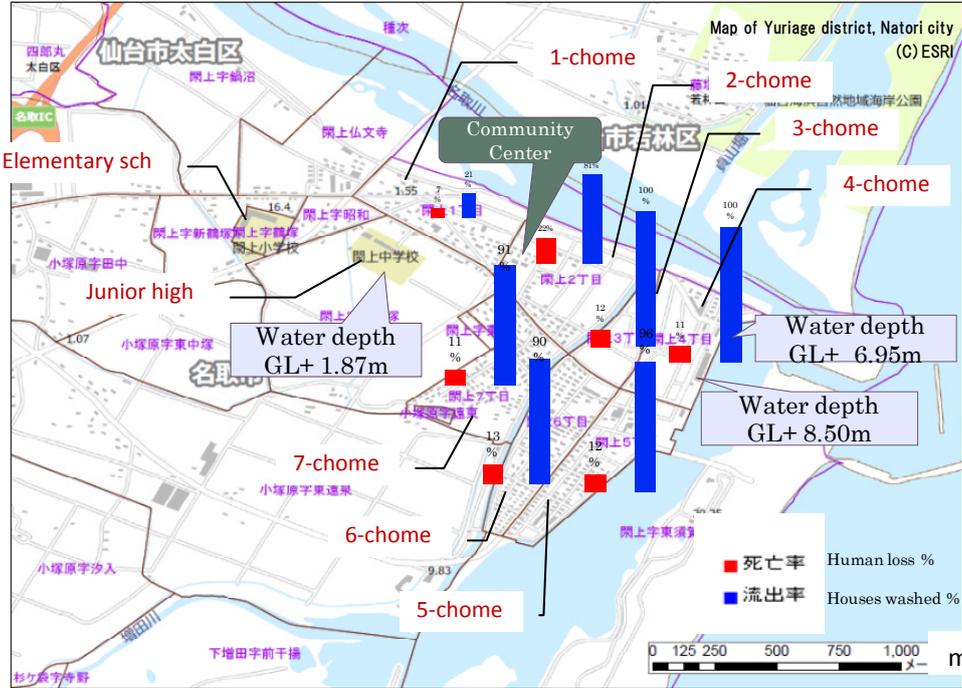
**Figure 6.** Human loss % and damage ratio of houses washed away with inundation depth in the map of Yuriage, Natori city (water depth as reported by Natori city office (2011))

Yuriage 3- to 5-chomes are located east of Teizan-bori canal, closer to the ocean, where inundation height was higher (8.5m – 6.95m), and ratio of wooden houses washed away was from 100% to 96%. Human loss ratio there was from 11% to 12%. In 6-chome, RC apartment buildings were located and housing damage ratio did not reach 100%. Worst affected was Yuriage 2-chome, where life loss rate reached 22.3%, while housing loss was 81%. The rate of elderly population was highest in surrounding farming area of Kozukahara (18.9%) and 3-chome (17.3%), whilst in 2-chome (14.6%) was the third highest. The hypothesis is that many residents of 3- to 5-chomes situated nearest to the ocean evacuated promptly while in 2-chome many of the residents thought that major tsunami will not attack their place which is approximately 1 to 1.4 km inland and thus did not start evacuation promptly. This hypothesis will be examined by the results of the questionnaire survey (see section 3.3 and Fig. 15).
