Seismic Performance of an Actual Member in an Existing RC Building

15 WCEE
LISBOA 2012

SUMMARY:

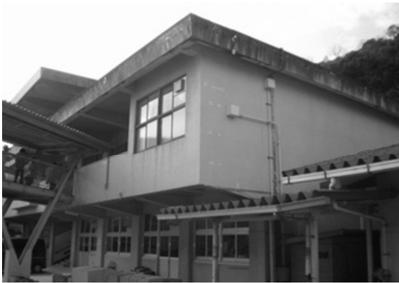
Figure 1. Side view of school building

The target building was a three story reinforced concrete building constructed in 1967, and used as an elementary school building. This building was judged to have a low seismic performance in the seismic diagnosis. The subjected beams located at the end of the slab were removed to reduce story weight and repairing in the retrofitting scheme. The school building is shown in Fig. 1. Elevations of the building are shown in Fig. 2.

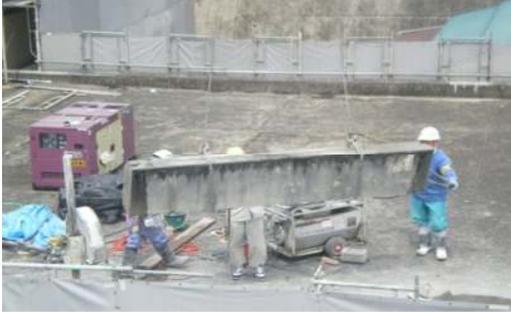
Figure 3. Actual beam from the existing building

The actual beams were taken out of the roof slab without any damage using a wire saw. Hoisting of a beam after cutoff is shown in Fig. 3, and two specimens E15 and E15-C1 were prepared. E15 is an existing beam and E15-C1 is the same beam strengthened using CFRP sheets and epoxy resin injection. The number of carbon fiber sheets used was based on the Draft⁽⁶⁾ of Architectural Institute of Japan (2001).

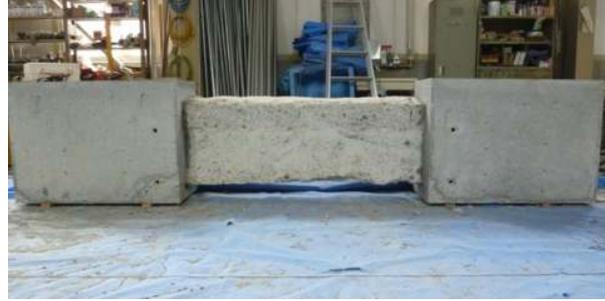
Figure 4. Completed specimen with stubs

The reinforced concrete stubs were manufactured at both ends of the existing beams. The three specimens shared a common shear span length and shear span ratio of 1350 mm and 1.5 respectively. Fig. 4 shows one of the completed existing beams after manufacturing of the stubs. Fig. 5 shows reinforcement details and dimensions of the test specimens. Concrete at both ends was removed to expose longitudinal reinforcement and to allow welding of a steel plate to ensure anchorage before manufacturing stubs for the

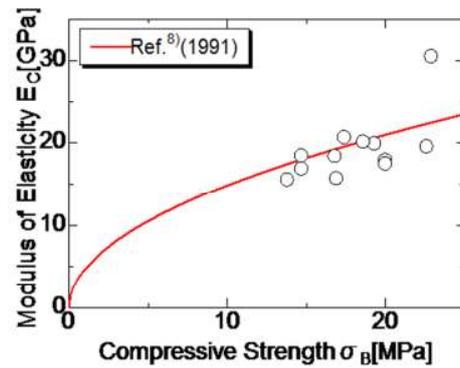
Figure 7. Relationship of compressive strength and Modulus of Elasticity

The relationship of compressive strength versus modulus of elasticity showed a relatively good correspondence with the formula⁸⁾ as shown in Fig. 7. Where the formula is:

$$E_c = 2.1 \times 10^4 \times (\gamma / 23)^{1.5} \times (F_c / 20)^{1/2} \quad (2.1)$$

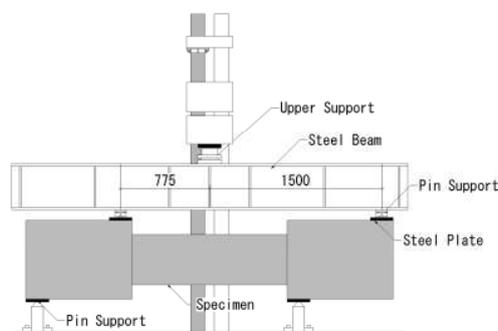
Figure 8. Loading apparatus

The beams were subjected to reversible loadings by using a universal testing machine with maximum vertical load 100ton and availability to displacement controlling under anti-symmetric moment as shown in Fig. 8.

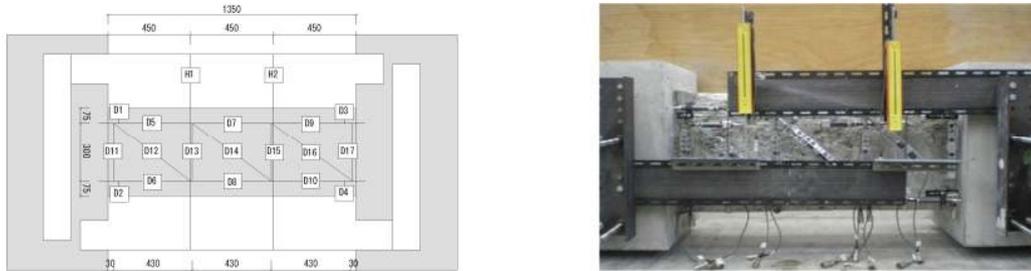
Figure 9. Displacement transducers on the rear side of specimen

The relative shear displacements between the stubs and the local displacements of the beam were obtained using electric displacement transducers instrumented on the rear side of the beam as shown in Fig. 9. The distributions of the flexural and shear deformation were obtained from those data. In specimen N15, strain gauges were attached to main bars to measure strains of these bars

Fig. 13 shows the relationship of drift angle versus percentage of flexural deflection. The flexural deflection was obtained by subtracting the shear deflection from total deflection. Shear deflection was obtained by the local displacement measured with displacement transducers as shown in Fig. 9. For the retrofitted beam E15-C1, the initial state of flexural deflection accounted for 80% to 90% of the total, similar to the other specimens. This flexural deflection was due to bond slip of the main bars or main bars yielding, because most of the flexural cracks were observed at both of the beam ends. For specimen E15, the initial percentage of flexural deformation was about 80% and then decreased rapidly because of

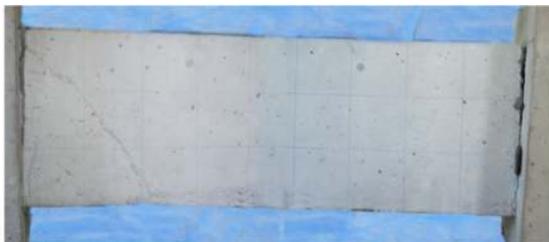
Figure (10-a) Failure Mode .N15

Fig. 10 shows the failure mode of each specimen. A large difference in failure mechanism between the existing beam E15 and the new one N15 was observed. For new beam N15, flexural cracks had occurred in the boundary surface between both ends of the beam and stubs from $R=1/400\text{rad}$, and their width increased when displacement increased as shown in Fig.10-(a). In addition, a slight shear cracks occurred in the left portion of the beam at drift angle $R=1/400\text{rad}$, but those shear cracks did not progress. The final failure pattern of N15 was bond slippage of the main bars as those bars were plain round bars. On the other hand, for the existing beam E15, flexural cracks occurred at the boundary surface between both ends of the beam and stubs, and shear cracks occurred in the mid area of the beam at drift angle $R=1/400\text{rad}$. With the increasing of deformation, the width of the shear cracks increased when displacement increased. The final failure mechanism was due to shear failure, Large X shaped diagonal cracks were observed as shown in Fig. 10-(b).

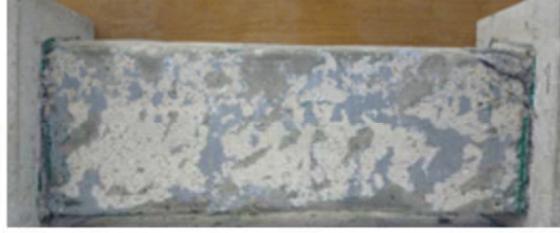
Figure (10-c) Failure Mode. E15-C1 after removing fiber

For the retrofitted existing beam E15-C1, the flexural cracks were observed at both ends of the beam and it was not possible to observe cracks in the mid area of the beam due to the fiber sheets. After loading, the fiber sheets were removed to inspect the appearance of the mid span of the beam. Disintegration of the concrete cover was observed in the hinging region of the beam.

Cracks in the mid area of the beam body were not observed, as shown in Fig.10-(c). It could not be judged whether the final failure mechanism was bond slip type or flexural failure due to the yielding of the main bars.

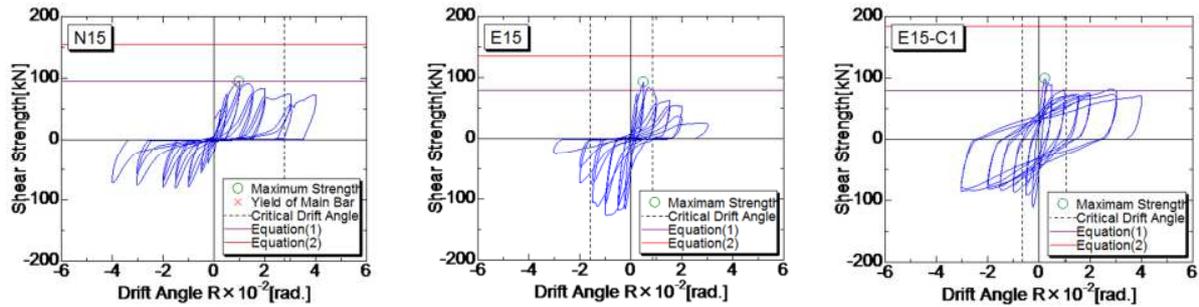
Figure 11. Relationship of shear force versus drift angle

Fig. 11 shows the relationship of shear strength versus drift angle. The strength of specimen N15 reached maximum strength at drift angle $R=1/200$ rad. The peak of the shear strength of each loading cycle did not decrease very rapidly. From the shape of the hysteresis loops it is found that bond slip of the main bars had an influence on the restoring force characteristics. Although the critical drift angle was approximately $R=1/32$ rad. The stiffness near the origin was very low due to the bond deteriorations when the displacement increased. For specimen E15, the strength had reached maximum strength at drift angle $R=1/200$ rad.

After the maximum strength was reached, the strength decreased rapidly. The hysteresis loops show a pinched shape in the vicinity of the origin. The critical drift angle was $R=1/100$ rad, which was less than that for N15. For specimen E15-C1 the strength had reached maximum value at drift angle $R=1/400$ rad in the first loading cycle. After the strength slightly decreased, it then became constant. The main bars had yielded according to the shape of the shear force loops which were a spindle type. Calculated values of flexural strength and shear strength using the following equations⁷⁾ are shown in the Figure. It was assumed that the bars arrangement were the same as in the structural drafts. Material strengths were obtained in the material tests performed before the loading tests. The strength was substantially greater than the value obtained by the flexural formula Eqn. (3.1).

The strength of each specimen was close to the value calculated by Eqn. (3.1). The critical drift angle was $R=1/100$ rad. For specimen E15, the calculated shear strength by Eqn. (3.2) was much greater than the observed strength although the failure mode of this specimen was shear failure.

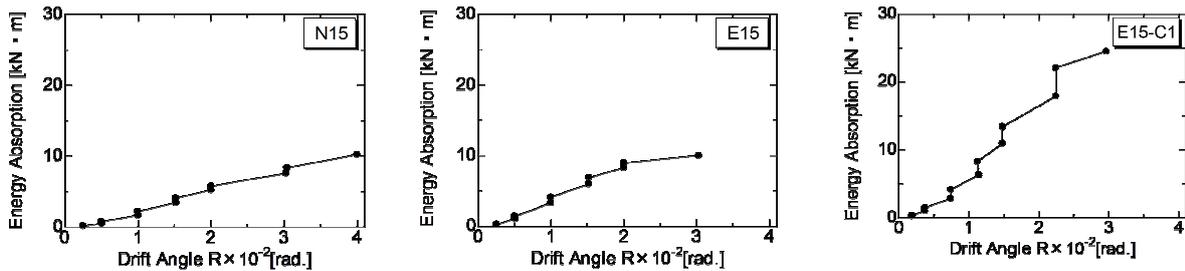
Figure 12. Energy Absorption

Fig. 12 shows the amount of energy absorption of each specimen. There was a slight difference in the increasing of energy absorption between N15 and E15, but there was an obvious difference between these specimens and the retrofitted specimen E15-C1, as can be seen in Fig. 12. For N15, increasing of energy absorption was approximately linear until the final failure with maximum value of approximately 10kN·m at drift angle $R=1/25$ rad. The same properties were observed in E15, but when the deformation increased over drift angle $R=1/50$ rad, the energy absorption was close to being constant. On the other hand, in the retrofitted beam E15-C1, the energy absorption was the same as the other two specimens before $R=1/100$ rad, and then began to increase rapidly. The rapid increase of E15-C1 resulted from yielding of the main bars. The energy absorption eventually neared 25kN·m, which was 2~3 times of those of the beams without retrofitting.

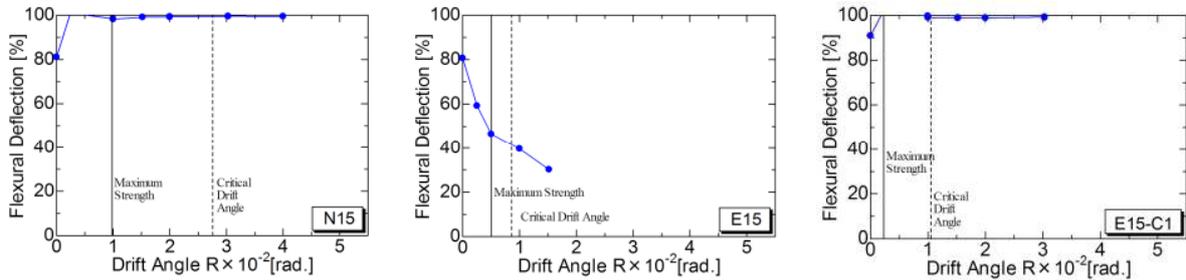
Figure 13. Percentage of flexural deformation to total deformation

the brittle shear failure, with final percentage of shear deformation at about 70%.

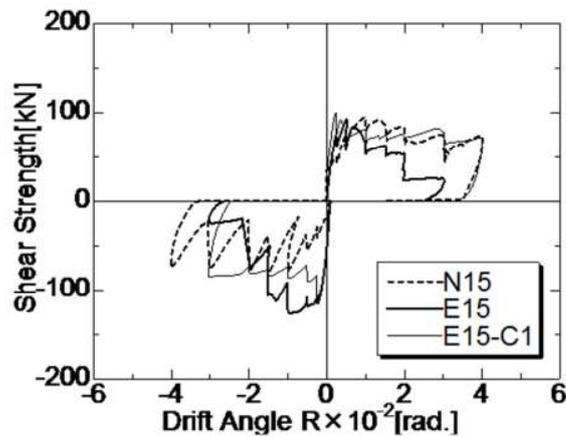
Figure 14. Envelope Curves of shear force-drift angle

Fig.14 shows the envelopes of the three specimens' restoring characteristics. There was an obvious difference between these envelopes. For specimen N15, differences in the positive and negative directions of loadings were observed. These differences are a result of the occurrence of the bond slip and the positive loading affect on the restoring force characteristic in the negative loadings. For both specimens E15 and E15-C1, envelope curves were almost the same in the positive and negative directions. For E15-C1, envelope was stable in both positive and negative directions.

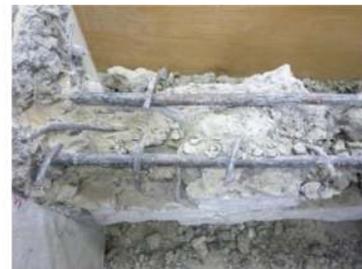
For specimen E15, the maximum strength was greater than the calculated flexural strength by approximately 1.11 times and less than the calculated shear strength by approximately 0.67 times. It was found for the existing beam that the maximum strength based on the failure mechanism could not be predicted. For retrofitted beam E15-C1, the maximum strength was greater than the calculated flexural strength by approximately 1.2 times. For specimen E15, after loading, the concrete cover was removed to reveal more information about reinforcement details as shown in Fig. 15~17. In the structural drafts, intervals of the stirrups were 300mm, but in the actual beam, intervals were approximately 500mm with 90 degree hooks at the connection to the main bars. The additional length at the hook was 40mm.

Because round bars were used for the stirrups, it is a possibility that a stirrup fell out of the concrete. Therefore, the stirrups were not effective in preventing shear cracks. In addition, the actual beam depth D was greater than 500mm, but $D=450$ mm in the structural drafts. The difference in depth between the structural draft specifications and the actual cross-section would have an effect on the shear span ratio (M/QD) and relative shear reinforcement ratio p_w . The cross-section shape of the existing beam was a

**Figure 16.** Stirrups with 90° hook**Figure 15.** Main reinforcement at beam ends

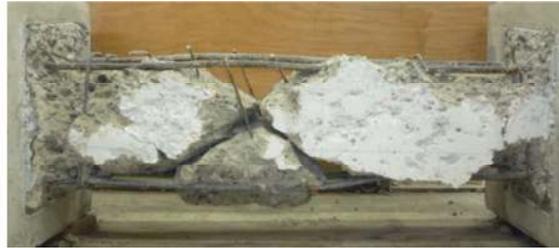
Figure 17. Bars arrangement

parallelogram rather than a rectangle. Based on the details of the actual beam the analysis was performed again assuming a stress block. The results of the analysis are shown in Table 5. The calculated shear strength became closer to the maximum of approximately 0.97. The calculated shear strength was not lower than the calculated flexural strength, although the final failure mechanism was a brittle shear failure. From the Design Guidelines of AIJ⁹⁾ the calculated shear cracking strength was approximately 80.2kN, and the maximum shear strength was 105.2kN. Further inspection is required to predict the maximum strength of the existing RC members.
