Comparison of Current Construction Practices of Non-Engineered Buildings in Developing Countries

SUMMARY:

Keywords: Non-engineered buildings, construction practices, developing countries, earthquake vulnerability

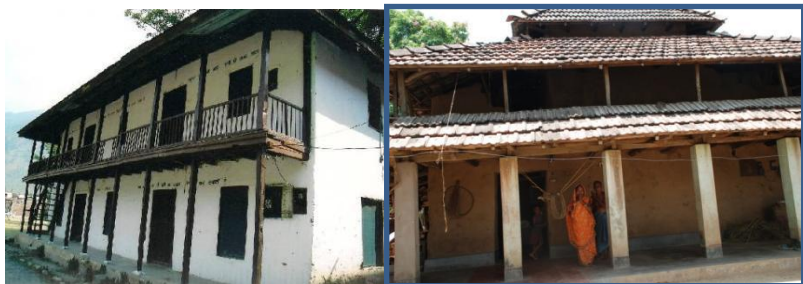
The most common non-engineered building in India is masonry building (of various types of bricks) with G + 1 story high. Most of the brick masonry building uses mud brick (adobe), CSEB and quarry stone.

Figure 1. Typical Non-Engineered Buildings in India

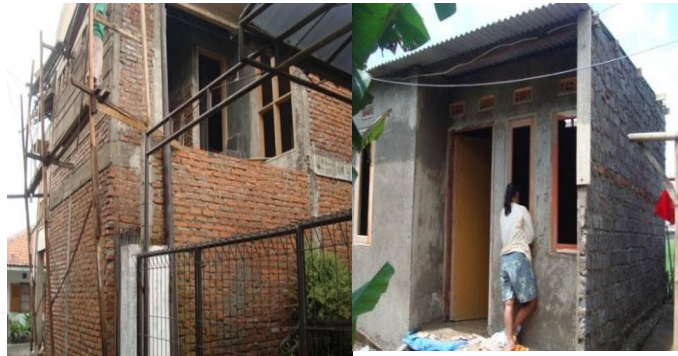
In general, there are three most common non-engineered constructions found in Indonesia, i.e. unconfined brick or concrete block masonry, confined masonry, and reinforced concrete frame with infill masonry. Unconfined masonry building relies on the wall as the only load bearing structural elements (vertical and lateral). There is no confinement on

Figure 2. Typical Non-Engineered Buildings in Indonesia

this type of building and it is rarely found in Bandung area. Confined masonry building relies on the masonry walls as the main load bearing structural elements. The confinement will contribute also to maintain the integrity of the wall when the loads are applied to the structures. Most of the confined masonry structures in Bandung are confined by reinforced concrete practical column/beams. Reinforced concrete with infill masonry wall building relies on the reinforced concrete columns and beams as the main load (both lateral and gravity) bearing structural elements

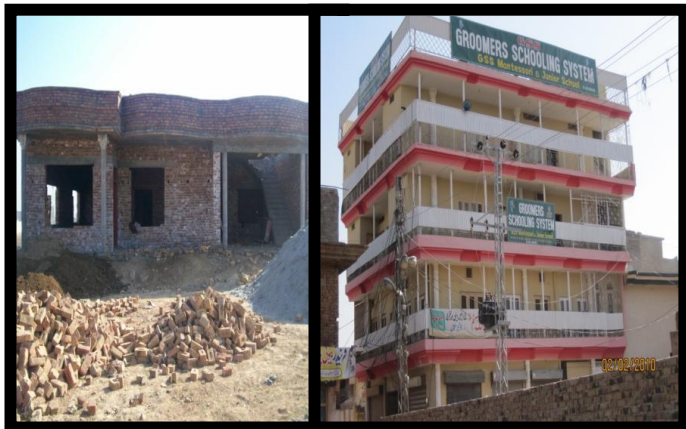
Figure 3. Typical Non-Engineered Buildings in Pakistan

Three types of non-engineered building (confined masonry, unconfined masonry and reinforced concrete with infill masonry) are mostly adopted in non-engineered buildings in Pakistan.

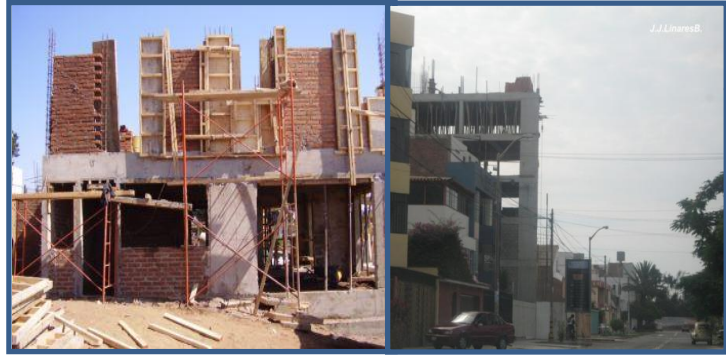
In Peru, there are three types of non-engineered buildings. Those are confined masonry building with horizontal and vertical confinements that support the bricks walls, Unconfined masonry walls building without reinforced collar beam and reinforced confined elements and Concrete moment resistant frame with concrete shear walls or infill masonry.

Figure 4. Typical Non-Engineered Buildings in Peru

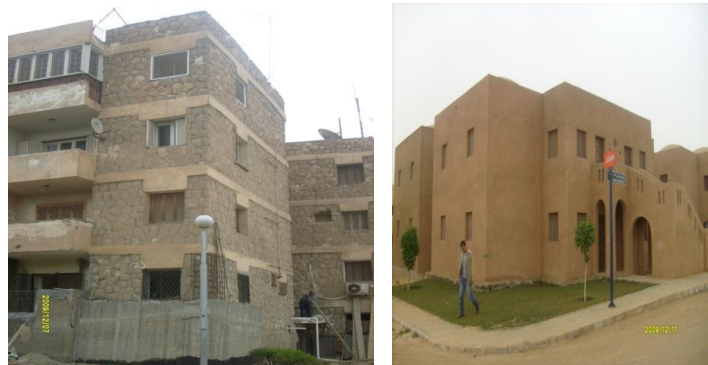
The most common types of non-engineered building in Egypt are reinforced concrete skeleton type buildings, wall bearing lime stone buildings and combined reinforced concrete and lime stone wall buildings.

Figure 5. Typical Non-Engineered Buildings in Egypt

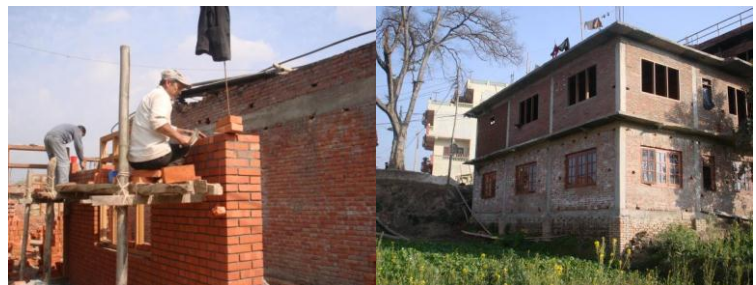
In Nepal, there are two types of non-engineered brick masonry buildings, i.e. unconfined brick masonry buildings and reinforced concrete buildings with brick masonry infill.

Figure 6. Typical Non-Engineered Buildings in Nepal

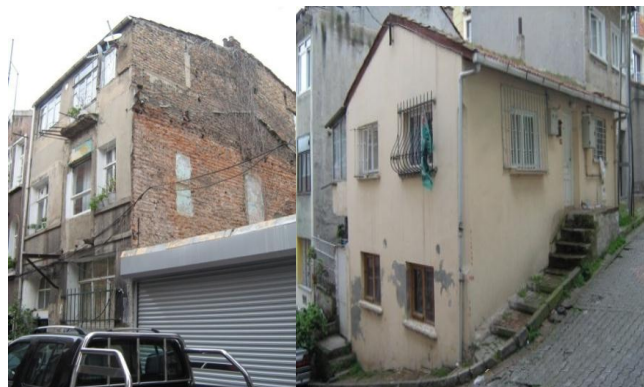
There are three types of non-engineered building in Turkey, i.e. reinforced concrete frame with clay hollow brick infill wall, unreinforced brick masonry and wooden structures.

Figure 7. Typical Non-Engineered Buildings in Turkey

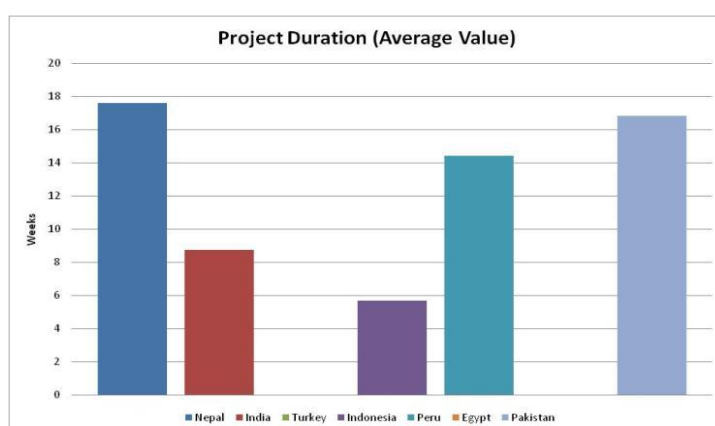
Respondents (house owners as well as workers) in Nepal, India, Turkey, Indonesia, Peru and Pakistan agree that earthquakes become the most common natural disasters, while in Egypt and also in Indonesia wind is also considered as common natural disaster. Some other countries like India and Peru also suffer from flood. Typically a non-engineered building is constructed within 6 to 17 weeks (see Figure 9).

Figure 9. Construction period

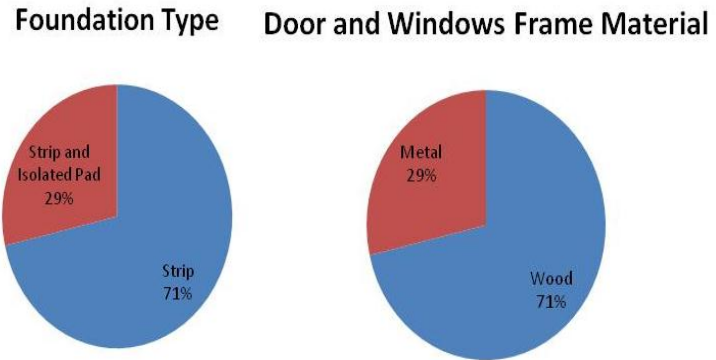
“Strip and isolated pad” (the simplest foundation system) is found mostly in the non-engineered buildings surveyed, constructed from various materials, such as stone and RC. For confined masonry, most of the buildings use reinforced concrete confinement. Wood is the most common material used for door and windows framing system (see Figure 10).

Figure 10. Foundation type and door/window frame material

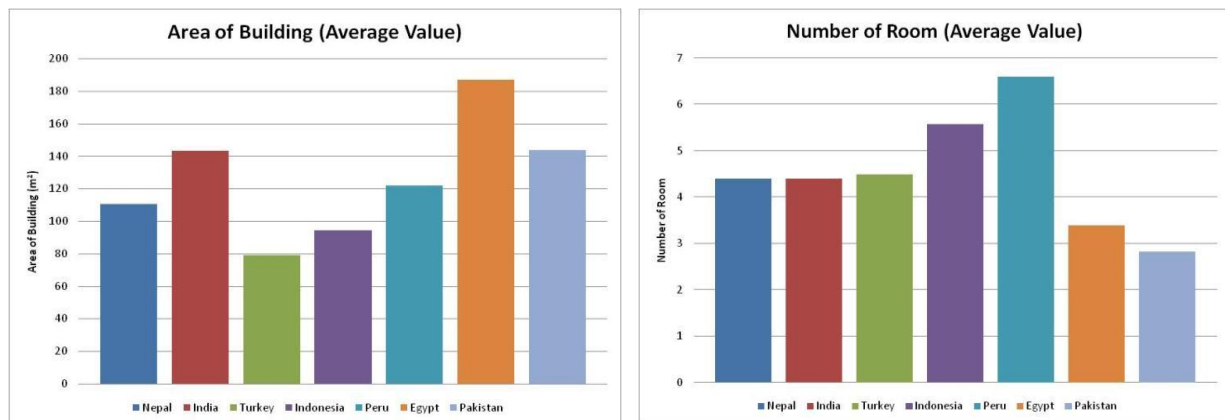
It is found that most of the non-engineered buildings in the selected countries are unconfined masonry, except in Indonesia and Peru where the confined masonry is more popular. Building area depends on its main function. Average value varies from 80 m² to 187 m². Typical number of rooms varies for each country (see Figure 11)

Figure 12. Area of Building (left) and Number of Room (right)

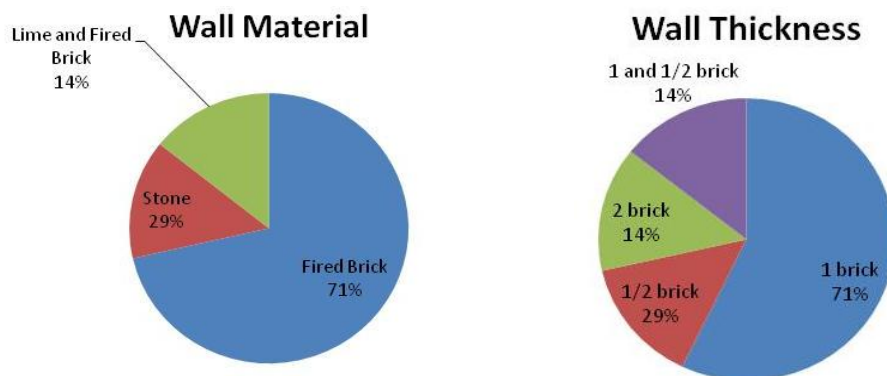
Most of the buildings utilize fired clay bricks as wall material, with one brick thickness (see Figure 13). In terms of wall height to thickness ratio, the highest ratio is found in Indonesia (19.83), while the smallest is found in Egypt (9.00). The higher value of the ratio indicates the lower wall stiffness (see Figure 14). The ratio of total length of wall to floor area indicates the capacity of the building in

Figure 13. Wall material (left) and wall thickness

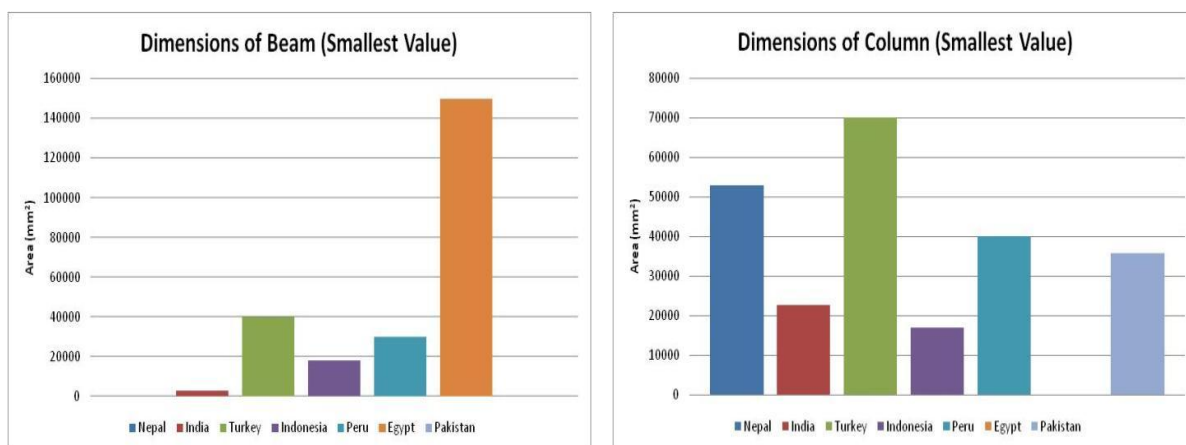
Most of non-engineered constructions provide beams and few of them provide columns. This depends on the structural system adopted in the surveyed country. In Indonesia, most of the surveyed sites exhibit confined masonry, so both columns and beams are available. On the other hand, in Pakistan, Egypt, and India, where most of the selected sites are unconfined masonry, the buildings are only provided with beam/lintel. From all of the selected countries, it was found that most of non-engineered construction had poor detailing on the connection of the structural elements. Pakistan exhibits the largest beam area, while Turkey exhibits the largest columns area. (see Figure 15)

Figure 15. Dimension of Beam (left) and Dimension of Column (right)

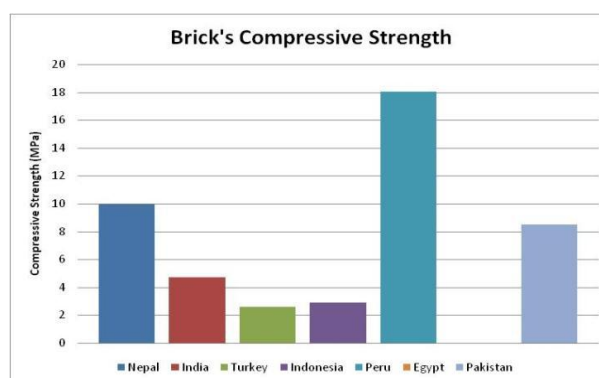
Most of the non-engineered constructions at the selected countries use baked clay or stone masonry for the wall materials. Brick sizes in Turkey, Nepal, Indonesia, Peru and Pakistan are relatively similar, meanwhile in India and Egypt bricks have different sizes compared to the others. Peru has the highest brick compressive strength, while Turkey has the smallest brick compressive strength compared to the other countries. Test results from sites in each country showed that some do not have adequate strength for the brick (see Figure 16).

Figure 16. Brick's Compressive Strength

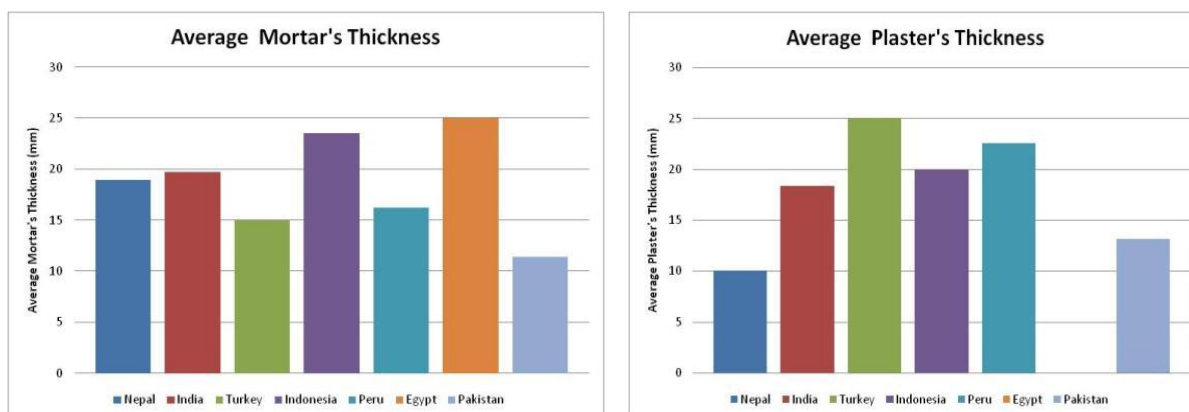
Most of the countries use ordinary Portland cement as plaster and mortar cementing agent. Pakistan found to have the highest mortar strength, even though the mix is similar with other countries. On the other hand, Peru has different mortar mix compared to the other countries, but it produce the same compressive strength. The mortar thickness in Egypt is found to be the thickest (25 mm), while Turkey and Pakistan have the thinnest mortar layer (10-20 mm and 11.5mm respectively). The

common plaster mix is either 1:6 or 1:4 (pc : sand) , except in Peru where the mix is 1:1. Turkey has the thickest plaster (20-30 mm), while Nepal has the thinnest plaster (10 mm) (see Figure 17).

Figure 17. Average mortar's thickness (left) and average plaster's thickness (right)
