# Vulnerability of traditional wooden shrines located at Yurihonjo, Japan

## SUMMARY:

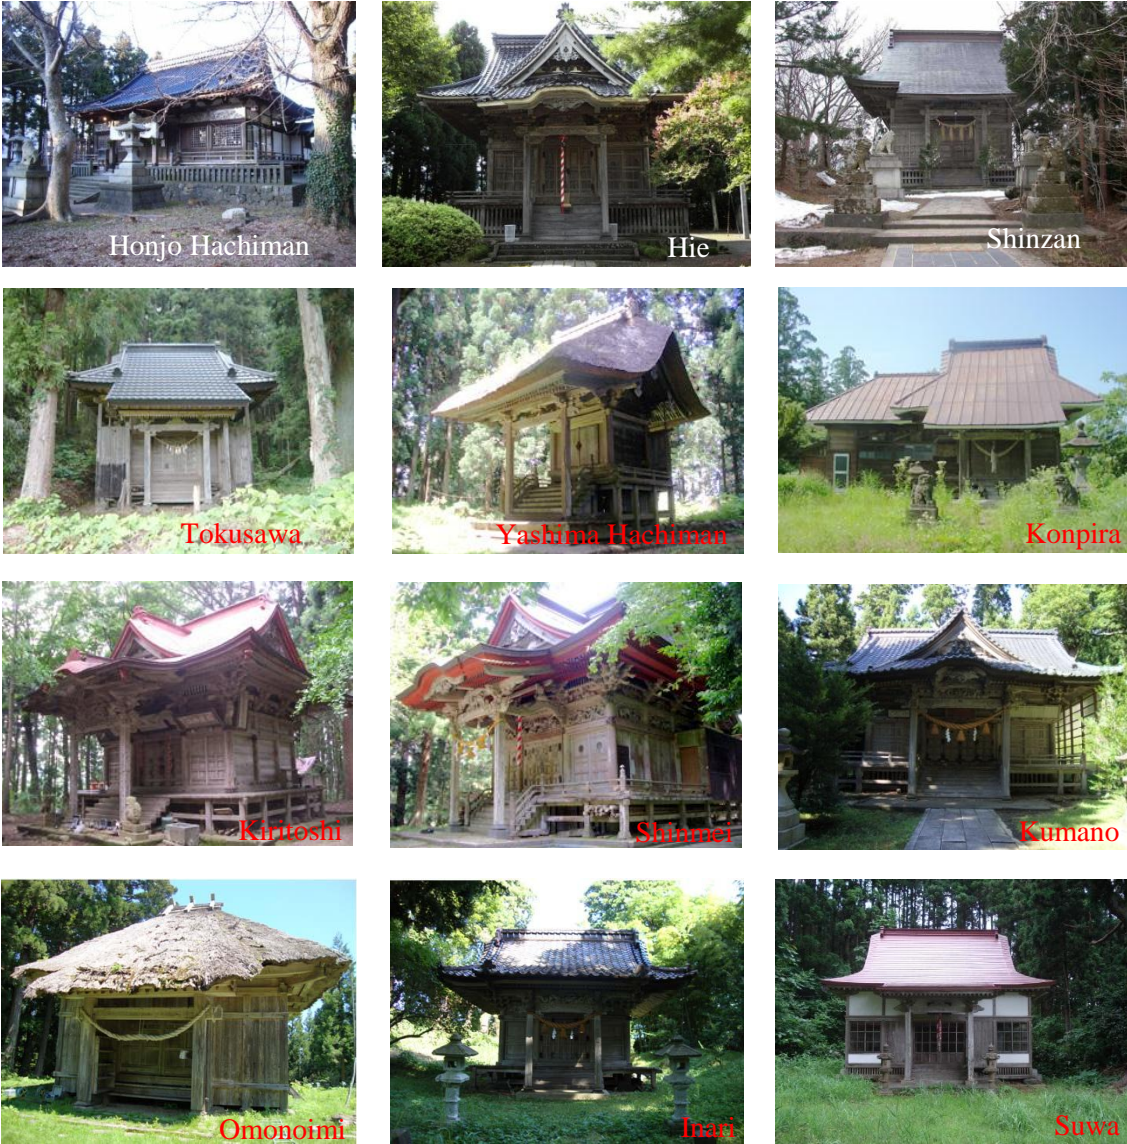
Figure 1. Selected temples

In Figure 1 nine temples of those declared as architectural heritage are shown. With exception of Tokusawa Fudou Sondou (Tokusawa) temple that is located near a vegetable field, all temples are located in the upper part of hills. The structure of all temples corresponds to a traditional wooden frame. The Tokusawa temple, Kumano temple and Inari temple have tile roof, the Yashima Hachiman and Omonoimi thatched roof and the Konpira, Kiritoshi and Shinmei have thin steel plates as roof.

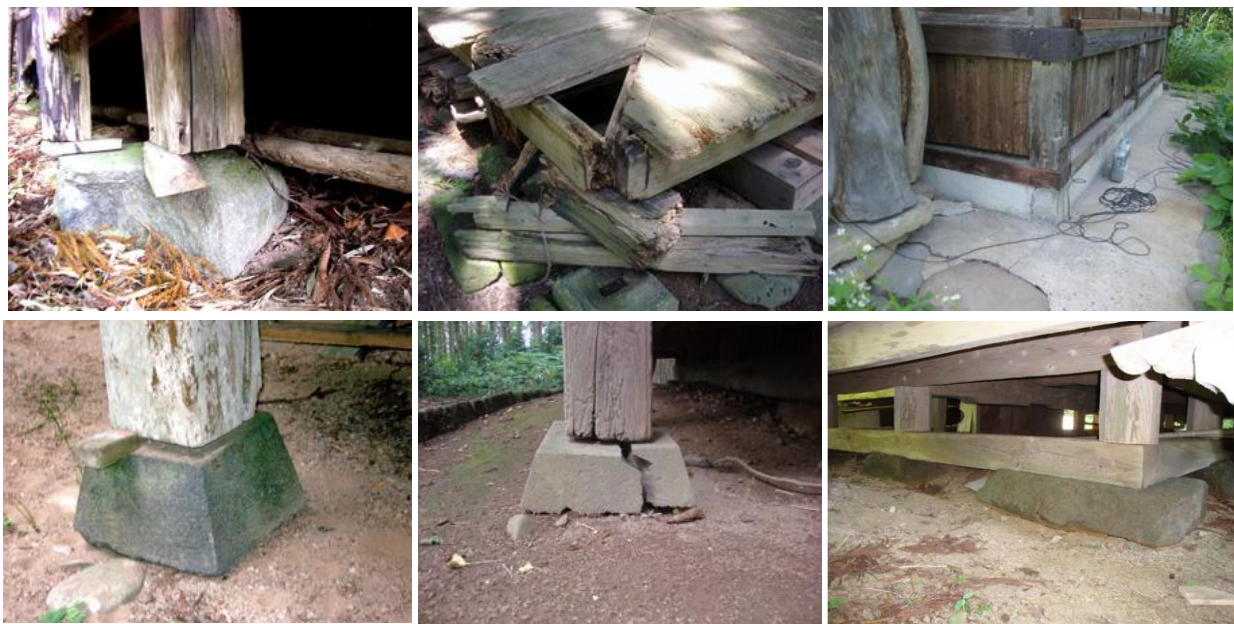
**Figure 2.** Details of the damages at the bottom of columns

Damages were observed mainly in temples that are declared as cultural heritage, since they are located usually on top of hills and therefore it is difficult to provide good maintenance. The temples that are not architectural heritage have a better maintenance since they are venues for annual festivals and are located inside cities or towns. The main damage observed in the selected places was the gap between the base stone and the bottom part of the columns as can be observed in Figure 2. Apparently, this failure is due to the deformation of the girders of the bottom part of the structure. In some cases the failure is a combination of the settlement for the central part of the building with the bending of the girder. Also some elements are seriously deteriorated by the weather action. In all of the cases was observed that the maintenance of the temples are poor and administration and management offices are always closed if they exist and in other cases there are no administration offices.

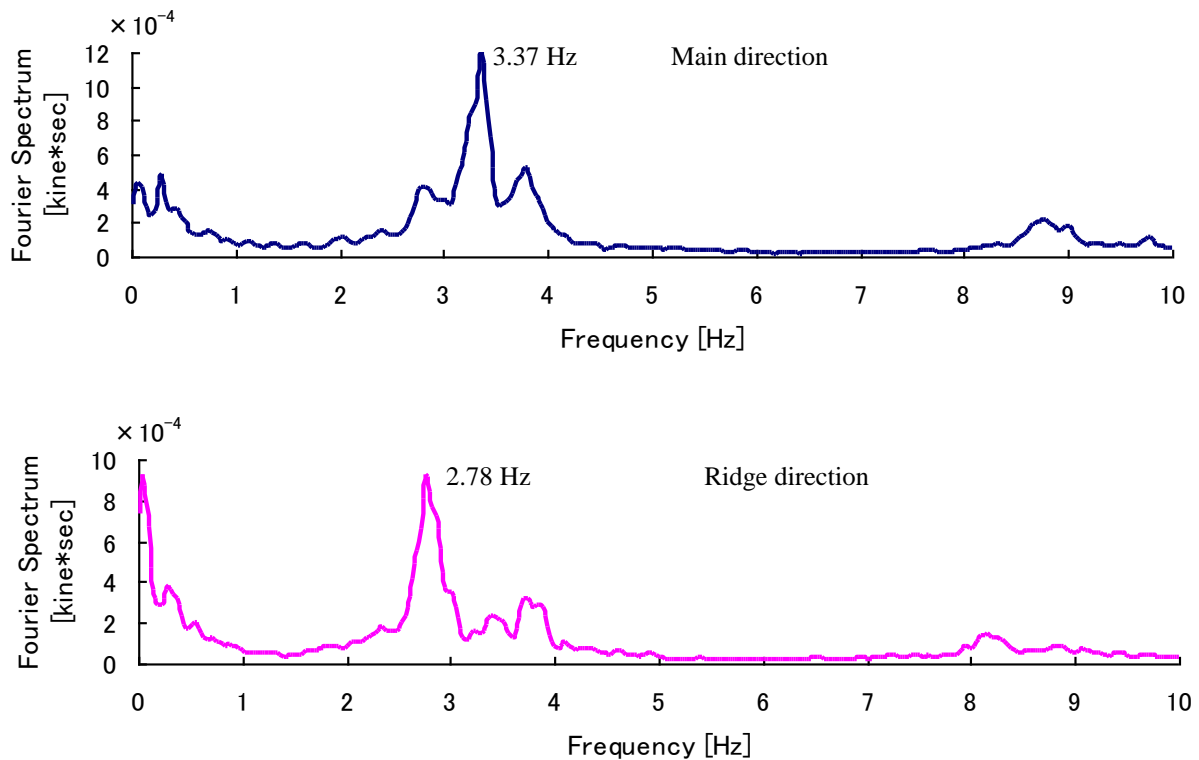
The results of measurement on temple buildings are presented for the main or span direction that is parallel to the façade and for the ridge direction. Simultaneous measurements were obtained for building and ground to estimate the building characteristics from transfer function however, the Fourier spectrum of the signal at the upper part of the building gives the same results. Therefore only Fourier spectrum is used to estimate the predominant period of the temples. Moreover, to estimate the torsional mode of vibration Fourier spectrum of the relative velocity between two points of measurements is used. As example, the results of the Fourier analysis for Tokusawa temple are show in Figure 4 and Figure 5. Figure 4 shows the results for each horizontal direction and the predominant frequencies are estimated as 3.37 Hz for the main direction and 2.78 for the transversal direction.

**Figure 4.** Fourier analysis results for Tokusawa temple

A second peak near 4 Hz can be appreciated in both cases of Figure 4 therefore is presumed that this peak corresponds to the torsional mode of vibration. To confirm this assumption Fourier spectrum of the relative velocity of two points (for example the difference between ch3 and ch5 in the EW direction) was calculated and the result is presented in Figure 5. For comparison the results of Fourier analysis for the two horizontal directions are also plotted. It can be observed that a clear peak at 3.78 Hz is obtained.

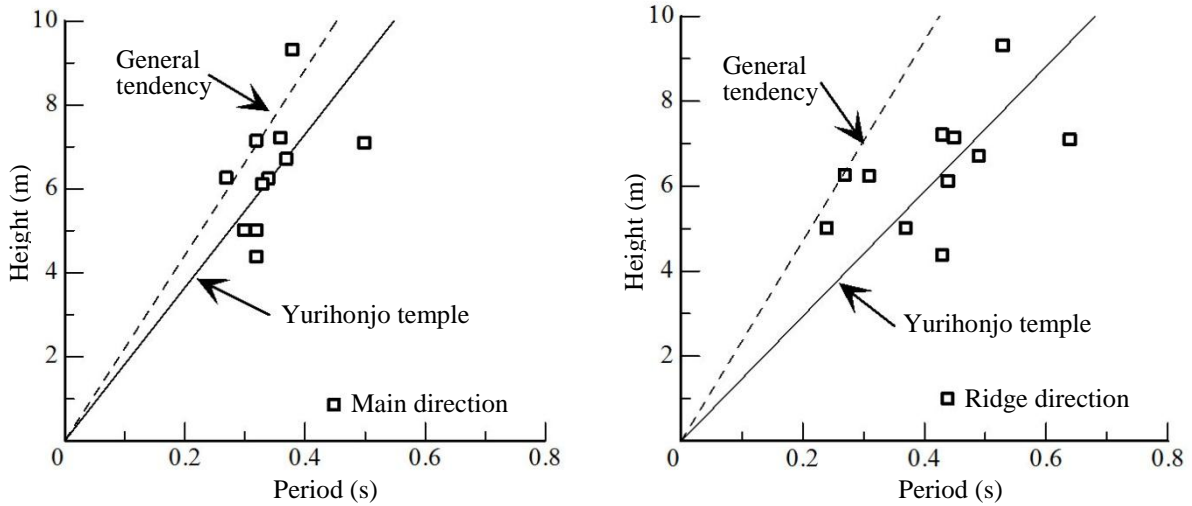
It can be noted that the general tendency is that periods for the ridge direction are longer than those obtained for main direction. These results are compared with the general tendency curve for traditional Japanese temples reported by Uchida et al (2001). Figure 6 shows this comparison where the periods for each direction are plotted versus the height of the temple. Results for Hie, Yashima Hachiman and Konpira temples are on the curve of general tendency or a little above the curve. These temples were repaired at the foundation level and therefore this effect could be reflected in the measurements results. The results for other temples lay below the curve for both directions and it indicates the weakness of the temples with long period for the corresponding height. In general the selected temples show unbalanced values for period of vibration in each direction. For main direction the results are closer to the general curve and for the ridge direction the results differ more from the general curve as can be observed in Figure 6. Then for temples of this region the critical or weak direction is the ridge direction and therefore if some reparation work is planned it is necessary to consider the reinforcement of temples in the ridge direction.

**Figure 6.** Periods of vibration versus temple heights

Microtremor measurements have been successfully employed to determine the dynamic characteristics of traditional Japanese wooden temples of Yurihonjo city. The general tendency of the selected temples is that periods for the ridge direction are longer than those obtained for main direction. These results compared with the general tendency curve for traditional Japanese temples show that some temples have longer period for the corresponding height. In addition, most of the temples show unbalanced results since for main direction the results are closer to the curve than results for ridge direction. In this case if some reparation work is planned it is necessary to consider the reinforcement of the temples in the ridge direction.

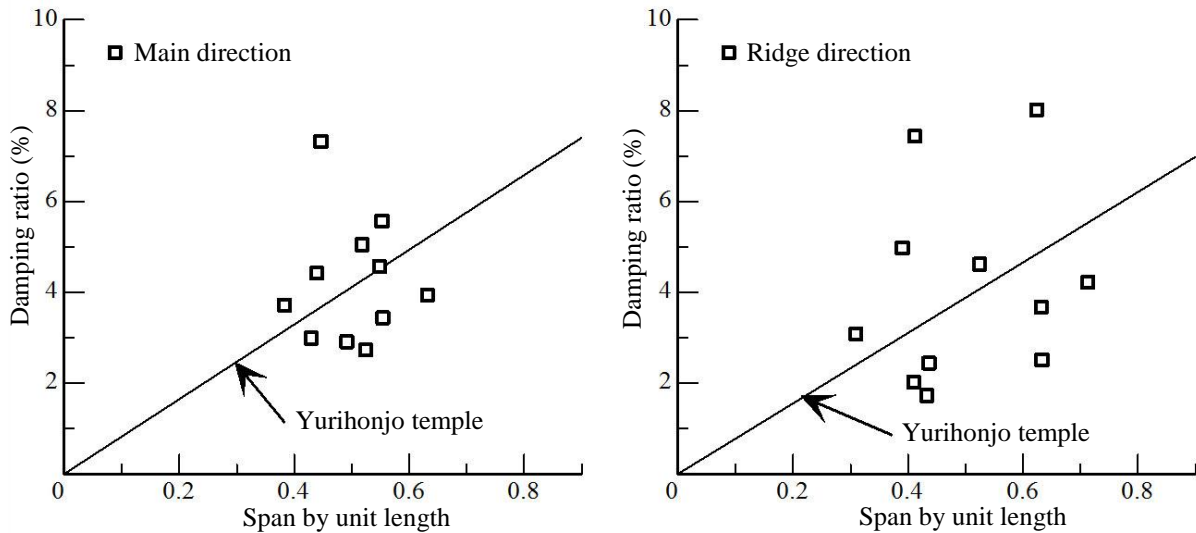
The damping factor ranges from approximately 2% to 8%. However in previous studies of other traditional temples smaller values of the order of 2 % are reported. This fact could indicate that temples with high values of the damping factor present higher potential for energy dissipation. However, it is believed that the energy dissipation occurs due to the lack of appropriate stiffness of joints and supports and therefore could be an indicator of the vulnerability of the structure. When the damping factor is related to the period of the structure or to the height of the structure unclear relationships are obtained. Therefore, in this research the ratio of the number of spans versus the length is taken to establish a relation with the damping factor. That is the number of spans by unit length is plotted versus the value of the damping factor as is shown in Figure 7.

**Figure 7.** Number of span by unit length versus damping factor

It can be noted that with the exception of one temple, the general tendency is to have a larger value of the damping factor when the number of span by unit length is increased. It is supposed that when the number of span by meter increases the structure presents more joints that could increase the dissipation of energy. However, the condition of the joints is an important factor as well as the distribution of joints along the height of the building which consider the presence of horizontal structural element like secondary beam.

The damping factor were correlated with the number of spans of the structure and general tendency of increasing damping with increasing number of spans was found. However more analysis is required since it is believed that damping has strong dependency of the number of joints and of the conditions of these joints.

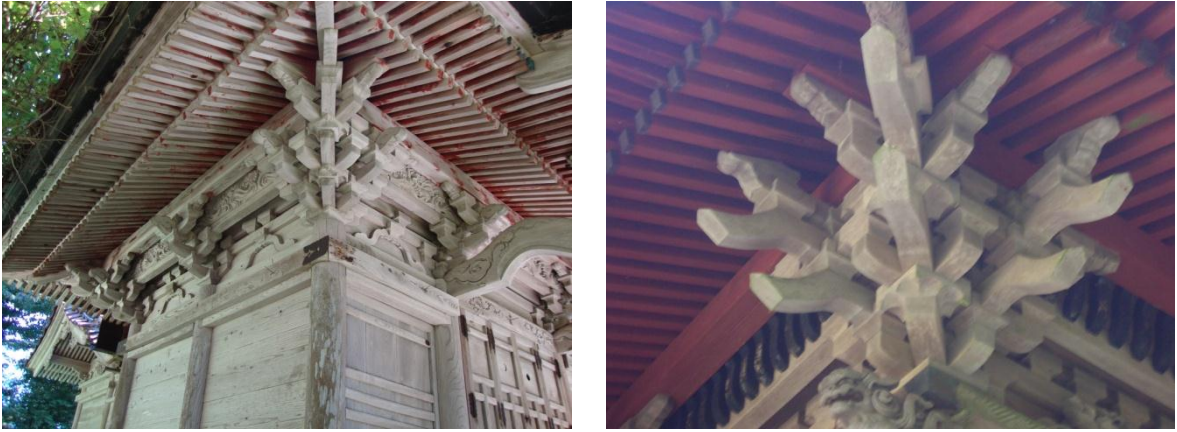
The connection between the upper part of columns and roofs present in some case an intricate carpentry work (entablature) as is show in Figure 8. The effect of the connection between the columns and roof (joint type) on the damping factor is investigated by plotting separately the damping curves for those temples with entablature and without entablature. The results are shown in Figure 9. It was supposed that the intricate joint (with entablature) could have higher damping than the simple joint. However, the connections with entablature, apparently provides larger stiffness to the joint and therefore the damping becomes smaller.

Figure 8. Detail of the entablature in the connection between column and roof

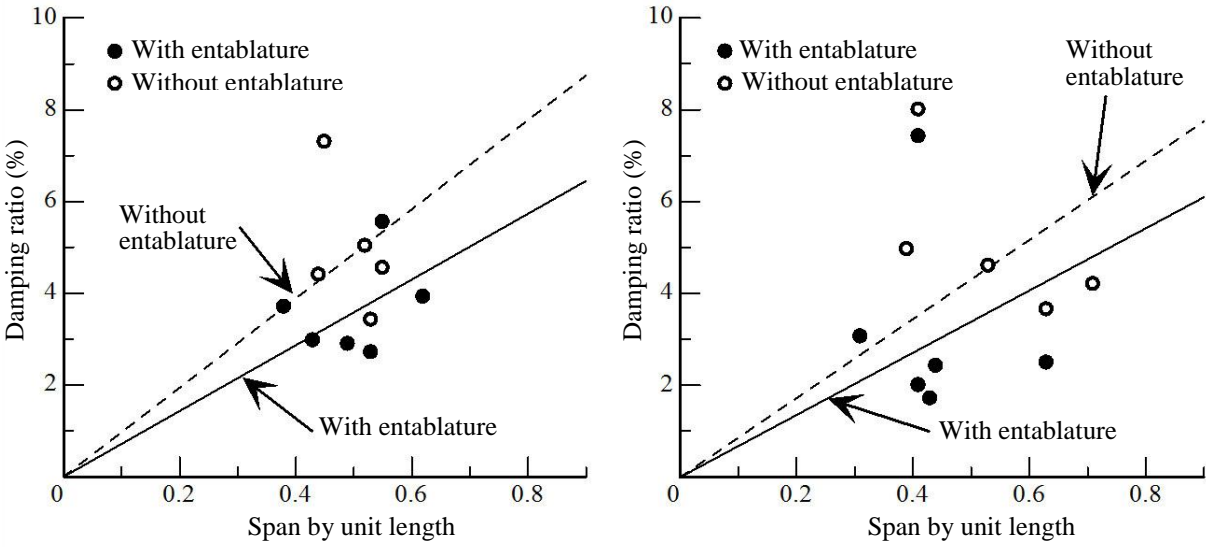
Figure 9. Number of span by unit length versus damping factor
