# In-Plane Cyclic Testing of Non-Structural Drywalls Infilled Within RC Frames

**A.S. Tasligedik, S. Pampanin & A. Palermo**

*University of Canterbury, Christchurch, New Zealand*

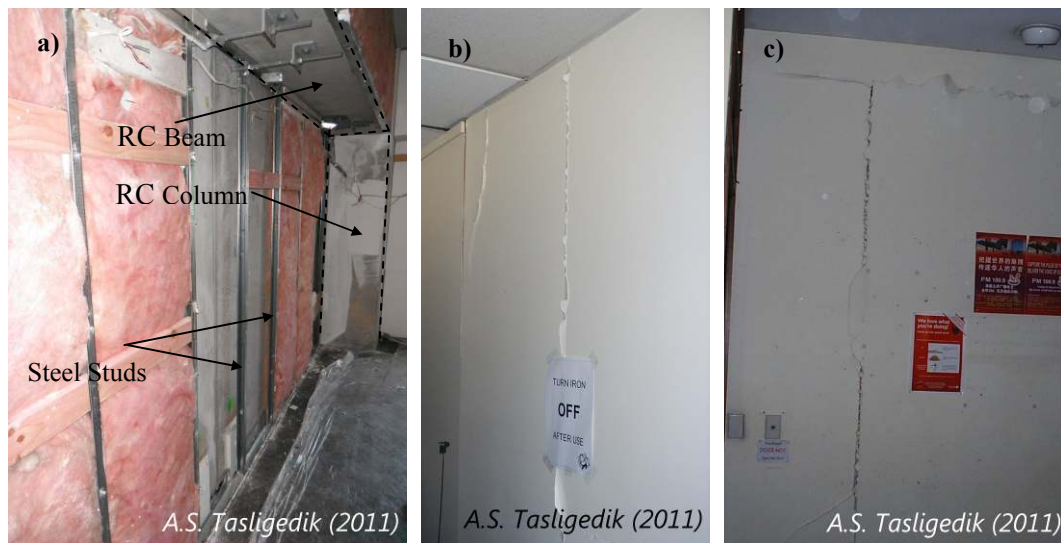
**Figure 1.** a) Drywall framing bounded by RC structural frame, b)-c) Observed damage at drywalls after February 2011 earthquake in Christchurch, New Zealand

Due to these facts and the evident brittle behaviour of unreinforced brick infill walls in that context, over the years, different practices have been adopted for infill walls. Among these practices, gypsum lined drywalls have been a common application, very popular for example both in New Zealand and in the US. These walls are usually formed by attaching gypsum linings to an underlying light framing. This light framing can either consist of light gauge steel or timber. The framing is usually bounded by the structural frame in RC/steel structures (Figure 1a) and in some cases by the upper and lower floor slabs.

Although these infill walls are not expected to be as strong as their unreinforced masonry counterparts, they have a degree of interaction with their surrounding structural framing. This can clearly be observed after earthquakes. For example, during and repeatedly after the Christchurch earthquake on 04 September 2010, most buildings did not collapse, but almost all of them suffered damage to their non-structural contents especially drywalls and ceilings (Figure 1b, 1c). Moreover, there were cases where drywalls were replaced completely after each significant aftershock occurred as part of the

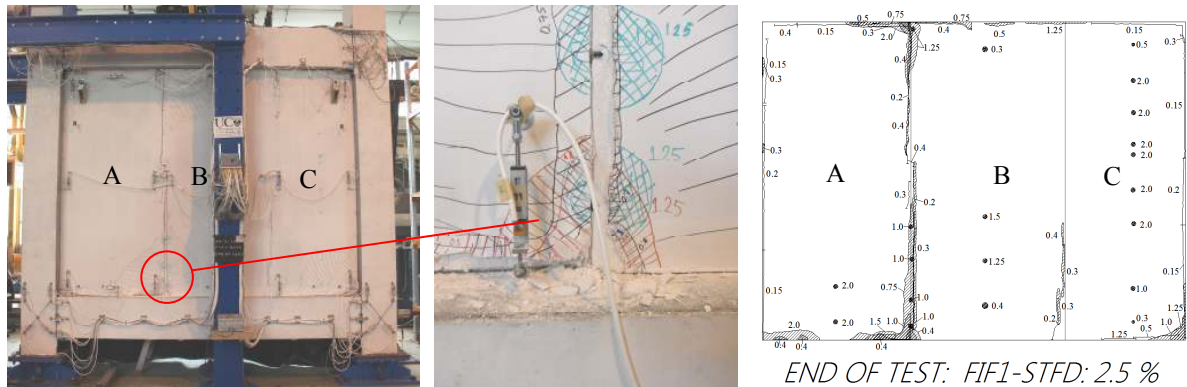
Figure 9. Damage state of steel framed drywall FIF1-STFD at the end of test

The first damage observed was given by the separation/cracking at the interface between the drywall and the RC frame at 0.15% drift. At 0.2% drift, the interface cracking occurred between lining panels A and B. At 0.3% drift, the interface cracking between lining panels A and B progressed and caused bowing on the surface of the interface. At this drift state, a drywall in real life would require definite repair or replacement. Moreover, this level of damage (and associated drift) corresponds to a sudden drop in lateral load (Figure 12a). After that, further damage concentrated on this lining-to-lining interface and lining A began to rock, causing toe crushing of lining A (Figure 9). Once mobilized, this interface had the most significant damage and controlled the failure mechanism of the drywall. An overview of the level of damage for this specimen at the end of the test is shown in Figure 9. The global lateral force vs. lateral displacement hysteresis curve is shown in Figure 12a. The behaviour of the post tensioning was the same as per the bare frame specimen BF.

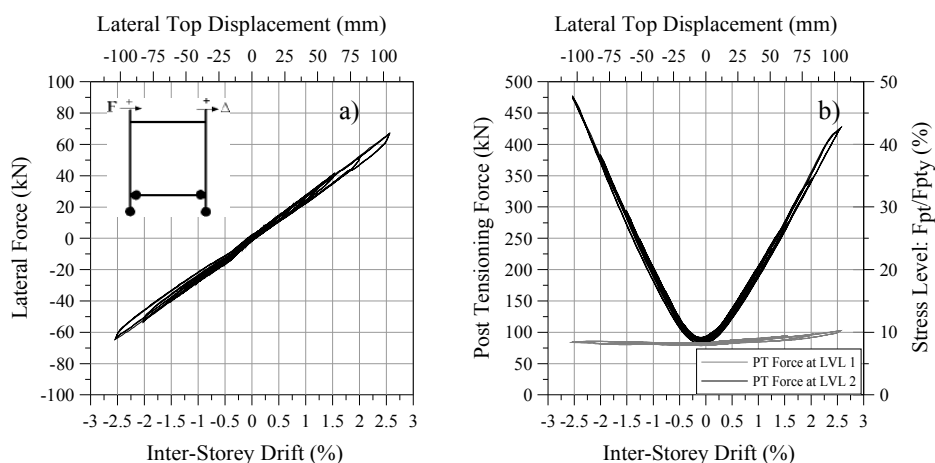
**Figure 11.** a) Hysteresis curve of bare frame, BF, b) Post tensioning vs. drift curve of bare frame, BF –Note: the post tensioning curves are the same for each test

The bare frame was tested three times. In each of these tests, the same displacement history was applied. As expected, the frame remained elastic with minor cover cracks. It should be noted that the amount of post tensioning to be applied was determined at this stage. In order not to force the setup to its limit, an initial post-tensioning force of 80 kN was used, which correspond to approximately 10% of the yield for the post tensioning bar. Also, the supplied central pivot points at the level 1 beam proved to work well to prevent beam elongation and thus clamping of level 1 to occur. In Figure 11a and 11b, the hysteresis curve and post tensioning vs. drift curves are shown.

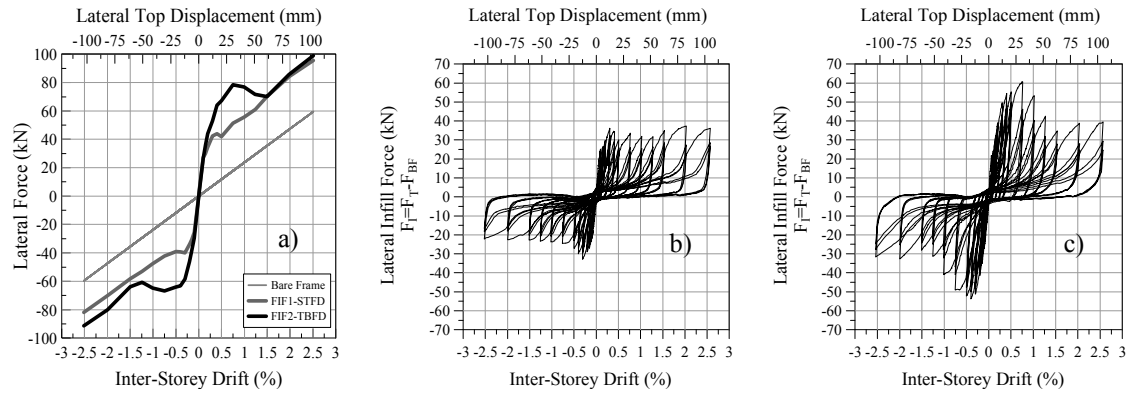
**Figure 13.** a) Force vs. drift envelopes of the tests, b) Lateral force exerted by only the steel framed drywall infill FIF1-STFD ( $=F_T - F_{BF}$ ), c) Lateral force exerted by only the timber framed drywall infill FIF2-TBFD ( $=F_T - F_{BF}$ )

An important observation can be made by checking the residual force capacity ( $F_{lu}$ ) exerted by the infill walls at 2.5% drift (Table 2). After 1.5% drift level, both steel framed drywall FIF1-STFD and timber framed drywall FIF2-TBFD have the same residual force capacity, which is approximately around 40 kN. Envelope curves, lateral force contributions exerted by the infill walls are shown in Figure 13. In addition, values at the observed damage limit states of the tests are given in Table 2.
