Experimental method and results from seismic testing of a two-storey, two-by-one bay, reinforced concrete slotted beam superassembly

This paper presents the experimental set up to test a large scale reinforced concrete slotted beam superassembly. The testing is described and results presented.

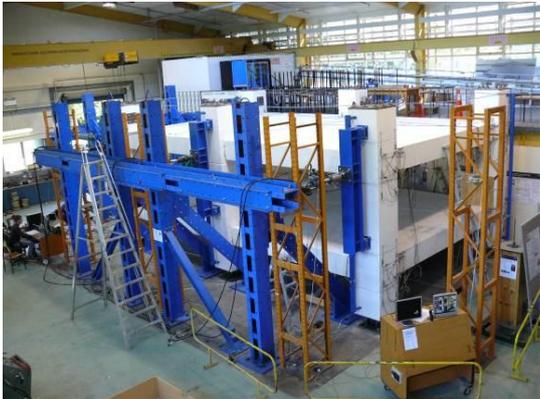
Figure 2.2. Experimental setup perspective.

Force was applied to the specimen through the columns at a constant force ratio of 2:1 between the top and bottom floors respectively. Because the specimen represents the lower two stories of a seven storey structure the inertial forces would be small in comparison to the column shear from the floors above. A perspective of the final experimental set up can be seen in Figure 2.2 and the elevations and plans in Figures 2.3 (a) – (c). The loading was quasi-static in nature. The laboratory is not capable of pseudo-dynamic or high speed testing on this scale at present. Even with a reduced loading rate the forces required in this test were at the maximum of what is achievable given the current laboratory facilities. A full analysis of the structural extension laboratory strong floor was undertaken to assess capacity and safe working limits.

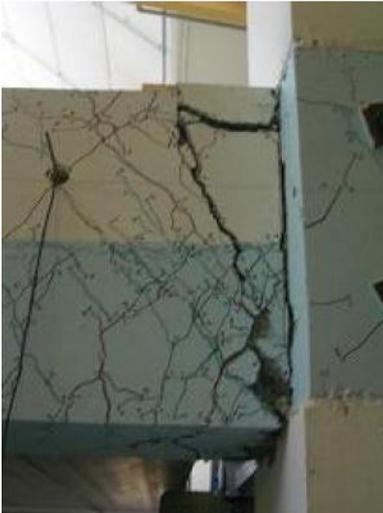
(a) Slotted beam end damage.

(b) Monolithic reinforced concrete plastic hinge damage (MacPherson, 2005).

The damage sustained by specimen SA1 at the ultimate limit state was far less than would be expected in a monolithic structure. The damage sustained at serviceability limit state would not require any repair. Recommendations by Priestley et. al. (2007) are used to define limit states. Figures 4.3 (a) and (b) compare the damage to the beam end for specimen SA1 and a monolithic reinforced concrete detail at the ultimate limit state. It is clear that the slotted beam has sustained significantly less damage. With the exception of the primary crack through the top concrete hinge, the cracks are typically less than 0.15mm. Strain penetration and cone-type pull out mechanism was observed in the lower longitudinal reinforcement. Full development of this damage coincided with the observed softening of response during the 2nd and 3rd cycles at 3.5% beam drift. Supplementary reinforcement welded to the lower

longitudinal reinforcement through the interior connection has been effective in reducing the amount of strain penetration developed and increasing bond.

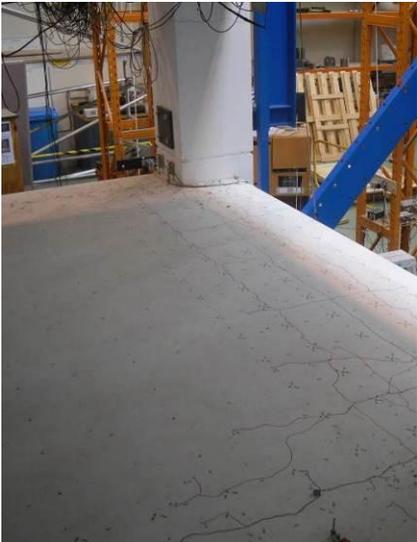
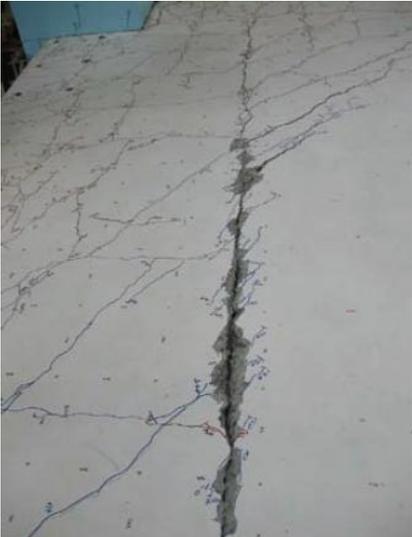
(c) Timber infill cracks, less than 0.45mm.

(d) Timber infill cracks, approximately 8mm (Lindsay, 2004).

Figure 4.3. Comparison of ultimate limit state damage in slotted specimen SA1 (L) and a conventional monolithic reinforced concrete structure (R).

Figures 4.3 (c) and (d) compare the damage to the hollow-core floor diaphragm for specimen SA1 and a monolithic reinforced concrete system at the ultimate limit state. Again, it is clear that there is significantly less damage in the slotted beam system. The cracks in the slotted system are fewer and smaller, peaking at approximately 0.45mm. Whereas the traditional system has developed an 8mm tear between the infill and the floor. The absence of diagonal cracks in the slotted system is indirect evidence of reduced beam elongation. Beam elongation is restrained by the floors, inducing compressive force in the beams and tension stresses in the floors. The diagonal cracks form as the force struts between the two. This is termed the “bowstring effect” (Matthews, 2004).
