Damage Mechanism of the Nakagawa Water-pipe Bridge during the 2011 off the Pacific Coast of Tohoku Earthquake

R. Kaminaka & Y. Kuwata

15 WCEE
LISBOA 2012

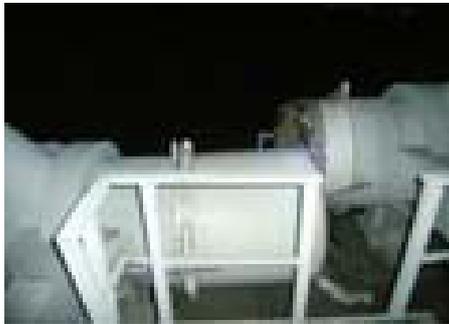
Figure 2.3. Damage of expansion joint at Pier 4

As for the earthquake damage to the Nakagawa water-pipe bridge, the expansion joints between the main cable-stayed bridge and the side bridge were pulled out and rotated at Piers 1 and 4 in Fig. 2.3, and water leaked from the joints. The bearings at all the piers of the main bridge were broken by pulling out of bolts and by sliding roller bearing as shown in Fig. 2.4. The damage to expansion joint and bearing is summarized in Table 2.1. The superstructure moved laterally in transverse direction to bridge axis at Piers 1 and 4 (see as Fig. 2.5.). On the other hand, damage to substructures was not observed based on our field survey. The damaged expansion joints of pipeline on the downstream side were fixed and water transmission restarted shortly after the earthquake.

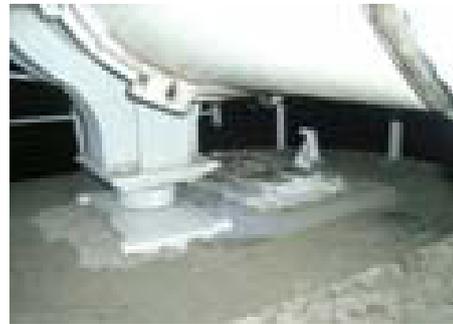
Figure 2.4. Damage of bearing at Pier 4

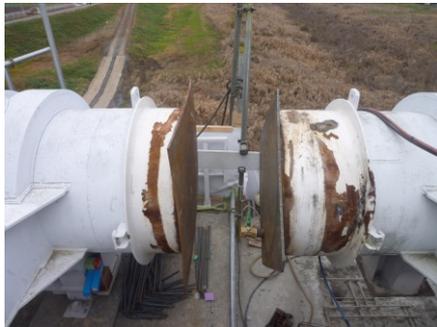
Figure 3.1. State of the restoration work

In order to understand the vibration characteristics of the Nakagawa water-pipe bridge and surrounding subsurface ground, the microtremor observation was carried out in December, 2011. One out of two pipelines was not repaired yet and it was not filled with water at that time (see as Fig. 3.1.). The servo-type velocity sensor was used for the observation as shown in Fig. 3.2. Fig.3.3 shows the location of 14 observation points for the bridge and 3 observation points for the ground. The sensor was set on the center of main truss. The microtremor was recorded by 200Hz sampling in three components for a sensor.

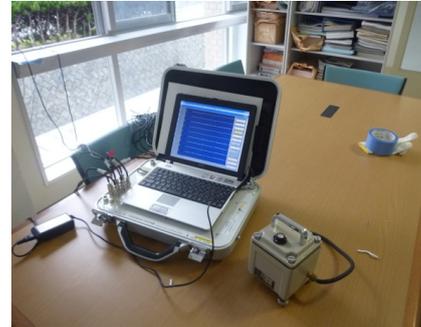
Figure 3.2. Measurement instruments
