A Study on Dynamic Behavior of Nikken Sekkei Tokyo Building Equipped with Energy Dissipation Systems when Struck by The 2011 Great East Japan Earthquake

15 WCEE
LISBOA 2012

Hiroaki Harada, Tatsumi Shinohara, & Keita Sakakibara

Structural Engineering Department, NIKKEN SEKKEI LTD, Tokyo Japan

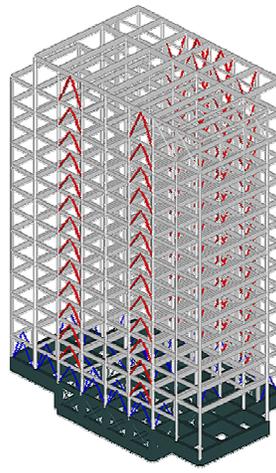
Figure 2. Schematic structural diagram

The Nikken Sekkei Tokyo Building was designed with a high seismic resistance energy dissipation structure in order to ensure continuation of the main work execution functions even during a major earthquake (Fig. 2). Seismic energy is absorbed by low yield point steel (LY = 100N/mm² class) buckling restrained vibration control braces and viscous damping walls, in order to ensure that there is generally no damage to the structure in a major earthquake (Fig. 4). The main structure is a structural steel moment resisting frame, while columns only have a CFT structure. The energy dissipation braces are designed to absorb energy in medium to large earthquakes, and the viscous damping walls are designed to resist small to medium earthquakes, strong winds, etc.

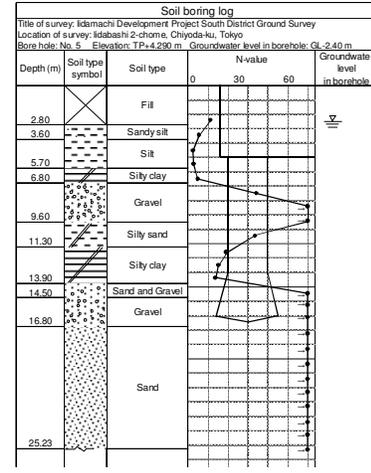
Figure 3. Soil Column Section

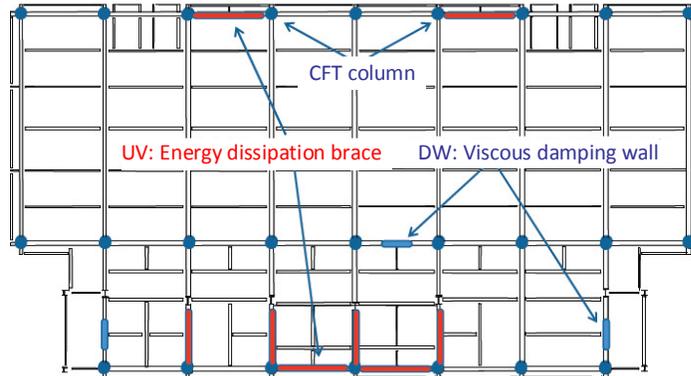
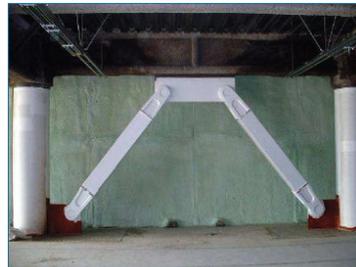
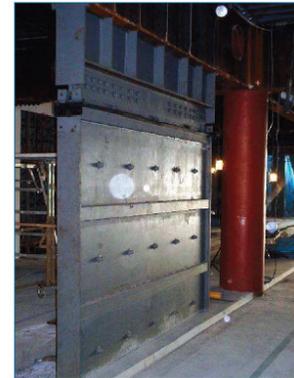
Energy dissipation brace
(100N/mm² class)

Viscous damping wall

Figure 4. Structural framing diagram and photos of energy dissipation members

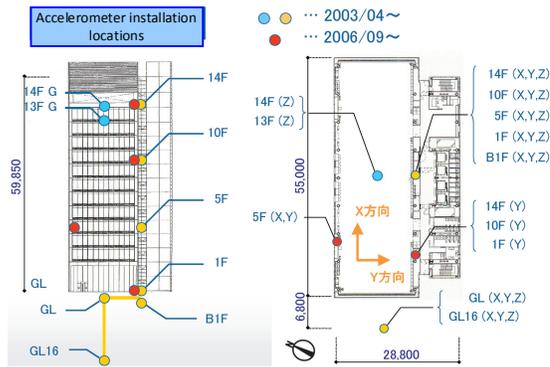
Figure 5. Earthquake observation system

The earthquake observation system consisted of accelerometers installed inside and outside the building (Fig. 5). Within the building, accelerometers were installed at a total of 11 locations: XYZ 3-component accelerometers were installed at five locations inside the services shaft from B1F to 14F, (Fig. 6). Outside the building, one accelerometer was installed near the ground surface (GL-1m) and one at the level of the tip of the piles (GL-16m) (engineering bedrock).

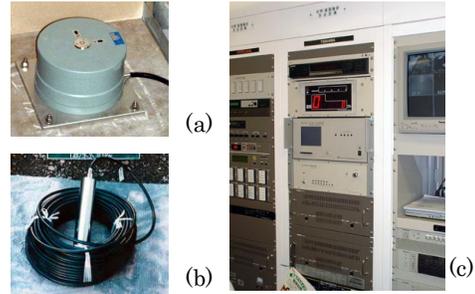
Figure 6. (a) Acceleration Sensor at EPS
(b) Acceleration Sensor at TOP of Pile
(c) Recording Apparatus

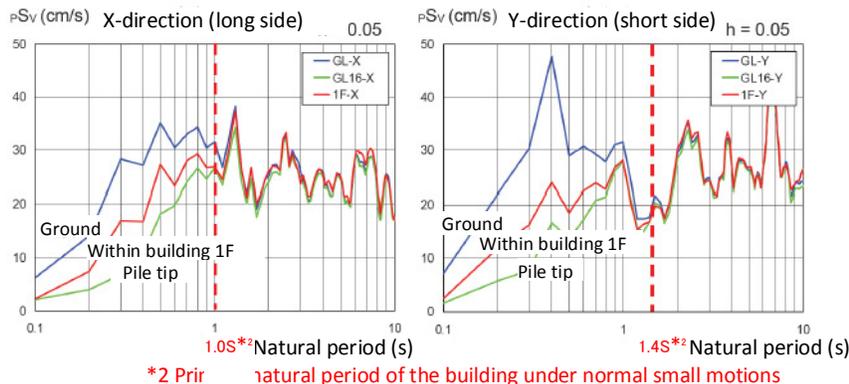
Figure 7. Velocity response spectra (2:47 p.m., March 11, 2011) (ground, pile tip, 1F)

Figure 7 shows the velocity response spectrum for the main shock at 2:47 p.m., March 11, 2011. The properties of a major earthquake having power in all period ranges can be seen, with seismic motions at periods of one second and longer virtually flat at around 30 cm/s. On the other hand, for periods shorter than one second, differences can be seen due to the differences in the position of installation of the accelerometers. The seismic motions increase in the order of pile tip (GL-16m), within the building (1F), and the ground surface (GL-1m). This is considered to be due to amplification of the soil strata near to surface in the case of the difference between pile tip and ground surface.

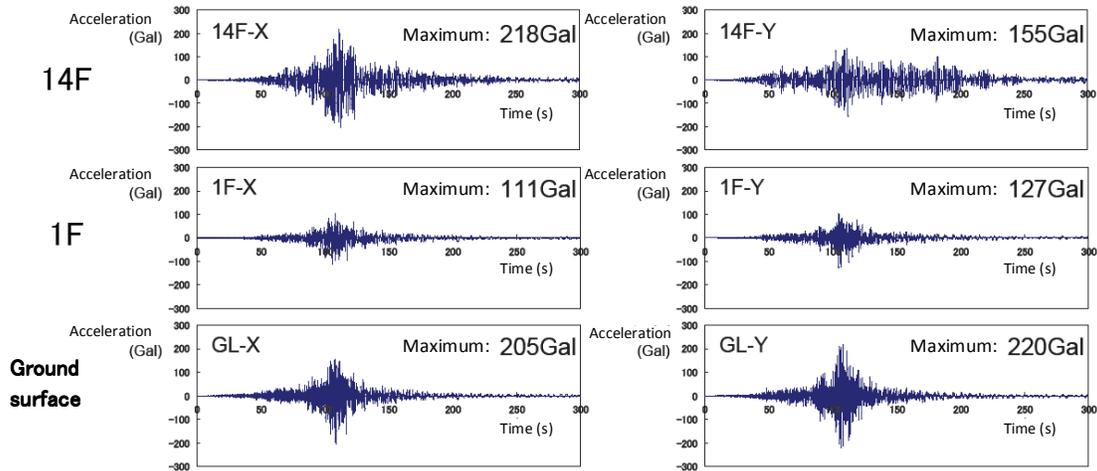
Figure 8. Acceleration waveforms for the core

Figure 8 shows the acceleration time wave form for the accelerometer installed within the core close to the position of the center of gravity of the building, and Fig. 9 shows the maximum values of acceleration in the height direction. In the distribution of acceleration in the height direction, the amount of amplification in the long side direction and the short side direction was different. This is considered to be due to the effect of the relationship between the seismic motions and the natural periods of the building. The vertical motions were about 0.4 to 0.53 times the horizontal motions. Also the vertical acceleration in the center of the large beam on 14F was 2.28 times the acceleration within the core, indicating that there was amplification.

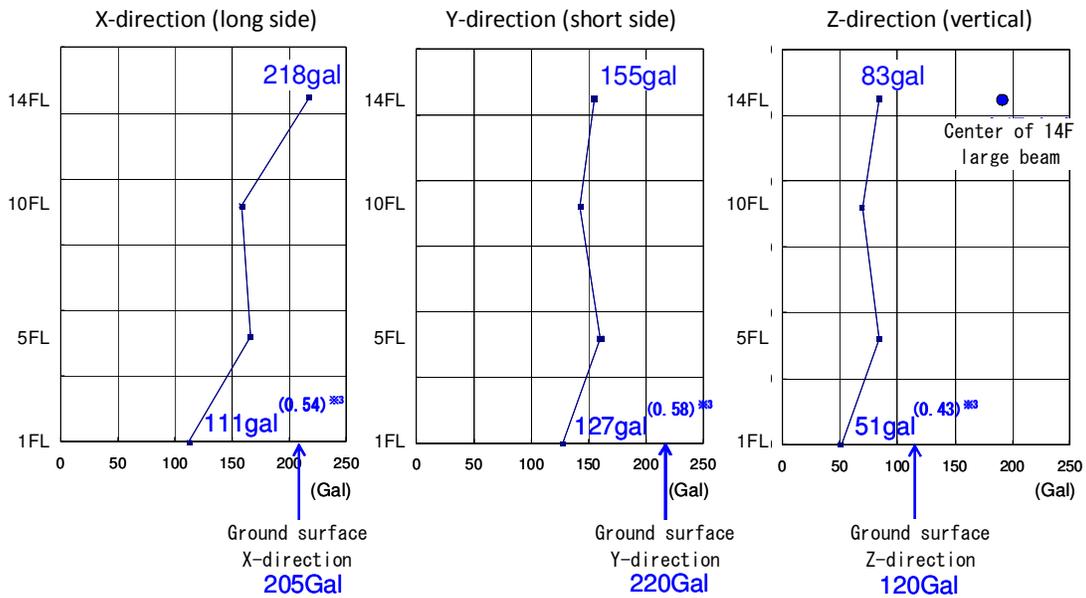
Figure 9. Maximum acceleration distribution (*3 indicates the ratio of 1F/ground)

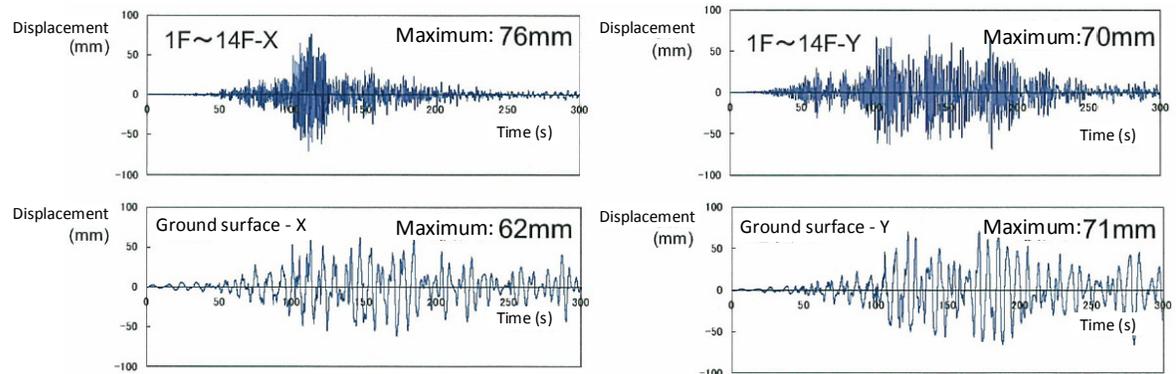
Figure 10. Displacement time wave form

The acceleration waveforms obtained were integrated to obtain deformations. The displacement time waveforms were calculated using third order spline interpolation between stories (Fig. 11). The overall displacements of the building were 76.1 mm, or 1/788 (long side, hereafter referred to as the X-direction), 69.8 mm (short side, hereafter referred to as the Y-direction) (Fig. 10), the maximum inter-story drift angle was 1/500 (X) (5F, inter-story displacement 8 mm), 1/667 (Y) (6F, inter-story displacement 6 mm), so estimating from the magnitude of the displacements no damage was expected, and a high level of seismic performance was confirmed (Fig. 11 and 12).

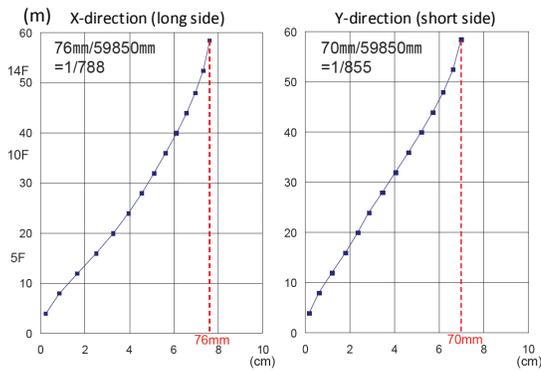
Figure 11. Maximum displacement (from 1F)

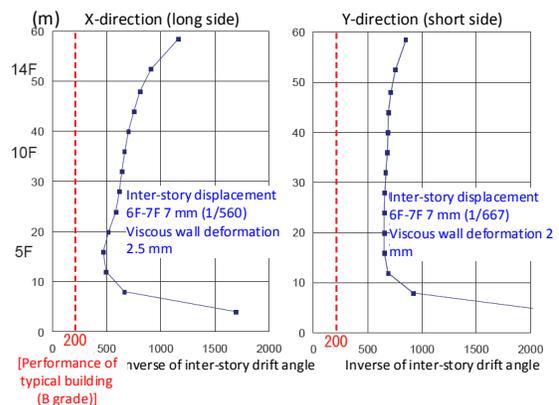
Figure 12. Maximum inter-story drift angle

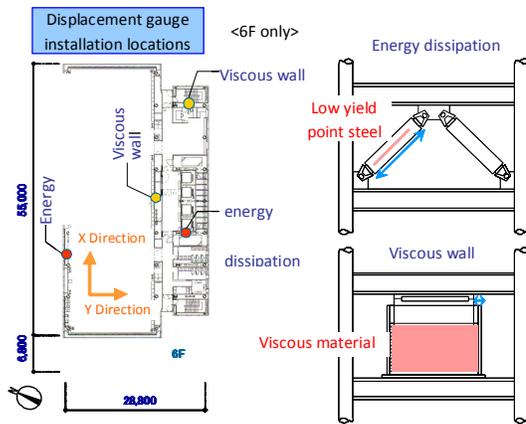
Figure 13. Displacement gauge installation locations

In order to more accurately analyze the performance as a vibration control structure, the deformations of the energy dissipation members were directly measured (Fig. 13). The 6F vibration control members were measured at only four locations. Deformations of 2.52 mm (X) and 1.91 mm (Y) were measured on the viscous damping walls (Fig. 14). It is considered that the building as a whole absorbed seismic energy, and performed as an energy dissipation structure. Deformation of the structural steel energy dissipation braces was less than 1 mm (0.55 mm Y), so from this result it is considered that the performance was within the elastic range.

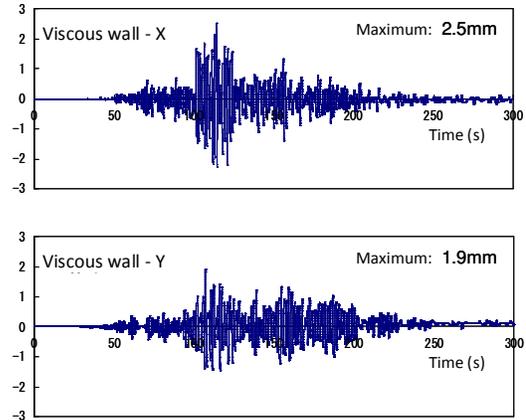
Figure 14. Viscous damping wall deformation

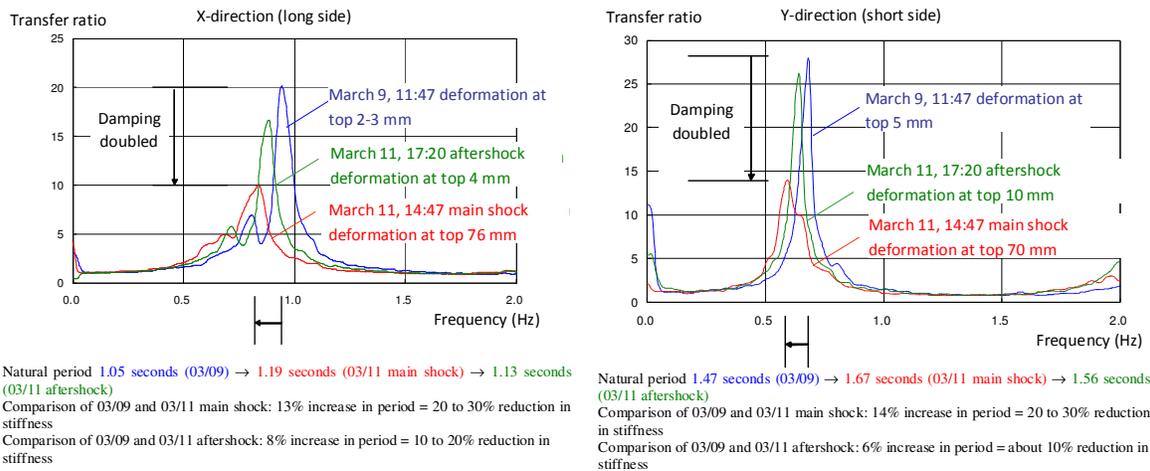
Figure 15. Change in the natural period and damping factor from the magnitude of the oscillations, and confirmation of vibration control structural performance

Figure 15 shows a comparison of the transfer function for the following three records: an earthquake that occurred in Sanriku-oki on March 9, 2011 (3/9 foreshock), the 3/11 main shock, and an aftershock that occurred two hours after the March 11 main shock. The transfer functions for the 14F with respect to the records for the 1F are shown for the X- and Y-directions. It can be seen that the two earthquakes apart from the main shock were small earthquakes from the fact that the values of the displacement at the top of the building were 5 mm and 10 mm. The natural period during the main shock on March 11 increased by 13 to 14% relative to the foreshock on March 9.

If the transfer ratio at the peak is considered to be proportional to the damping factor, then the natural frequency at the time of the March 11 main shock was reduced by 12 to 15% compared with prior to March 11, and the damping factor was increased by about a factor of two. Also, by comparing the March 9 foreshock and the March 11 aftershock it can be seen that there is a reduction in natural frequency. This is considered to be due to the internal and external finishing materials contributing to the stiffness of the building as a whole in addition to the structure. Also, the damping effect in the main shock was about double that in the two small earthquakes (4 to 6% damping factor), which confirms that the damping performance was exhibited.

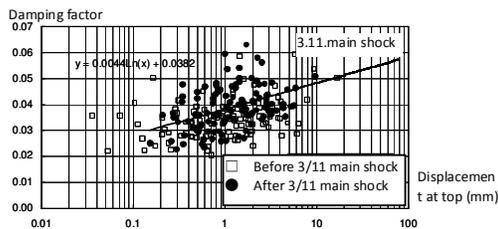
Figure 16. Dependence of X-direction primary damping factor on amplitude

All the records obtained since the start of measurement were divided into before and after the 3/11 main shock, and the damping factor was estimated using the half power method. Figures 16 and 17 plot the damping factor against displacement of the top of the building in the X- and Y-directions. Although the values themselves were evaluated slightly higher, a trend indicating a larger damping factor the larger the response amplitude was confirmed.

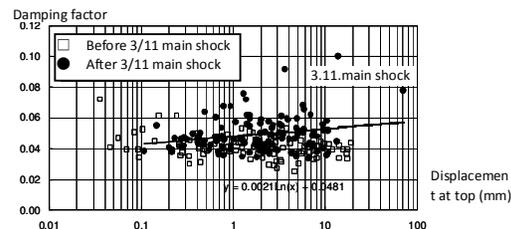
Figure 17. Dependence of Y-direction primary damping factor on amplitude

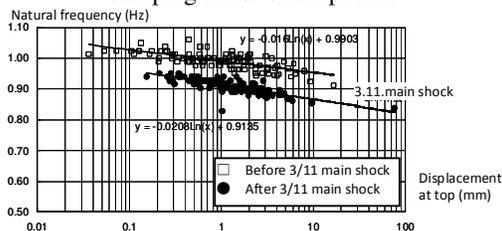
Figure 18. Dependence of X-direction primary natural frequency on amplitude

On the other hand, Figs. 18 and 19 plot the results with the frequency at the point of the peak in the transfer function taken to be the natural frequency. From these figures a clear difference between before and after 3/11 can be seen. The natural frequencies in both the X- and Y-directions after 3/11 are considered to be reduced by about 10%. It is considered that this was caused by the stiffness reduction of the filling materials and sealing materials between finishing materials or between finishing materials and the structure.

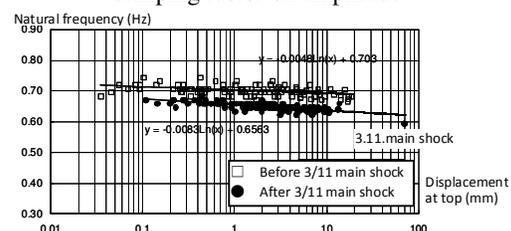
Figure 19. Dependence of Y-direction primary natural frequency on amplitude

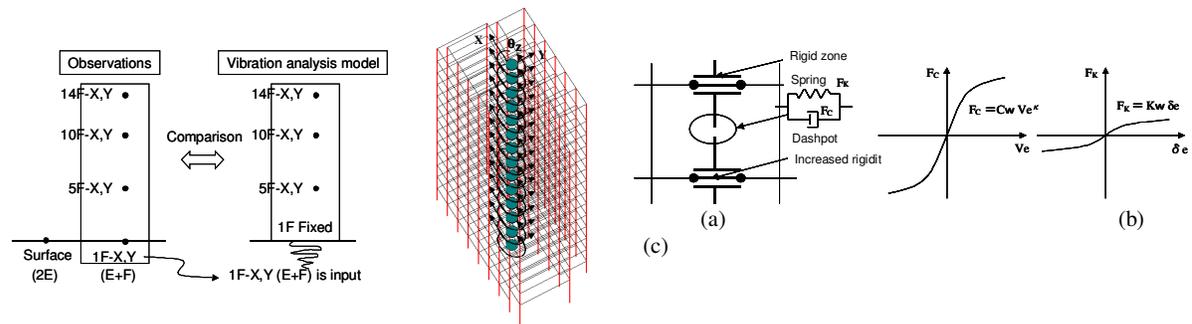
Figure 20. Relationship of Observed and Analytical Vibrations **Figure 21.** Vibrational Analysis Model **Figure 22.** Modeling of Viscous Damping Walls

The design model is a three-dimensional vibration analysis model that evaluates all the members, B1F and 1F are fixed in the horizontal directions (X and Y), and vertical springs are provided at the pile caps to take in consideration loads in the vertical direction (Fig. 21). It was assumed that there is a stiff floor on each story, and that the vibrational degrees of freedom having mass and rotational inertia are concentrated into 3 degrees of freedom (X, Y, and θ_z) at the center of gravity of each story.

$$F_w = C_w \cdot V_e^K + K_w \delta_e \quad (1)$$

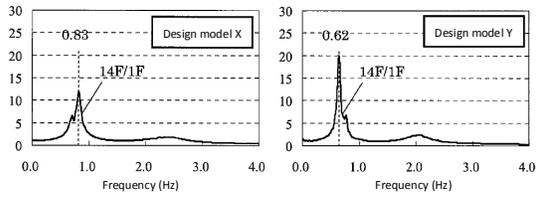
Figure 23. Design model transfer functions (3/11 main shock input)

Figures 23 to 26 show the transfer functions in the X- and Y-directions for 14F response accelerations with respect to 1F accelerations; Fig. 23 is for the 3/11 main shock input to the design model, Fig. 24 is for the 3/11 main shock, Fig. 25 is for the 3/11 aftershock input to the design model, and Fig. 26 is for the 3/11 aftershock. The predominant frequencies of design model and the 3/11 main shock are virtually the same, indicating that evaluation of the stiffness of the design model was highly accurate. On the other hand, the value of the predominant frequency of the 3/11 aftershock was slightly on the high-frequency side compared with the design model. The deformation of the top of the building in the 3/11 aftershock was small at 2.7 mm (X) and 7.0 mm (Y), so there was no reduction in stiffness of the internal and external finishes, so it is considered that the frequency was high compared with the 3/11 main shock. From the above it was confirmed that the design model is capable of appropriately evaluating the stiffness in earthquakes with amplitude levels similar to those of the 3/11 main shock. The value of the amplification ratio from the design model was generally greater than the measured records. It is considered that if the actual behaviour is estimated based on the design model, there is an overall tendency to under-evaluate the damping, so the evaluation of the design model is on the safe side.

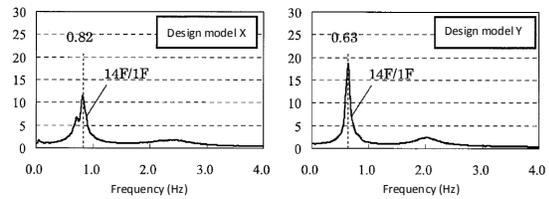
Figure 25. Design model transfer functions (3/11 aftershock input)

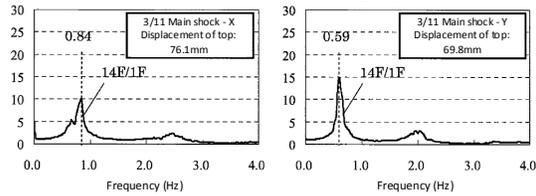
Figure 24. Transfer functions for 3/11 main shock (2:47 p.m. 2011/3/11)

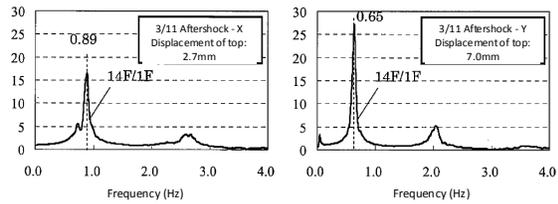
Figure 26. Transfer functions for 3/11 aftershock (4:29 pm, March 11, 2011)

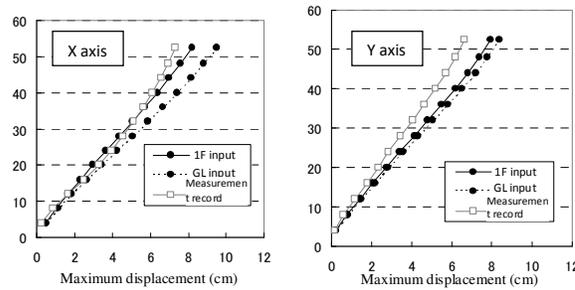
Figure 27. Maximum displacement

Figures 27 to 30 show a comparison of the measured earthquake records and the design model response analysis results for the 3/11 main shock. It can be seen that the vibration analysis using the design model can generally reproduce the measured results.

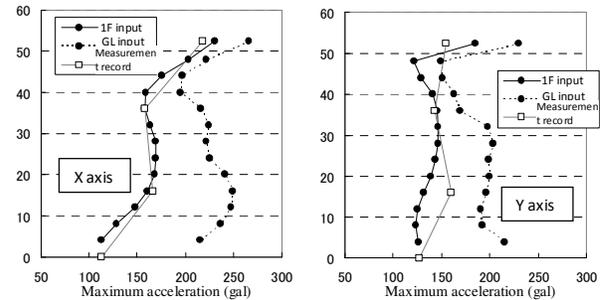
Figure 29. Maximum floor response acceleration

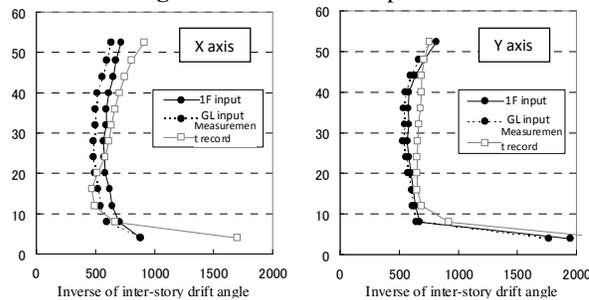
Figure 28. Maximum inter-story drift angle

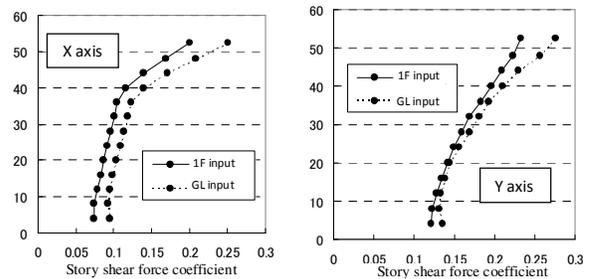
Figure 30. Story shear force coefficient

Figures 25 to 29 also show the results when the ground surface (GL) seismic record for the 3/11 main shock was input to the design model. As shown in Table 1, when a comparison of the input earthquake measurement points 1F and GL for 1F story shear force coefficient is carried out, differences in input acceleration of 0.54 (X), and 0.58 (Y) were obtained. In contrast for the story shear force coefficient, differences of 0.81 (X) and 0.88 (Y) were obtained. From this it can be seen that the effect on the story shear force was smaller compared with the reduction in input acceleration.
