Dynamic Response Parameters and Damage Assessment of Educational Building located in Earthquake Prone Area

C.S. Dragomir

M.C. Calin

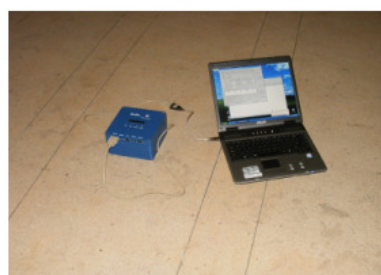
Figure 4.2. GeoSIG GBV 316 device

Below are presented the records made with GBV GeoSIG 316 device (see Fig. 4.2) in 2009, when the new design code P100-1: 2006 entered into force. Records were made on the 4th floor of body A of F.L.R.E.E. building. Processing's were performed with GeoDAS program that leads to the displacements, velocities, accelerations, time varying accelerations and the oscillation fundamental periods of the building (see Fig. 4.3).

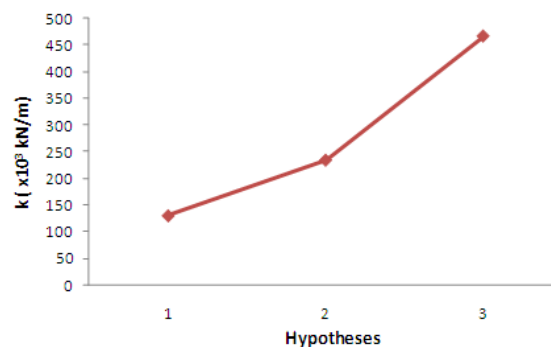
Figure 4.5. Structural stiffness variation in three hypotheses

In Fig. 4.5 are presented the results of structural analyses performed with the program Robot Millennium in three structural hypotheses: first in 1973, after the first strengthening, in 1986 and existing building in 2011. The results indicated an increase in overall stiffness of the structure with 72% of initial stiffness. However, the values obtained by calculation in all three structural hypotheses differ from values obtained from seismic instrumentation of the building, especially in the second hypothesis (after the first consolidation).

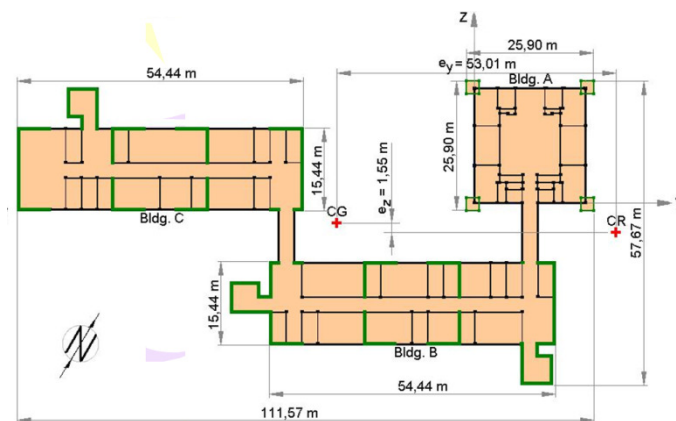
Figure 4.8. Eccentricity between two intrinsic centres after structural interventions-hypothesis without seismic joints

By closing the seismic joints the distance between the two intrinsic centres has increased significantly, as can be seen in Fig. 4.7 and 4.8. This increasing of the calculation eccentricity leads to an increased torque and therefore to major efforts in the structure.

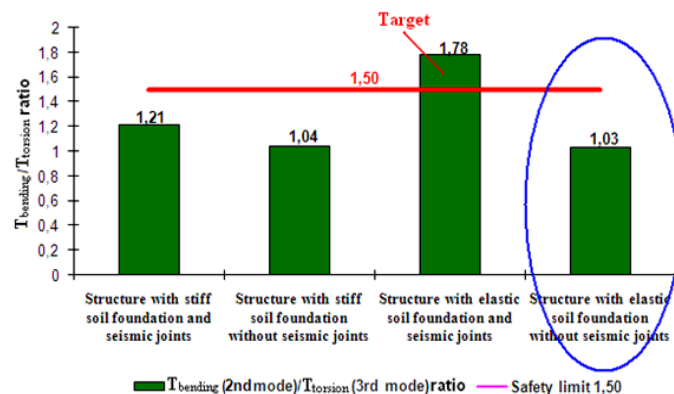
Figure 4.11. Relationship between 2nd oscillation mode and the 3rd oscillation mode of buildings

5. By comparing the oscillation modes 2 and 3 in both cases with rigid foundation and without seismic joints, the ratio of dynamic parameters remains well below 1.5.
6. Even in the hypotheses of structure with elastic foundation without seismic joints, which is the real situation, the ratio of two modes 2nd (bending) and 3rd (twisting) the ratio is only 1.03 showing the danger of instability through the coupling.
7. To be noted however that in the hypotheses of structure with elastic foundation and seismic joints, the ratio of modes 2 and 3 remains above 1.5, which is a strong argument for the practice of seismic joints between existing bodies of the building.

Regarding the case study is found that after strengthening interventions, the joints were closed and therefore the construction was constrained, all 6 degrees of freedom were cancelled. Although through the strengthening interventions the improvement of the situation was desired, by closing the joints the situation was complicated because the dynamic conditions were not met (see Fig. 4.10 and 4.11).
