Seismic Improvement of an Existing Building with Relevant Vertical Slope due to Foundations

S. Biondi

InGeo Engineering and Geology Department, "G. d'Annunzio University" of Chieti-Pescara, Architecture Faculty, viale Pindaro 42, 65127 Pescara (Italy)

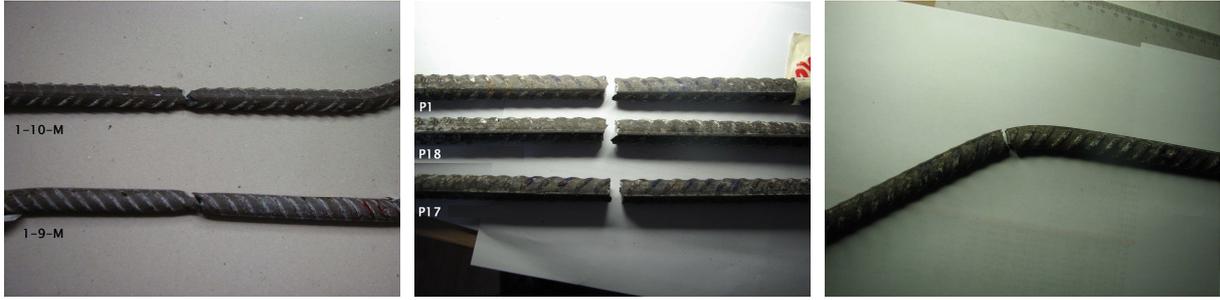
Figure 3. Steel reinforcement ($D_s = 14 \text{ mm}$ left) after tensile tests and bend test: low ductility is detected in $D_s = 16 \text{ mm}$ rebars (centre and right). Good ductility in $D_s = 14 \text{ mm}$ rebars

Test results were not encouraging both for steel reinforcement and for concrete compressive strength on drilled cores. In Figure 3 steel reinforcement after tensile tests (left & centre) and bent test (right) are shown. This reinforcement was extracted from both a beam at first floor ($D_s = 14$ mm) and a column at partial underground floor ($D_s = 16$ mm): it is possible to note a low extension of restriction length in the fracture zone and a fragile fracture due to bend test on mandrel for $D_s = 16$ mm rebars. All these facts reveal low ductility in these bars, while $D_s = 14$ mm show a good ductility.

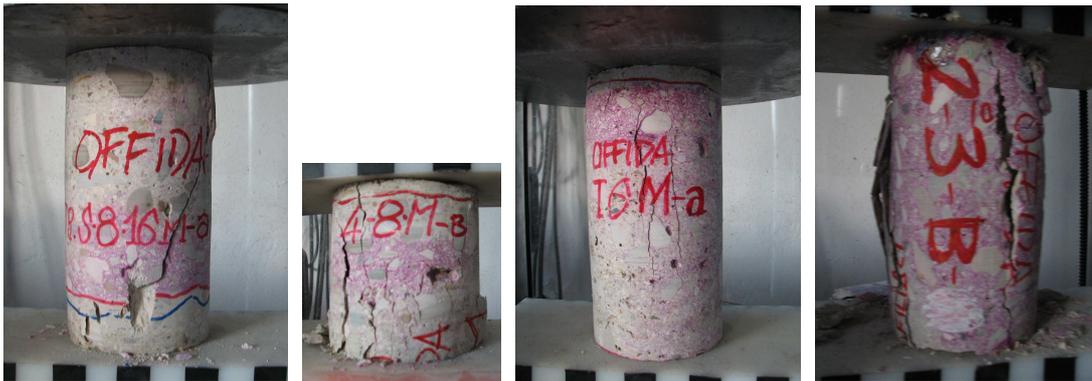
Figure 4. Concrete drilled cores after compressive tests: lower strength cores (S 8-16 M-a & 4-8 M-b [left]), medium strength core (T6 M-a [centre]) and highest strength core (2-3 B [right])

In Figure 4 concrete drilled cores after compressive tests are shown. In these cases great dispersion in compressive strength are detected ($f_c = 11.40 \text{ MPa}$ for S 8-16 M-a [beam at partially underground level]; $f_c = 12.10 \text{ MPa}$ for 4-8 M-b [column at 4th level]; $f_c = 21.30 \text{ MPa}$ for T 6 M-a [column at ground level]; $f_c = 29.90 \text{ MPa}$ for 2-3 B [column at 2nd level]). In Table 2 in-situ and laboratory test results (average values) for structural materials are shown: f_{ym} , f_{tm} yielding and tensile strength, A_{5m} ultimate strain in 5 diameters length in the fracture zone, $(f_t/f_y)_m$ steel over-strength; γ_{cm} specific weight, f_{cm} and R_{cm} cylindrical and cubic compressive strength, R_{cBm} real compressive strength taking into account in-situ drilling out. It is possible to note a lower value of actual cubic compressive strength R_{cBm} with respect to the design value $R_{ck} = 30 \text{ MPa}$, nineteen years after the last concrete cast-in-place in 1993!

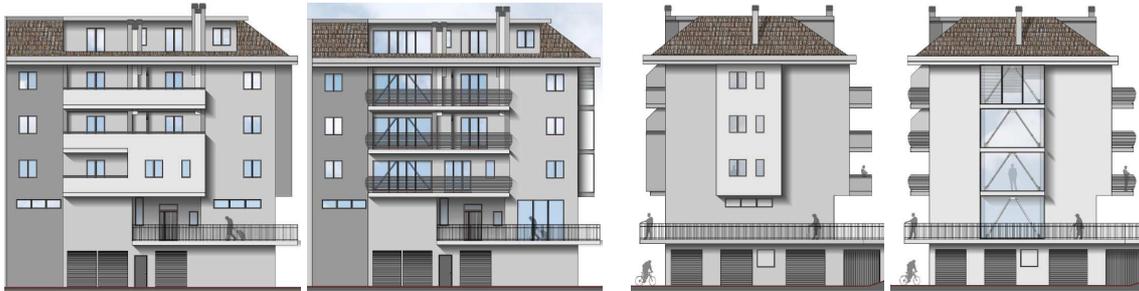
Figure 9. Mass removing hypotheses for East (left) and North building fronts (right) of the study building

Therefore the dissipative approach has to be supported by a classical structural strengthening. In order to respect Code conditions for pile foundation, i.e. elastic foundation behavior in respect to superstructure plastic behaviour, the structural strengthening has to have a minimum impact on base columns. Furthermore, together with structural strengthening at upper floors, a seismic demand reducing can be carried out in order to complete the dissipative approach. In particular, seismic demand can be reduced by removing upper floors or other mass from the structure. Assuming that the first alternative isn't possible, mass removing can be usefully planned too. Heavy concrete parapets, external infilling masonry portions, cantilever element for overhanging masonry facades without external bracing can be removed, Figure 9. With these simple actions a reduction of the global base shear almost greater than 7% is obtained. If this mass reduction is combined with partial jacketing in
