Experiences on Retrofitting of Low Strength Masonry Buildings by Different Retrofitting Techniques in Nepal

National Society for Earthquake Technology-Nepal (NSET)

15 WCEE
LISBOA 2012

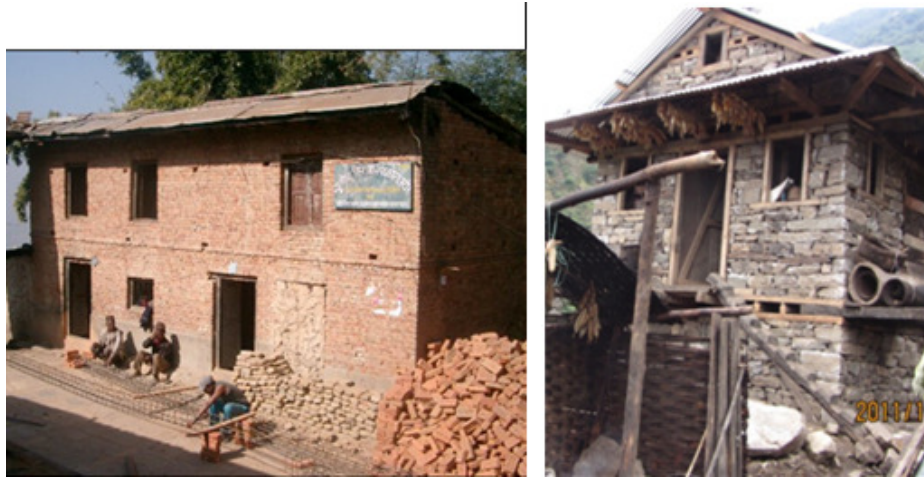
Fig 1.1 Typical brick (left) and stone (right) masonry buildings in Nepal

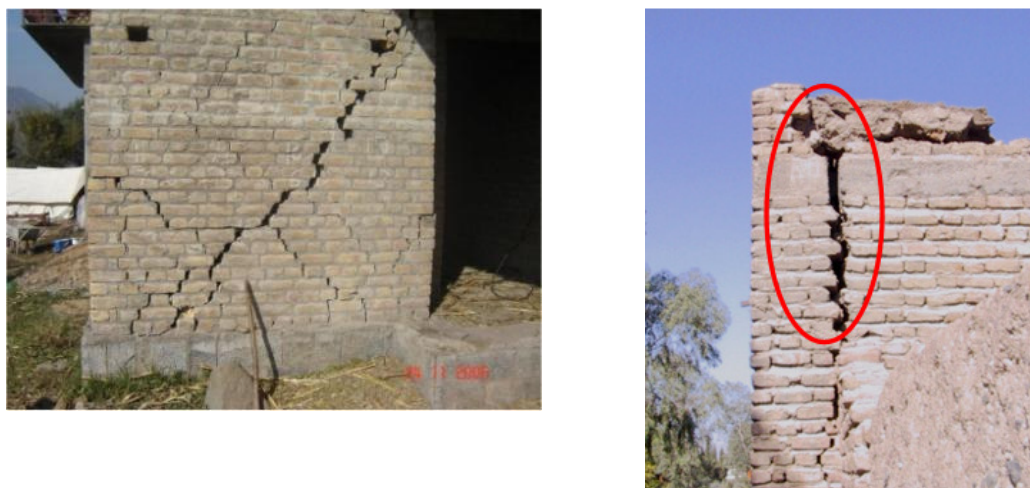
Fig 2.1 Diagonal shear failure, (left); Corner separation due to lack of integrity (right), 2005 Pakistan earthquake, Photo courtesy NSET

The damage and destruction in stone and brick masonry walls is attributed to the violation of the most basic rules of masonry construction, such as the absence of ‘through’ stones and ‘long corner’ stones in stone walls, use of mud mortar/lean cement mortar in stone or brick masonry, lack of proper connection between orthogonal walls or between the roof and walls, lack of proper workmanship and quality control, lack of cross walls and above all, the absence of earthquake resistant features, causing the building to fail in a brittle manner rather than in a ductile manner. A large number of masonry buildings suffered severe damage through past earthquakes, indicating the high level of seismic vulnerability in the region . The most common damage patterns are corner separation, formation of cracks near the corners and at openings, out-of-plane tilting of walls, collapse of roof etc. Improvement in construction practice and maintaining the integrity of the building structure, can significantly enhance the earthquake resistant performance of such buildings.

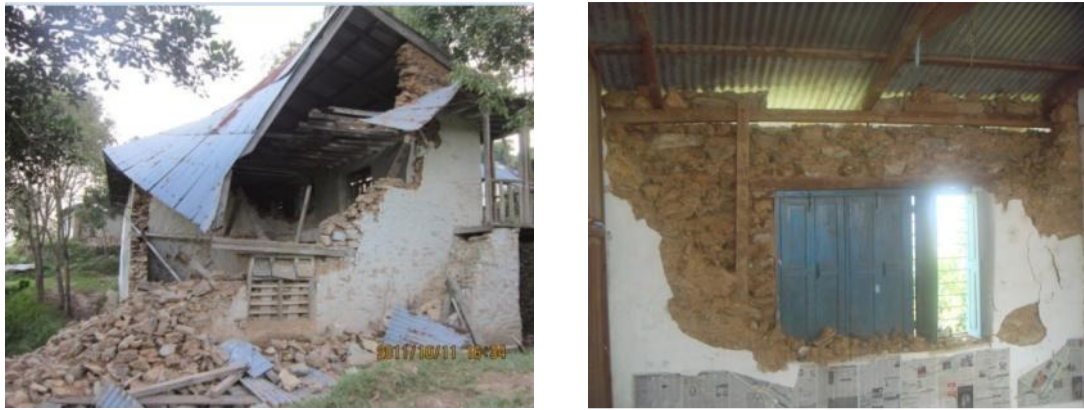
Fig 2.2 Failure of roof connection to wall (left); Collapse of inner wythe of stone wall due to lack of through stone (right), 18th Sept 2011 Taplejung Nepal earthquake, Photo courtesy NSET

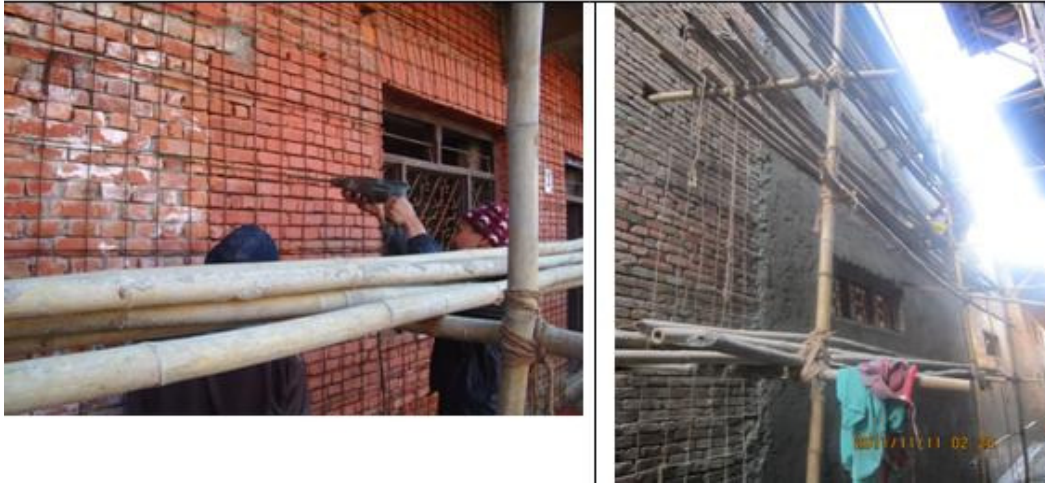
Fig 3.1 Retrofitting process using steel wire mesh

includes 1) Removal of plaster from walls in the proposed area for RC jacketing and Bandage/Splint 2) Rake out mortar joints to 15-25 mm depth, clean surfaces and wet with water 3) Excavate the soil for tie beam and lay the reinforcement of tie beam and wall 4) Drill in the wall and provide anchor rod to tie inner and outer steel reinforcement 5) Cast tie beam and apply concrete/plaster in two layers 6) Cure concrete.

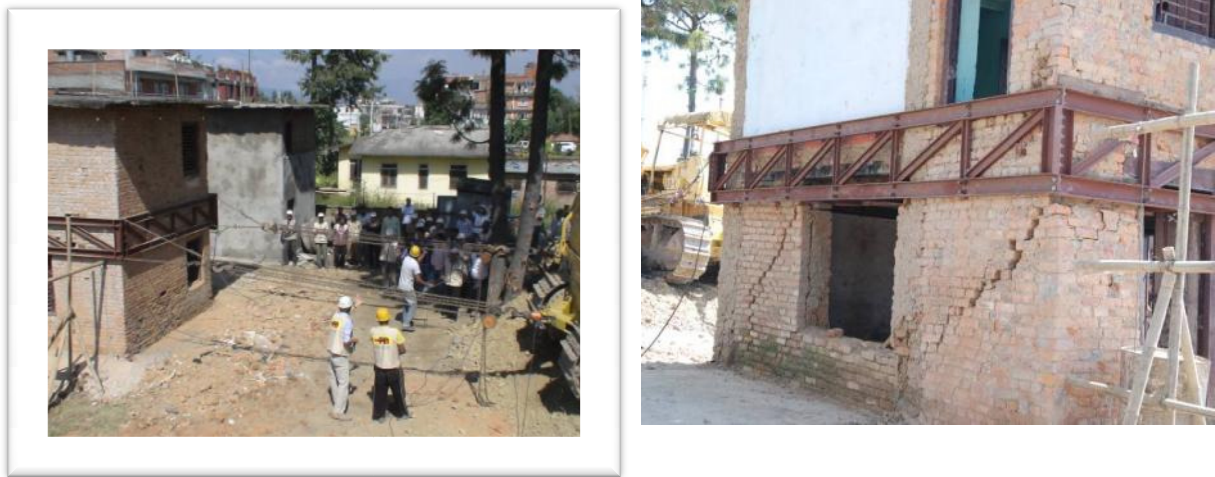
Fig 3.2 Loading arrangement (left) and crack propagation (right) during pull down test of non-retrofitted building

A pull down test has been carried out to assess the effectiveness of this system in the seismic upgrading of the existing buildings in Nepal. For this, two, full scale, identical brick in mud buildings were used, one in its original condition and the other with seismic retrofitting, using galvanized wire mesh. 16 gauge galvanized wire mesh @ 19 mm c/c spacing was anchored on both faces of the wall and plastered with cement sand mortar of ratio 1:3. Holes were drilled through the wall to fix the galvanized wire with cross wires, staggered @800 mm c/c.

The pulling forces vs. roof displacement, i.e. the pushover curve of the buildings, were developed from the experimental test. The loading was applied gradually to avoid dynamic amplification of stresses. Two load cells of 20 ton capacity were used to record the applied loads on each building. Three displacement transducer gauges, of 25mm measuring capacity, were used to record the small displacements induced by each increment of load. Two displacement transducer gauges of capacity 500mm were used to measure large displacements, beyond the elastic and plastic limits. Light sensors were used to capture the collapse pattern by still camera. A data logger was used to communicate the signals between the transducer and PC.

The mud mortared non-retrofitted building collapsed under a pulldown loading of 17 tons, as compared with the estimated 19.0 ton collapse loading of the numeral modelling. The numerical model indicates that the wire mesh retrofitting and plastering, increases the rigidity of the structure within the elastic limit and can resist large deformations in plastic range. The experimental results indicate an increase in rigidity of the structure within the elastic limit, with 3.5 mm displacement under 26.3 tons of loading, with no visible cracks. The building could sustain further loading but it could not be tested above 26.3 ton due to limitations of test set up. The retrofitted building sustained 1.55 times the pulldown load as compared with the similar non-retrofitted building, without any visible cracks and an estimated load carrying capacity of 2.47 times the pulldown load from numerical calculations [NSET, December, 2009]. Both analytical and experimental results concluded that this upgrading technique significantly increases the strength and stiffness of the buildings. If adequately implemented, the system will improve the performance of the buildings during future earthquakes.

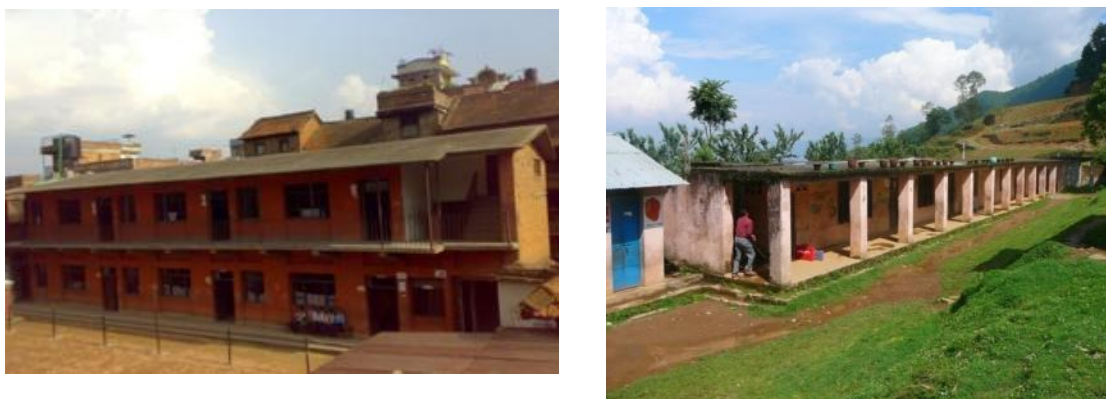
Fig 3.3 Two of the school buildings before retrofitting

Similar retrofitting techniques were employed in fifteen school buildings in Kathmandu Valley. Of the selected 15 school buildings, 8 were built in mud mortar, 2 in weak cement mortar, and 5 were a mix, with mud mortar in ground floor and cement mortar in first floor. Shear strength of the mortar was determined by in-situ shear test equipment for all schools. Full wall jacketing on the exterior faces of peripheral walls, and splint and bandage systems through inner wall surfaces, was opted in thirteen of the school buildings (87% of selection). Full wall jacketing on both the faces of load bearing inner and outer walls was employed for two buildings, due to inherent weaknesses. Retrofit design is shaped by the required safety levels for important structures such as school buildings, which also play a major role in post earthquake events. These two weaker buildings were of poor construction, with irregular load paths and a lack of integrity between inner and outer walls, hence the jacketing of both sides, to address the pertinent deficiency whilst ensuring minimum modification to door/window openings. This system of retrofitting was selected as the appropriate option for these buildings as the most technically and economically feasible method, aesthetically acceptable whilst enhancing the overall performance of the building, ensuring a level of life safety. More importantly, local builders and masons are easily able to carry and replicate the process independently, without any difficulty. The cost per sq ft of the plinth area was estimated at \$6-7, within an affordable range for the target subjects. As more than 60% of the existing building stock in Nepal is unsafe and does not fall under the acceptable range of Life Safety [JICA, , March 2002], Nepal must resort to a seismic strengthening strategy, using appropriate measures for earthquake disaster mitigation rather than demolition and reconstruction. Unless the existing vulnerable buildings are strengthened, Nepalese citizen will be constantly facing a high risk of earthquake damage in terms of human and property loss.

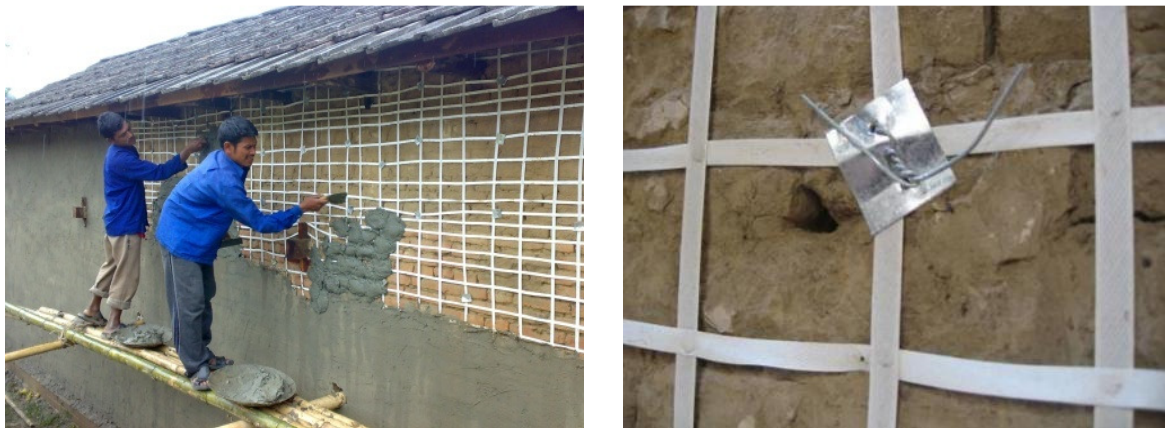
Fig 3.5 Implementation of PP band method of retrofitting in Kathmandu Valley (left) and anchorage throughout the wall (right)

Polypropylene meshing uses common polypropylene packaging straps (pp-bands) to form a mesh which is used to encase masonry walls, preventing both collapse and the escape of debris during earthquakes. PP-bands are used for packaging all over the world and are therefore cheap and readily available while the retrofitting technique itself is simple enough to be suitable for local builders. PP-meshing has been applied in Nepal, Pakistan and more recently in China.

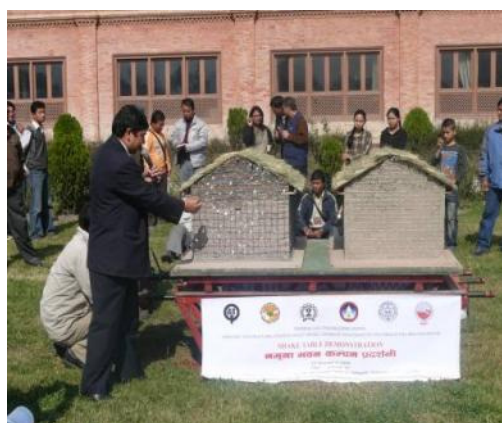
Fig 3.6 Two identical buildings with and without retrofitting by PP Band before shake table

In order to demonstrate the seismic response of the target building, with and without PP-band mesh retrofitting, and to compare crack patterns, failure behavior, and overall effectiveness of the retrofitting technique, a shake table test was carried out. The test verified that PP-band mesh retrofitting significantly improves the performance of the masonry building structures, maintaining the structural integrity with sufficient energy dissipation through extensively developed cracks [NSET, June 2009]. The general process of retrofitting by PP Bands includes 1) Plan modifications such as adding or removing solid walls, changing door/window openings, if required, to balance wall stiffness in both directions 2) Chipping off the wall plaster 3) Fixing of base anchor beam and tying on either side of the wall 4) Fixing of vertical PP Band starting from the outer anchor beam and ending at the inner anchor beam (this is feasible with flexible timber flooring) 5) concreting of anchor beam 6) Meshing the horizontal PP band on vertical PP band then connecting horizontal PP-Band with vertical PP-Band by Welder 7) Connecting inner and outer mesh with wires and aluminum plates 8) connecting roof elements with wall and bracing of roof 9) Mud plaster on wall to protect PP Band from ultraviolet rays.

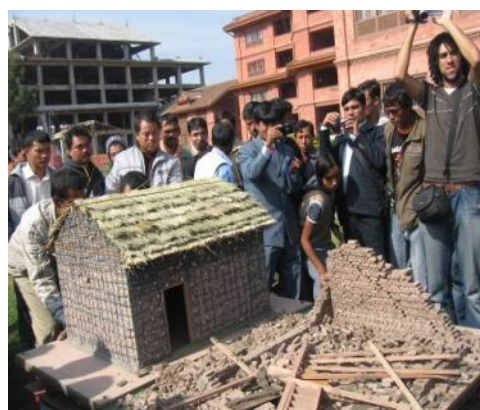
Fig 3.7 Shake table result' Non-retrofitted building collapse while retrofitted building is standing
