Effect of Polypropylene Fiber Reinforced Concrete for Enhancing the Seismic Performance of Bridge Columns

SUMMARY:

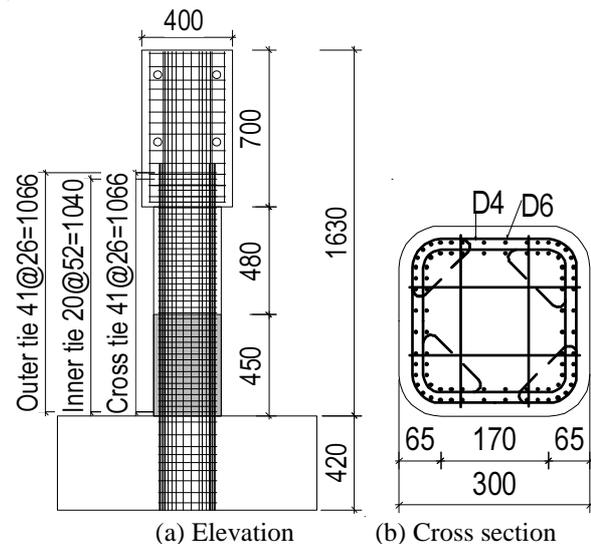
Figure 1. Experimental Specimen

Two columns with the same size, reinforcement and materials were constructed for experiment under two loading conditions. The columns used PFRC at the plastic hinge region as shown in Fig 1. The geometrical scale was assumed to be 6/35 relative to the full-scale PFRC column (C1-6 column) excited by E-Defense (Kawashima and Zafra et al. 2012). C1-6 column was a 7.5 m tall and it had a 1.8 m by 1.8 m square section with round corner. It was designed for Level 2 design ground motions based on the 2002 JRA code assuming the moderate soil condition. In C1-6 column, PFRC was used in the plastic hinge region of the column within 2.7 m from the base and a part of the footing within 0.6 m from the surface. Eighty deformed longitudinal bars with a diameter of 35 mm were set in double in C1-6 column. Deformed tie bars with a diameter of 22 mm were set at every 150 mm and 300 mm interval for the outer and inner longitudinal bars, respectively. Two cross ties in the longitudinal and transverse directions each were set at every 150 mm.

Based on the geometrical scale of 6/35, two scaled models were designed such that they were 1.37 m tall from the base to the loading point (total height from the base to the top is 1.63 m) having a 0.3 m by 0.3 m square section with four 65 mm round corners. PFRC was used in the plastic hinge region within 450 mm from the base while the standard concrete was used in the rest including the footing. Note that a part of the footing was constructed by PFRC in C1-6 columns while regular concrete was used in the scaled model. As will be described later, this resulted in larger column failure at the base in the scaled models. The nominal strength of PFRC was 40 MPa and 3 % volume of polypropylene

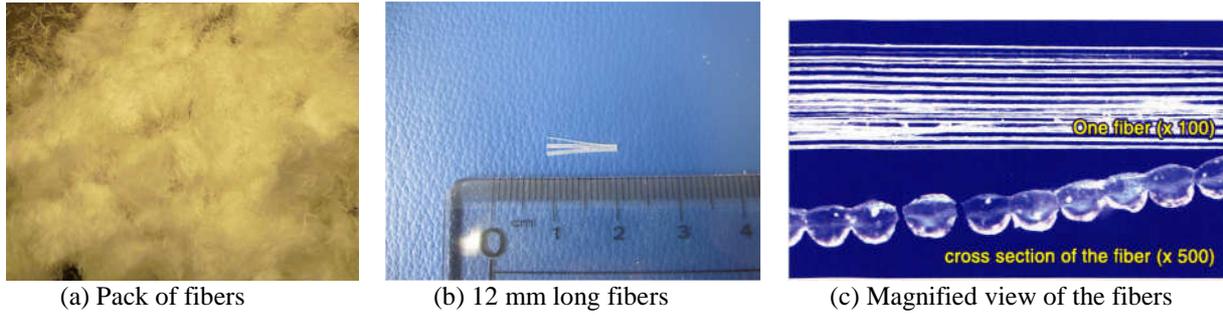
Photo 1. Polypropylene fibers used in the experiments

fibers were combined in the PFRC. The polypropylene fibers as shown in Photo 1 were used. They were 12 mm long fibrillated fibers with a diameter of $42.6 \mu\text{m}$, the tensile strength of 482 MPa and the Young's modulus of 5 GPa. Based on the coupon experiments, the compressive strength and tensile strength of PFRC were 40.1 MPa and 2.1 MPa, respectively, as shown in Fig. 2.

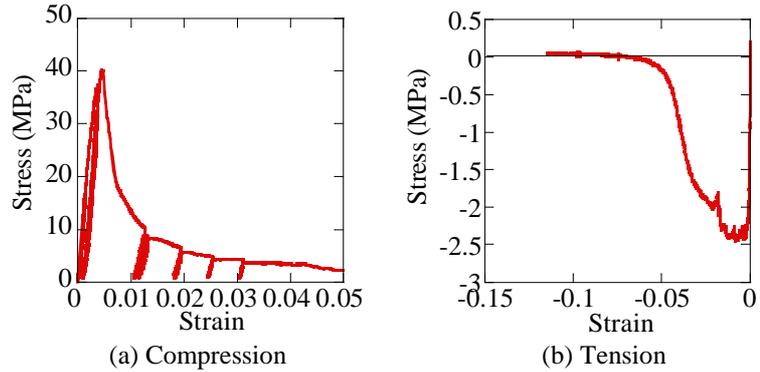
Figure 2. Stress vs. Strain Hysteresis of PFRC

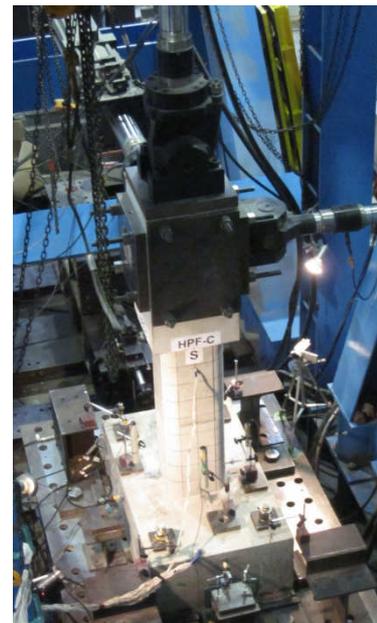
Photo 2. Experimental Setup

Photo 2 shows the experimental setup. Two loading protocols were used. The first model was subjected to a bilateral cyclic loading assuming a circular orbit under a constant vertical compression force of 88 kN. The model was first loaded in the East (E) direction until the displacement reached 0.5 % drift at the loading point. From this point, the model was loaded three times along the circular orbit. Finally, the pier was unloaded to the rest position from the E direction. This set of loadings was repeated until failure of the model with an increment of 0.5 % drift, where drift is defined as a ratio between a column displacement at the loading point divided by the distance between the base and the loading point (1.37 m)

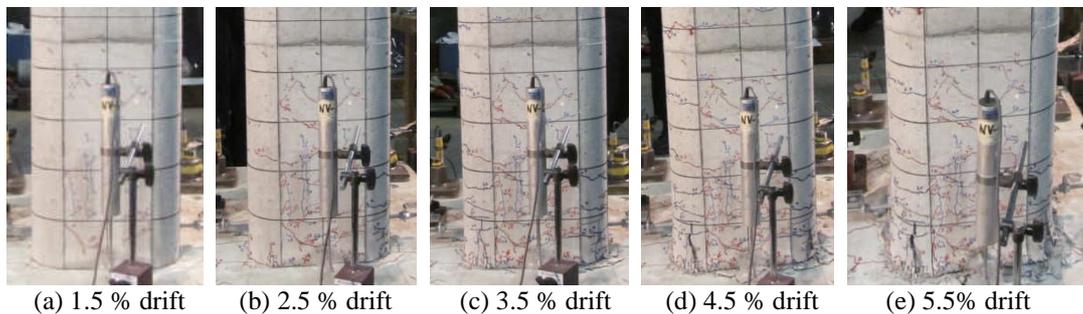
Photo 3. Progress of Damage in the Plastic Hinge Region under Cyclic Loading

Photo 3 shows the progress of damage at the plastic hinge region under the cyclic loading. During 1.5 % drift loading, flexure cracks opened as wide as 0.08 mm. A crack opened between the footing and the column during the 1.5 % drift loading. During the 2.0 % and 2.5 % drift loadings, the crack width increased to 0.15 mm and 0.2 mm, respectively. During the 2.5 % drift loading, a major vertical crack as wide as 0.45 mm opened at a corner at the base. The concrete at a part of the surface of footing within 50 mm from the column crushed during the 2.5 % drift loading. During the 4.0 % and 4.5 % drift loading, a lateral actuator touched to the steel frame resulting in some increase of the measured restoring force as will be described later. During the 5.0 % drift loading, at least five longitudinal bars ruptured. During the 5.5 % drift loading, longitudinal bars further ruptured. Since the restoring force significantly deteriorated, the cyclic loading was completed.

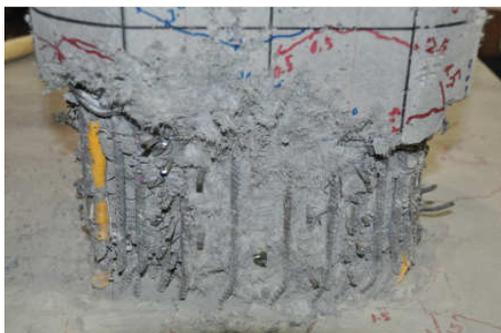
Photo 4. Damage in the Plastic Hinge Region after Cyclic Loading Experiment

Photo 4 shows damage of the column at the plastic hinge region after the cyclic loading was completed and covering concrete was removed. At the column base, 37 outer longitudinal bars and 17 inner longitudinal bars ruptured as shown in Fig. 3. The concrete at the footing surface crushed as deep as 30 mm and this lead to local buckling of several longitudinal bars. For mitigating such a

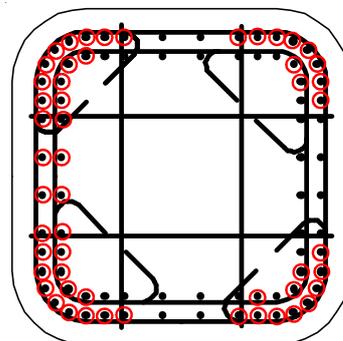
Figure 3. Raptured Longitudinal Bars in Cyclic Loading Experiment

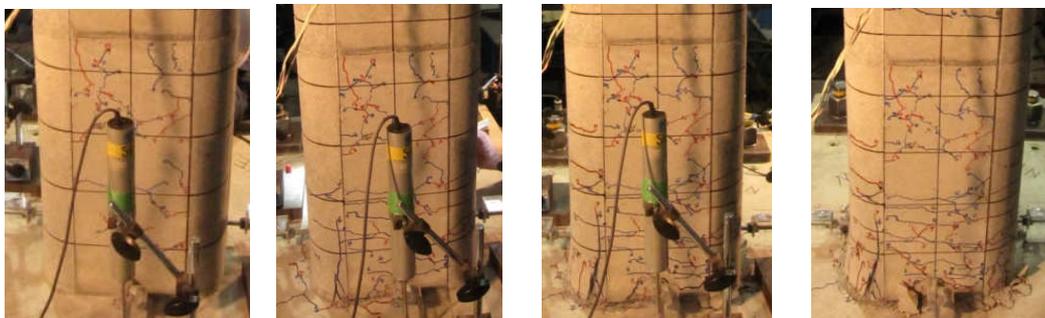
(a) After 3rd excitation (b) After 5th excitation (c) After 8th excitation (d) After 9th excitation

Photo 5. Progress of Damage in the Plastic Hinge Region under Seismic Response Loading

Photo 5 shows the damage of the column at the plastic hinge region after the 3rd, 5th, 8th and 9th seismic response loading was completed. During the 1st, 2nd and 3rd excitations with the peak lateral drift of 1.1 %, 1.2 % and 1.9 %, respectively, only flexural cracks as large as 0.06-0.15 mm occurred. During the 4th excitation, the peak lateral drift of the column was 3.7 % drift, and a major vertical crack occurred at the SW corner and it extended during the 5th excitation (the peak lateral drift was 5.1 % drift) as shown in Photo 5(b). During the 6th and 7th excitations (the peak lateral drift was 6.0 % and 7.5 % respectively), the vertical cracks further extended however PFRC did not suffer extensive damage without deterioration of the flexural restoring force. During the 8th excitation, the peak column displacement reached 9.0% drift, and at least four longitudinal bars ruptured. Since longitudinal bars started to rupture during 5.0 % drift loading under the cyclic loading, the 9.0 % drift at which longitudinal bars started to rupture under the seismic response loading was 1.8 times larger. After the 9th excitation, the flexural restoring force deteriorated.

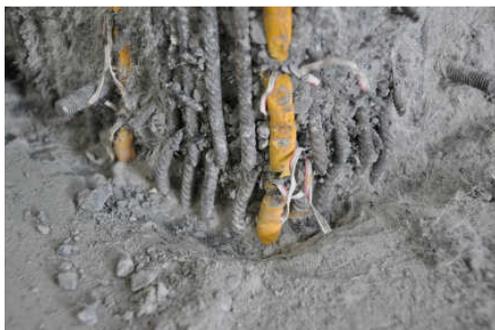
Photo 6. Damage in the Plastic Hinge Region after Seismic Response Loading Experiment

Photo 6 shows the damage of the column after the 9th seismic response loading experiment and Fig. 4 shows the locations of ruptured longitudinal bars. As shown in Fig. 4, 12 outer longitudinal bars ruptured, however, no inner longitudinal bar ruptured. Consequently, the number of ruptured bars under the seismic response control was nearly 1/4 of the number of ruptured bars under cyclic loading. Therefore, the effect of loading protocols on the damage of the model columns is significant. Similar to the damage under the cyclic loading, the concrete at the footing surface crushed as deep as 30 mm and local buckling of longitudinal bars were developed there under the seismic response loading too.

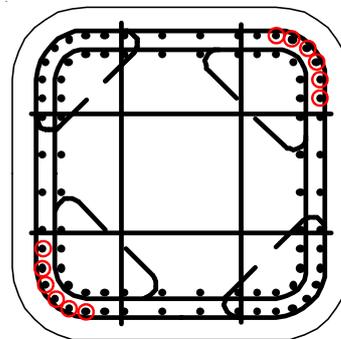
Figure 4. Ruptured Longitudinal Bars after Seismic Response Loading Experiment

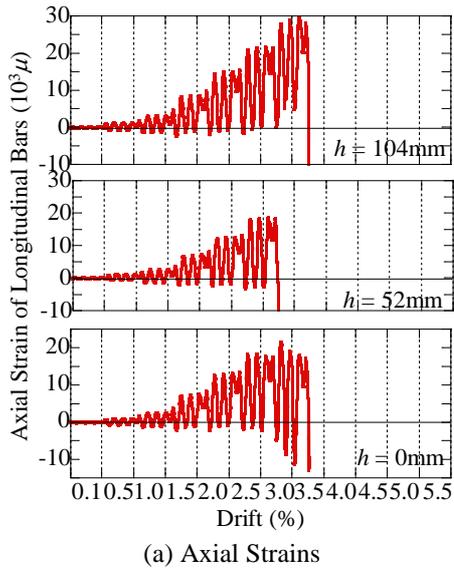
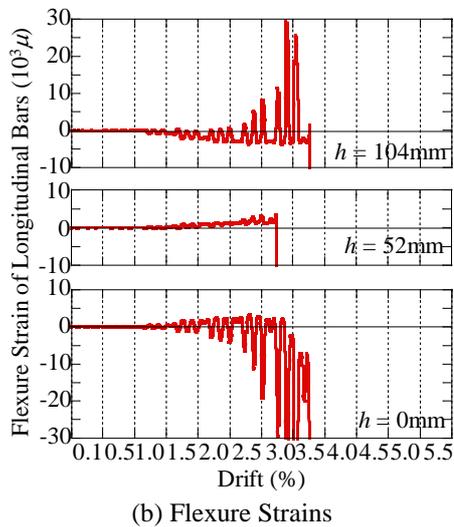
(a) Axial Strains

(b) Flexure Strains

Figure 5. Strains of a Longitudinal Bar at SW Corner under Cyclic Loading

Fig. 5 shows strains of a longitudinal bar at the base and 52 mm and 104 mm from the base at SW

corner in the column subjected to the cyclic loading. Both axial and flexural strains are shown here. Axial strains of the longitudinal bar gradually increases from 1.0% drift. On the other hand, the flexural strains started to sharply increase at 2.5% drift which shows that local buckling of the longitudinal bar occurred.

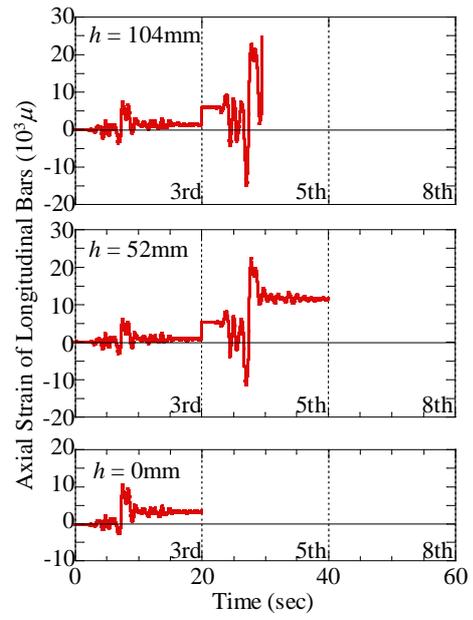
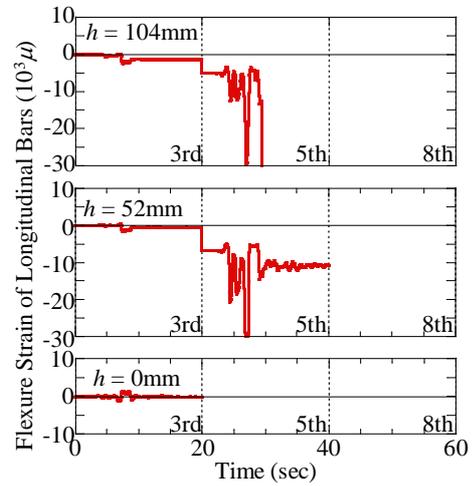
(a) Axial Strains

(b) Flexure Strains

Figure 6. Strains of Longitudinal Bars at SW Corner under Seismic Response Loading

Fig. 6 shows strains of a longitudinal bar at the same locations in the column subjected to the seismic response loading. Axial strains started to increase at the 3rd excitation, and they reached over 20,000 μ at the 5th excitation. On the other hand, the flexural strain started to increase at the 4th excitation, and they extensively increased at the 5th excitation indicating that local buckling of the longitudinal bar became predominant.

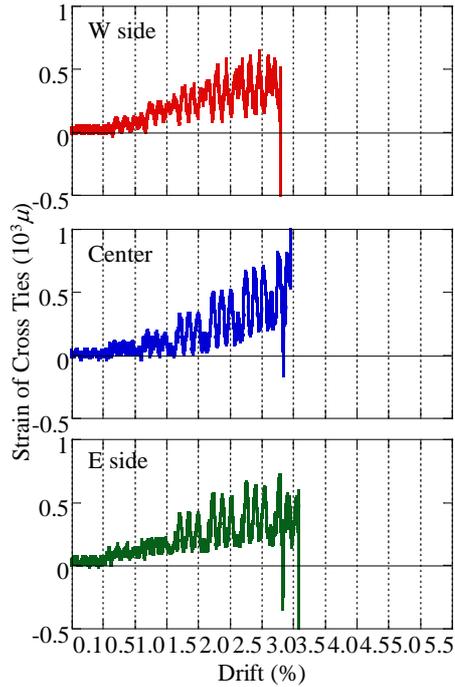
Figure 7. Strains of Cross Tie at 67mm from the base in EW direction under Cyclic Loading

Figs. 7 and 8 show axial strains of a tie, at three locations (west side, center and east side) 67 mm from the base located in EW direction under the cyclic loading and the seismic response loading, respectively. It is noted that the strains are similar between the three locations.

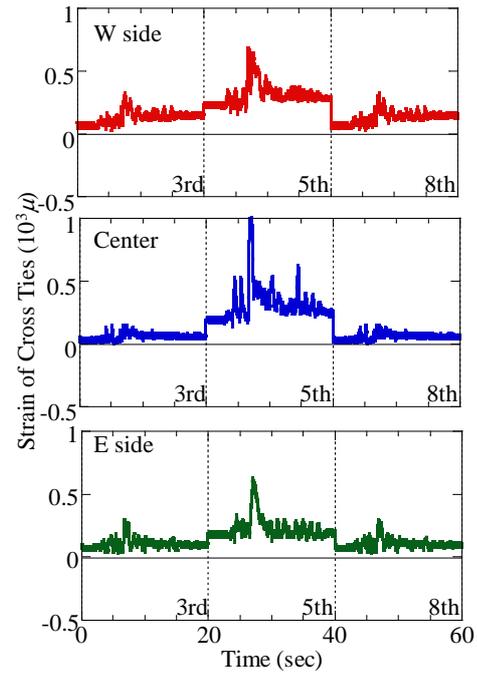
Figure 8. Strains of Cross Ties at 67mm from the base in EW Direction under Seismic Response Loading

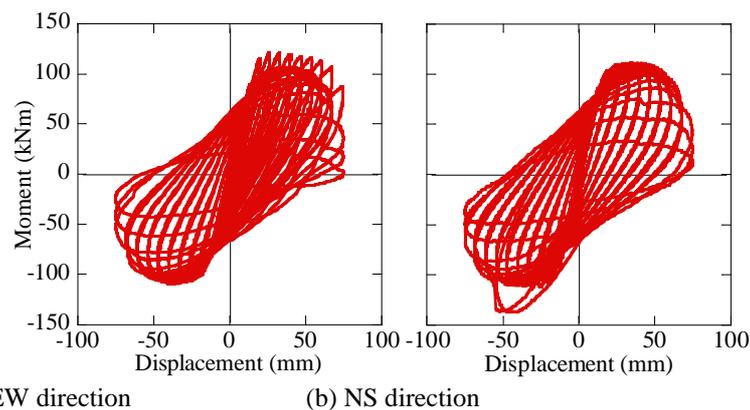
Figure 9. Moment at the Base vs. Lateral Displacement at the Loading Point Hysteresis under Cyclic Loading

Figs. 9 and 10 show hysteresis of the flexural moment at the column base vs. the lateral displacement at the loading point under the cyclic loading and the seismic response loading, respectively. The hystereses in the NS and EW direction are shown here. Since the moment capacity was similar between the EW and NS directions, the flexural moment in the EW is shown below. The flexural moment reached the maximum value of 122 kNm when the drift reached 2.0 %. At 5.5 % drift, the moment deteriorated to 87 kNm which was 71 % of the maximum flexural moment. On the other hand, the maximum flexural moment was 133 kNm at the 5th excitation (4.6 % drift). Even during the 8th excitation (8.1 % drift), the maximum flexural moment was 126 kNm which is 95 % of the flexural moment during the 5th excitation.

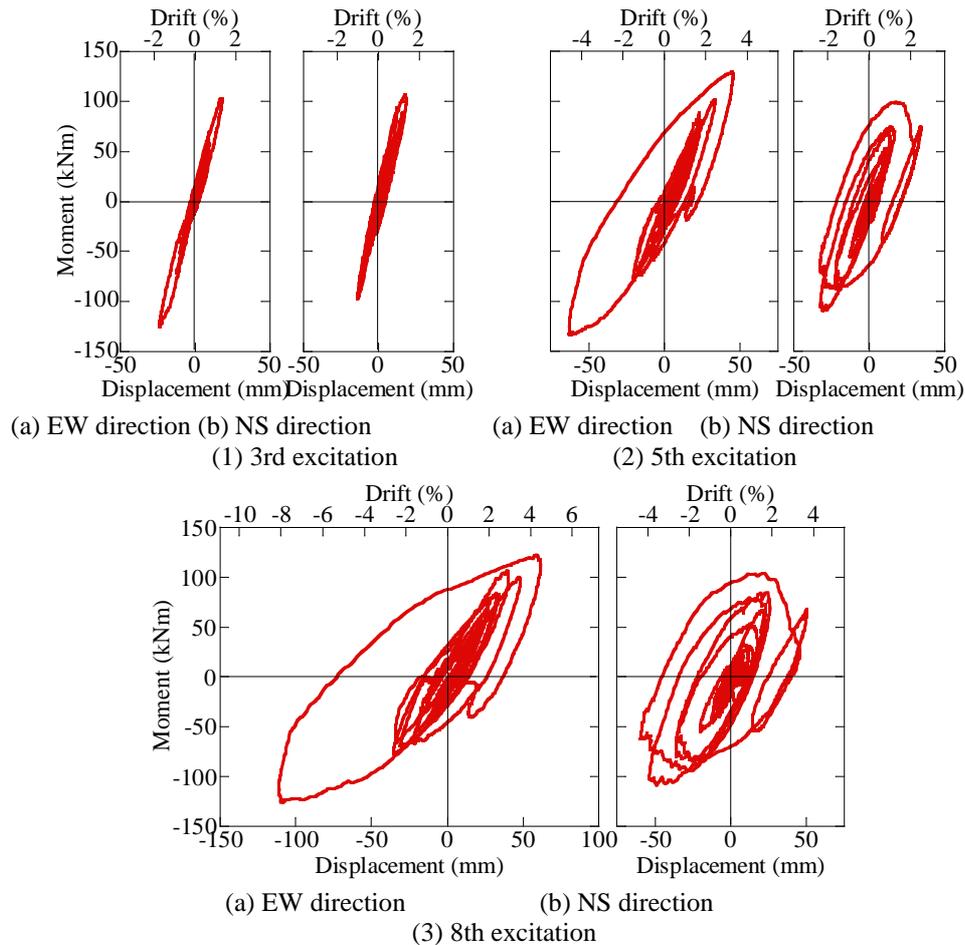
Figure 10. Moment at the Base vs. Lateral Displacement at the Loading Point Hysteresis under Seismic Response Loading

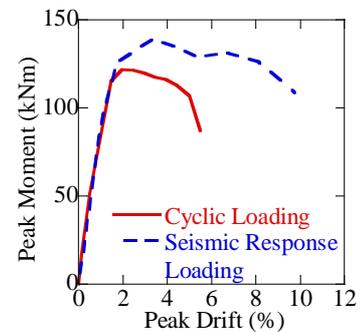
Figure 11. Peak Moment at the Column Base vs. Peak Drift at the Loading Point Hysteresis in the longitudinal direction

Fig. 11 compares the peak flexural moment at the column base vs. the peak drift at the loading point curves. It is noted that the moment capacity of the model column was larger under the seismic response control than the cyclic loading. Rupture of longitudinal bars at the earlier loading stage deteriorated the column flexural capacity. It is also noted that under the cyclic loading, the flexural moment started to sharply deteriorate at 5.5 % drift while the flexural moment did not deteriorate even

at 8.1 % drift under the seismic response loading. The rupture of longitudinal bars at the early stage also decreased the column ductility factor. Thus the loading protocol dependence of the column flexural capacity and ductility capacity should be properly evaluated for column capacity. The PFRC model column showed significantly high ductile behaviour under the seismic response loading.
