The Performance of Post-Byzantine churches during the Kozani-1995 Earthquake – Numerical Investigation of their Dynamic and Earthquake Behavior.

G. C. Manos, V. J. Soulis & N. Karamitsios

Laboratory of Experimental Strength of Materials and Structures, Department of Civil Engineering, Aristotle University of Thessaloniki, Greece, gcmayos@civil.auth.gr

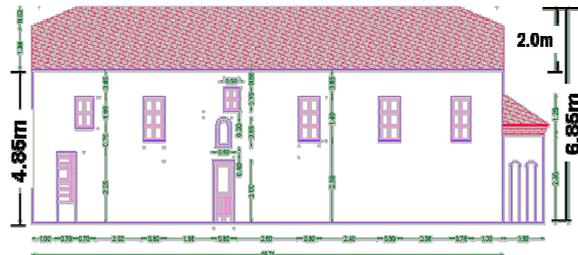
Figure 4b. 2nd Post-Byzantine “Basilica” – South Elevation

b) This structural formation is also a 19th century Post Byzantine church of Taxiarches at the village of Rodiani in the prefectures of Kozani, Greece; it was also damaged by the Kozani Earthquake of 1995. The length of the longitudinal walls is 18.7m whereas that of the transverse walls 11.75m, almost similar to the plan dimensions of the 1st church. However, the height of the peripheral walls is 4.85m, lower than that of the 1st case. Moreover, an additional distinct difference from the 1st case is a system of masonry cylindrical vaults, spherical domes and arches which support the wooden roof that rises another 2.0m from the top of the peripheral masonry walls (Figures 4a and 4b). The thickness of the masonry walls varies from 700mm to 1200mm. A church of the same structural formation with a similar vaulting system, located in the village of Sarakina, was also damaged by this earthquake.

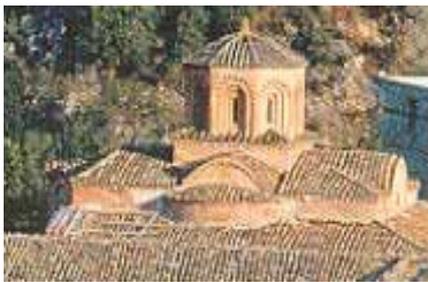
Figure 5. The Katholikon of the Metamorfofi tou Sotiros, in the monastic complex of Zavorda

The church to be investigated here is the Katholikon of the Metamorfofi tou Sotiros, in the monastic complex of Zavorda, in the prefecture of Grevena, Greece (Figures 5 & 6). Its structural system is of the “cruciform with a central dome”. The central dome is formed by spherical or cylindrical shapes and is supported by the cylindrical vaulting through a system of cylindrical rings and spherical pendentives that form the basis of the central dome and the links with the vaulting. Apart from the main vaulting system that forms the cruciform, the superstructure is also composed of a transverse secondary vaulting system. Moreover, the peripheral walls are either plane or are combined with semi-cylindrical apses (figures 7a and 7b).

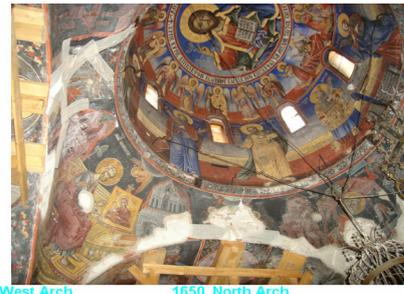
Figure 8b. Damage of the cruciform vaults and the pendentives supporting the central dome.

shape of this church in plan. All the peripheral walls and the apses are 0.75m thick. The height of the peripheral walls is 3.2m. The dome has a diameter of 3.50m, a thickness of 0.3m and a height of 1.857m; it rises from the top of a ring formed internally by the four pendentives. Externally, at the base of the dome, a square masonry “box” is formed with its vertical sides rising from the top of the main cylindrical vaults (Figure 8a). Externally, the vaulting system and this masonry “box” support a wooden roof system with ceramic tiles. An additional feature of this church is the narthex, which is located at the front of the church (figure 8a). The narthex is formed by peripheral walls with a height of 2.60m and a thickness of 0.70m, and in this way extends at a lower level than the West transverse peripheral wall. This church was damaged (figure 8b) during the 1995 strong earthquake sequence and its repair was completed in 2010.
