# Shaking Table Test of Two-Story Masonry House Model Retrofitted by PP-band Mesh

This paper introduces the results of shaking table tests using 1/4-scale two-story masonry house models with and without retrofitting by PP-band method. The two-story masonry house model used in the study is an ordinary dwelling house in south Asia. Shaking table test was carried out using the sinusoidal input wave of the horizontal one direction. Acceleration and displacement of shaking table and some parts of models were measured. Based on the comparison of dynamic response properties and seismic performance of unreinforced and retrofitted two-story models by PP-band method, it can be concluded that PP-band method can increase a lot seismic capacity of two-story masonry house and retrofitted two-story masonry houses could withstand much stronger ground motions that unreinforced two-story masonry house easily collapsed. From these results, PP-band retrofitting technique proposed can enhance safety of both existing and new two-story masonry buildings and can contribute earthquake disaster in the future.

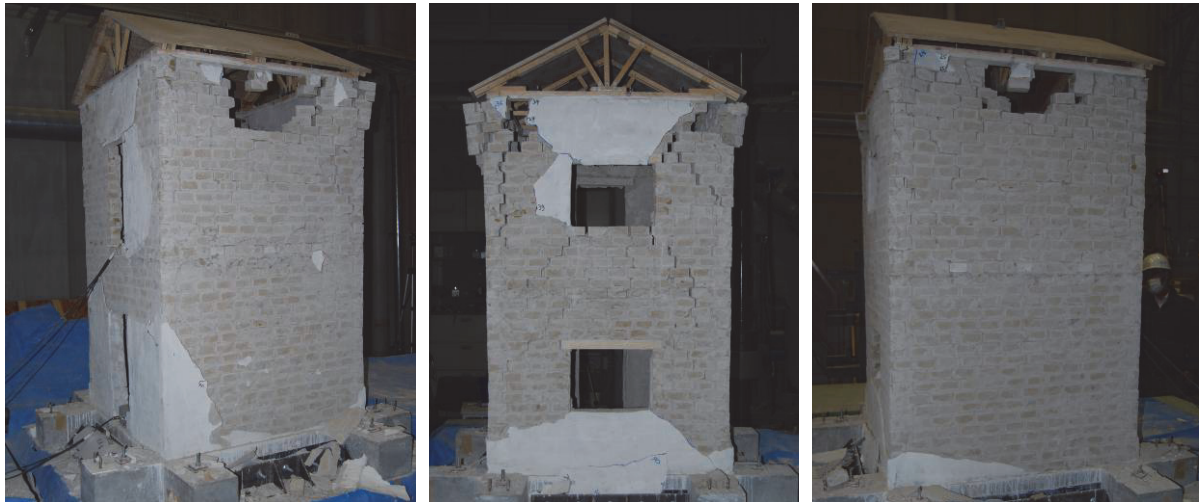
**Figure 7.** Non-retrofitted model after Run 43

Although in case of unreinforced model, cracks widened with each successive run after Run 24, Run 43 was critical. **Figure 7** shows the unreinforced model after run 43. There were large amount cracks observed in walls in the direction of shaking and exciting cracks widened and connection between adjacent walls was become weak. At the end of this shake, as shown in **Figure 7**, some top portion of the north and south walls above totally separated and removed from the model before resuming the

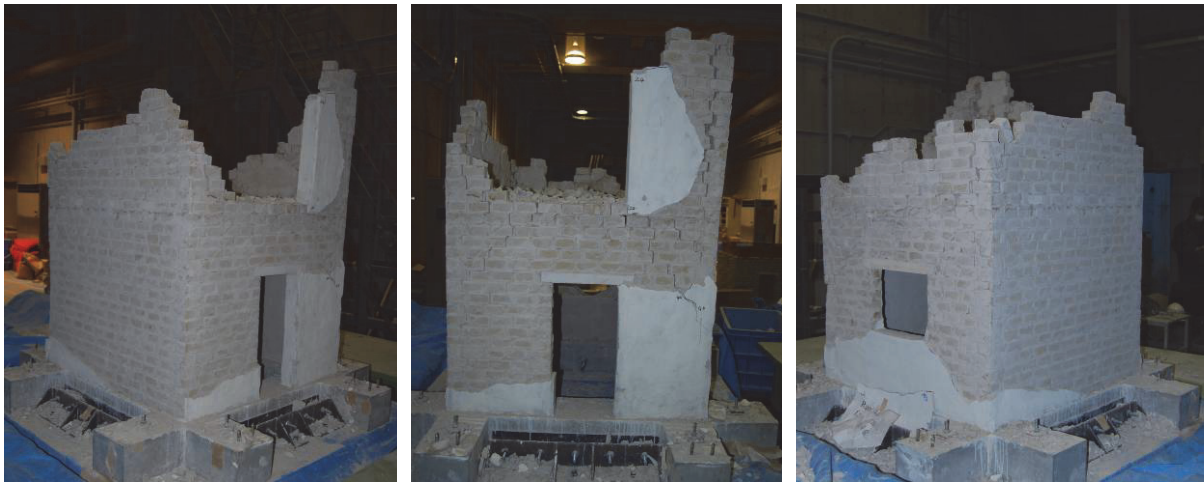
**Figure 8.** Non-retrofitted model after Run 44

testing program. Now the roof only supported by two walls, which were in the opposite direction of shaking. Therefore, they were busted outwards in shaking direction. This finally led to the structure collapse. Run 44 was corresponding to base velocity and displacement equal to 125mm/s and 4mm, respectively.

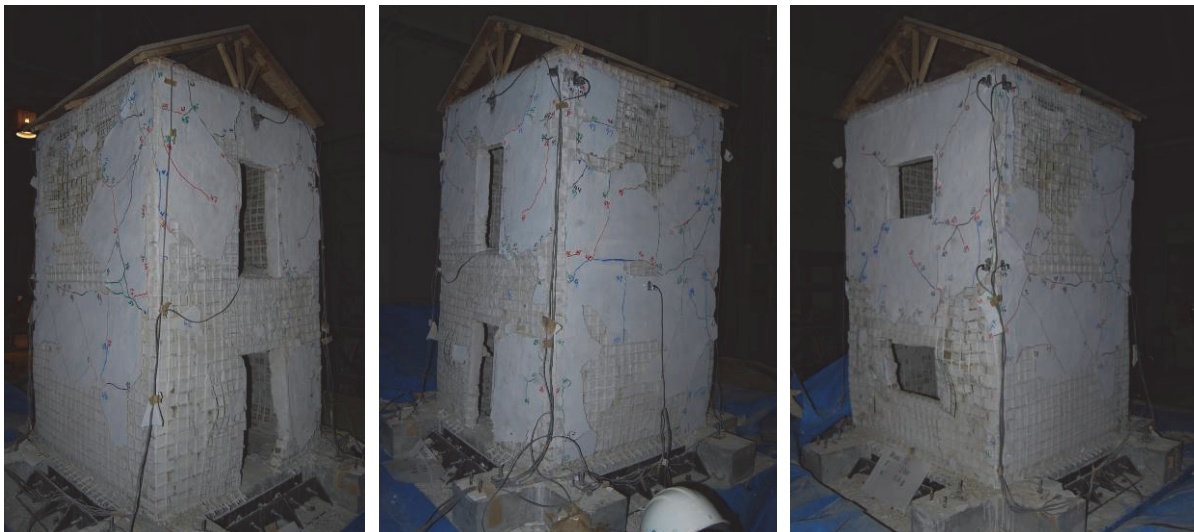
**Figure 9.** Non-retrofitted model after Run 52

In case of retrofitted, each successive shake caused new cracks after Run 33. In each loading, cracks widen and sliding along mortar joints could be clearly observed. At the final stage of the test, run 52 virtually, all the brick joints were cracked, and the model had substantial permanent deformations. This input motion corresponds to a velocity and displacement equal to 467.5mm/s and 37.3mm, respectively, 3.7 and 9 times larger than the motion that caused the failure of unreinforced model. However, building did not lose the overall integrity as well as stability and collapse was prevented in such a high intensity of shaking.

At the final stage of the test, Run 53, with 50.6 mm base displacement, 12 times larger input displacement and 5 times larger input velocity than the Run 44 was applied. At this stage, most of the brick joints were cracked and the building had substantial permanent deformations. However, building did not loose the overall integrity as well as stability and collapse was prevented in such a high intensity of shaking. Thus, we could say that, PP-band retrofitting technique could maintain the

integrity of the structural elements. Further, the retrofitted model showed the better energy dissipation mechanism as many new cracks were propagated without losing the overall integrity and stability of the structure.
