# An Experimental Study on the Effect of Opening on Confined Masonry Wall under Cyclic Lateral Loading

**M. Suarjana, D. Kusumastuti & K.S. Pribadi**

*Department of Civil Engineering, Institut Teknologi Bandung (ITB), Indonesia*

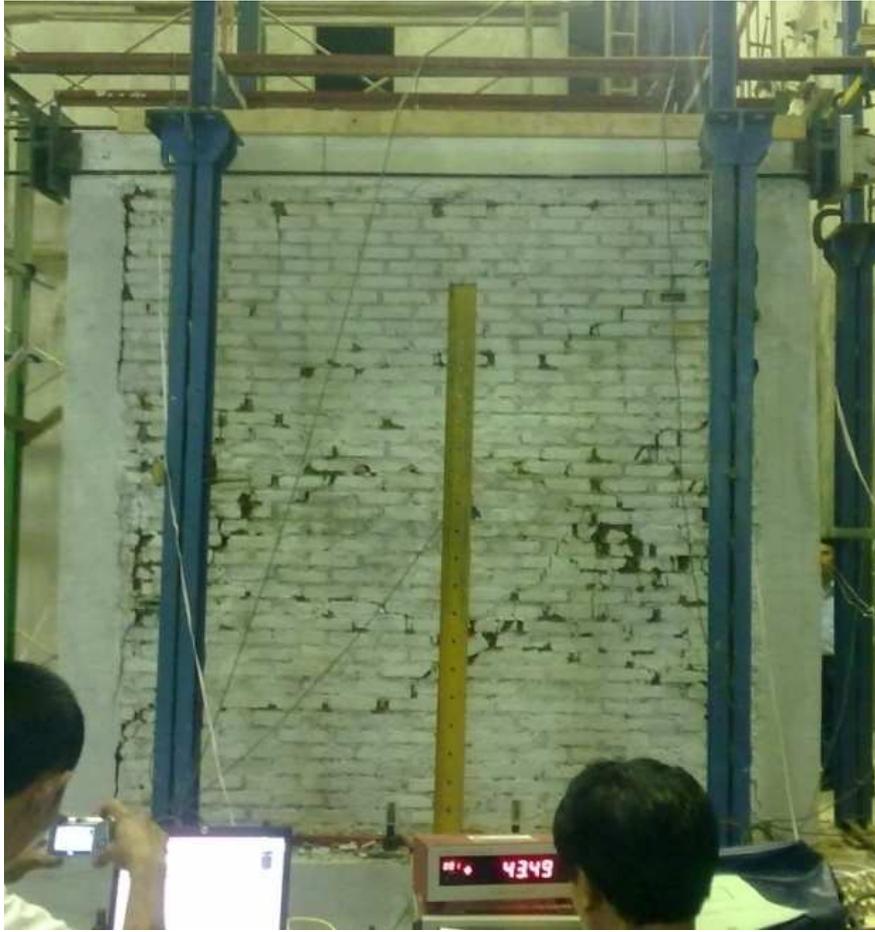
**Figure 5.** Damages observed during the test of specimen 1.

During the experiments, observation was focused on development of cracks, damage pattern and failure mechanism at the end of each test. Fig. 5 and Fig. 6 show selected pictures of specimen 1 during the tests. Similarly, Fig. 7 and Fig. 8 show selected pictures of specimen 2 during the tests. Fig. 8 shows that the window frame can resist the masonry strut compressive force and act as element that bridge the upper part of the masonry compression strut to the lower part of the strut. The window frame was not seriously damaged until the collapse of the masonry wall element.

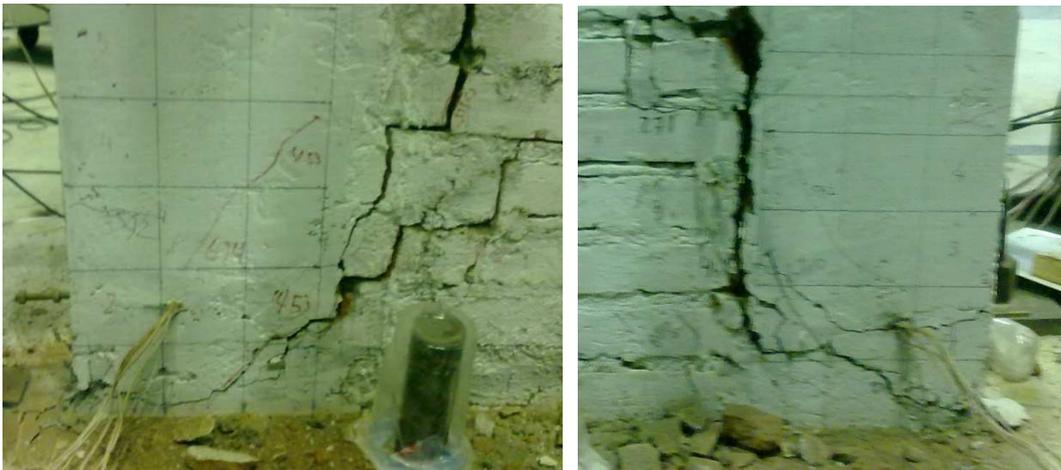
**Figure 6.** Damages observed at the corners of the concrete frame during the test of specimen 1

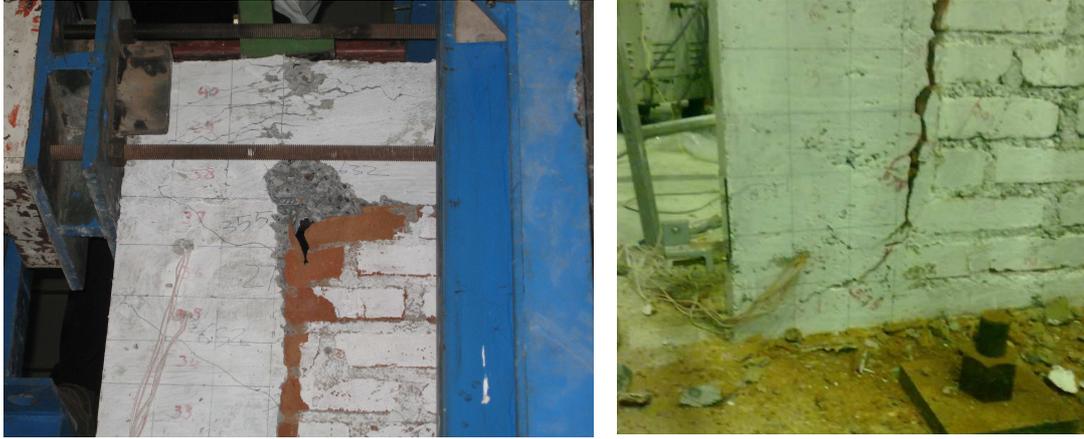
**Figure 7.** Damages observed at the corners of the concrete frame during the test of specimen 2

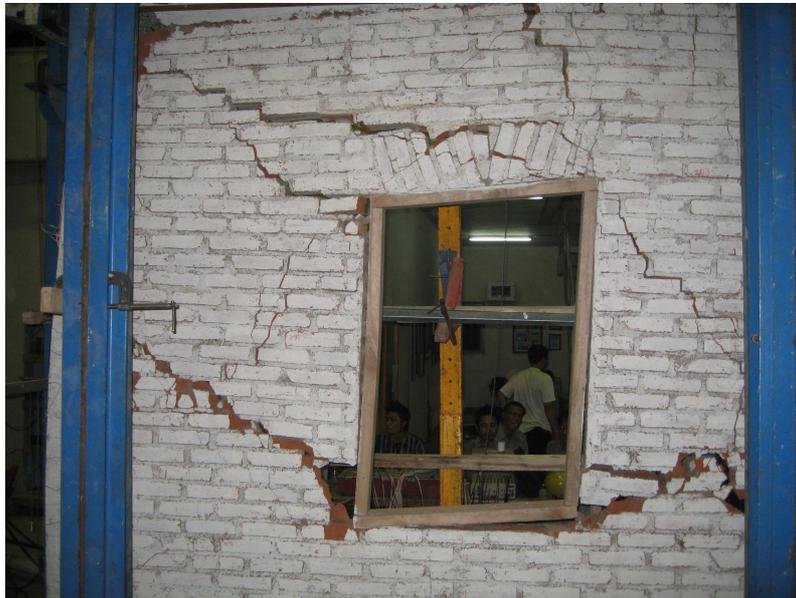
**Figure 8.** Damages around window frame of specimen 2 near the end cycle of test
