Seismic Assessment and Retrofitting of Peruvian Earthen Churches by Means of Numerical Modelling

C. Fonseca Ferreira & D. D'Ayala

University of Bath, United Kingdom

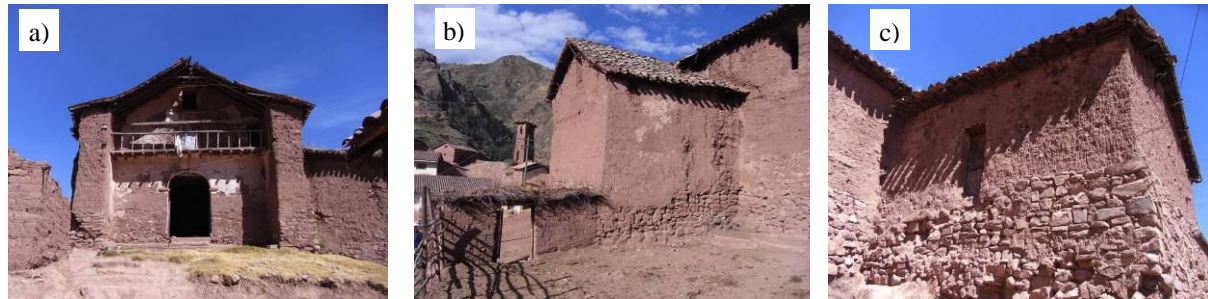
Figure 3. The Church of Kuño Tambo: a) frontal façade; b) baptistry; and c) sacristy

Buttresses and walls are made of adobe masonry, with block of 700x350x200mm laid in mud mortar joint 15mm thick on average (Fig. 3). The base courses, of thickness similar to the thickness of the walls, are made of stones of variable dimensions also set in mud mortar, as depicted in Fig. 3c. In the cases where it is assumed that a physical connection exists between the walls and walls/buttresses it was observed during field work that there is intercalation of the adobe blocks of adjacent parts.

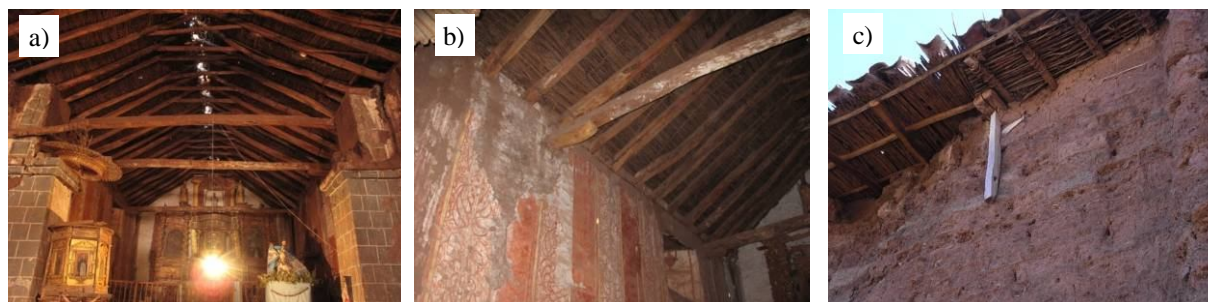
Figure 4. Roof's structure and structural details: a) nave's trussed roof; b) wooden tie-beams; and c) timber anchors

The church has a traditional roof's structure, known as 'par y nudillo' (rafter and collar beam), the construction system of which is based upon pre-Hispanic techniques. The nave's roof is composed of forty-seven roof-trusses, each one with two rafters and one collar beam (Fig. 4a). Wall plates rest on the top of the longitudinal adobe walls and they are composed of several discontinuous segments, each segment supporting four or five rafters. This configuration of the wall plates enables the load that comes from the roof weight of being distributed along the top of the adobe walls; however, it does not absorb the roof thrust, especially because many collar beams are nowadays damaged and highly deteriorated.

The longitudinal walls of the nave and the lateral walls of the baptistry are restrained by means of wooden tie-beams (Fig. 4b) of approximately 0.20m diameter. Some of these tie-beams are fixed to the walls by means of timber anchors, as shown in Fig. 4c.

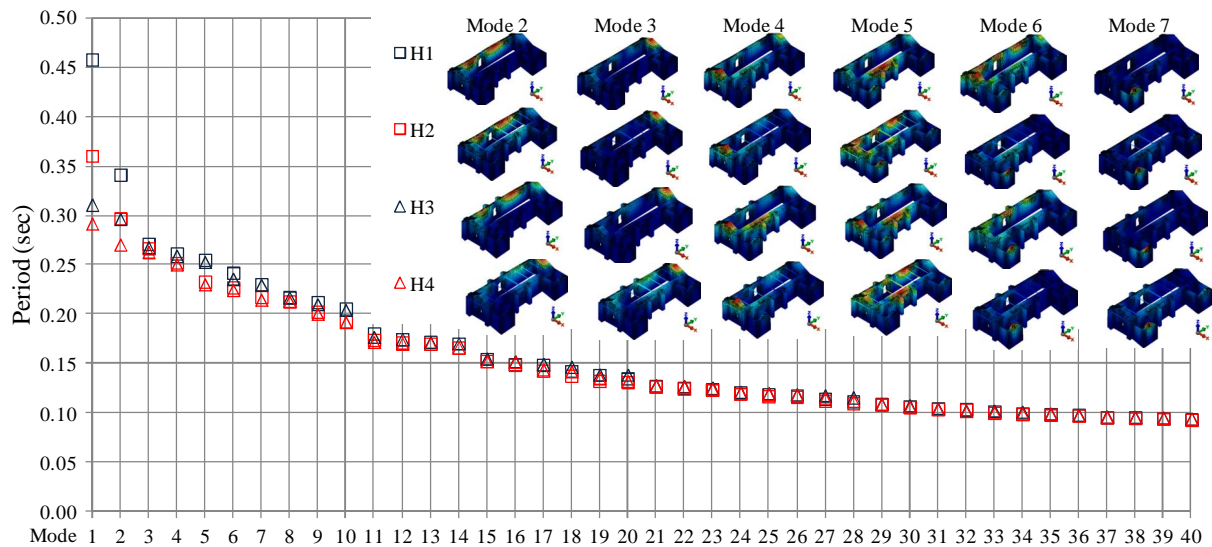
Figure 6. Eigenvalue analysis: natural periods of the first 40 modes

Fig. 6 presents the natural periods of the first 40 modes for hypotheses H_i , $i = 1-4$, and the modal shapes of mode 2 up to mode 7. The cumulative modal effective masses in the X and Y direction are shown in Fig. 7. If 100 modes are calculated, the cumulative masses are approximately equal to 73.5% and 72.5%, in the X and Y direction, respectively. The dynamic response of the church is characterized by the existence of several local modes, in which different portions of the structure vibrate depending on the frequency, as shown in Fig. 6. This response is typical of unreinforced masonry structures.

The most relevant differences on the natural periods between the different hypotheses occur at the first 10 modes, which are predominantly transversal modes (X-direction), as evidenced by Fig. 7, due to the fact that most of the tie-beams and the collapsed buttresses are effective in this direction. The tie-beams diminish the occurrence of local modes, favouring the global modes, as evidenced by mode 5 (see Fig. 6), implying the possible use of ridge purlins to connect the baptistery and sacristy's façade to the nave and, subsequently, to avoid local modes such as mode 7 (see Fig. 6).

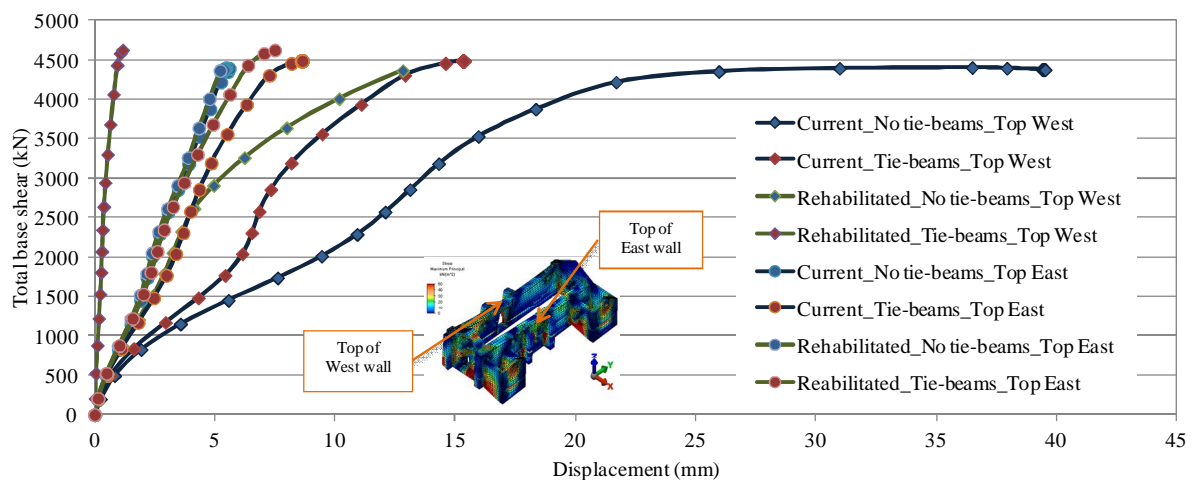
Figure 9. Capacity curves of hypotheses H_i , $i = 1-4$

The benefit of the tie-beams with anchors and collapsed buttresses is further evidenced by the capacity curves of Fig. 9, where the displacement at the top of the East and West façade is shown.

The structural capacity (maximum total base shear) of the structures is almost the same for the four assumed hypotheses. However, the model without the collapsed buttresses and without the tie-beams (H_1) presents 40mm as maximum displacement at the top of the West wall, while the model with collapsed buttresses and tie-beams (H_4) presents 1.2mm. The substantial decrease on maximum displacement could be sufficient for the wall maintain the stability during an earthquake. Nevertheless, it should be emphasized that these values of displacement appear to be rather low for adobe structures and they can be justified by the fact that the walls are continuously connected.
