# A New Testing Capability for Seismic Resistance Assessment of Structures Damaged Due to a Fire

**Hossein Mostafaei**

*National Research Council Canada, Ottawa, Canada*

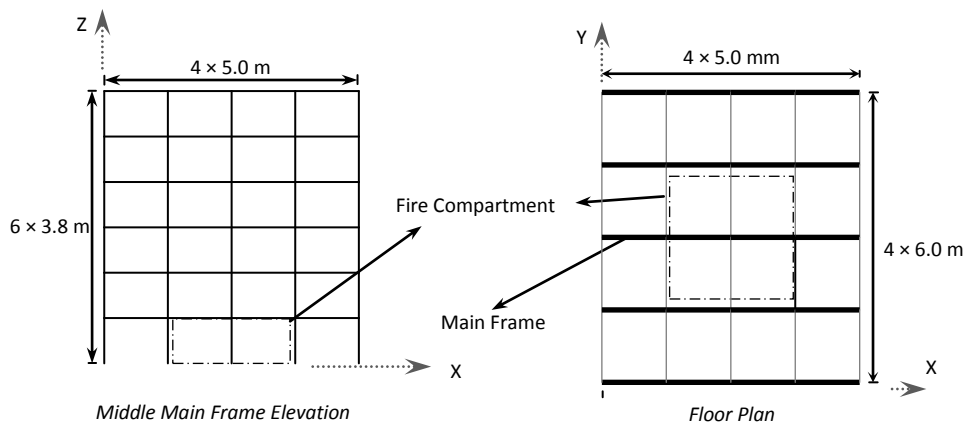
**Figure 2.** Elevation and floor plan of the building with location of the fire compartment.

For this study a fire scenario was considered on the first floor of the building. Figure 2 shows both the floor plan of the building and the elevation of the main frame as well as the location of the fire compartment for the fire test. The floor loads are considered to be carried only by the main frames. The frames perpendicular to the main frames are considered secondary frames.

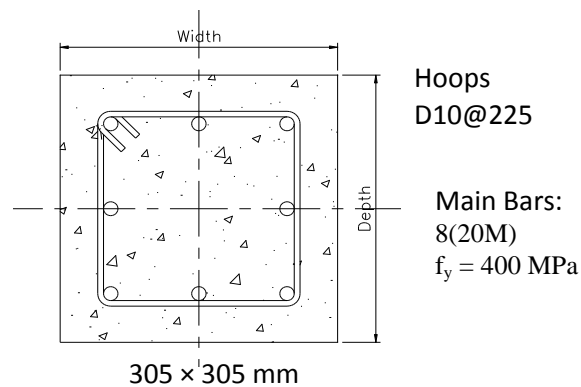
**Figure 3.** Cross Section of Columns at all Levels.

The cross section and details of the reinforcements for columns are shown in Figure 3. The concrete had a compressive strength of 96 MPa and was made of siliceous aggregates with a mix of steel fibre, 42 kg per cubic meter.

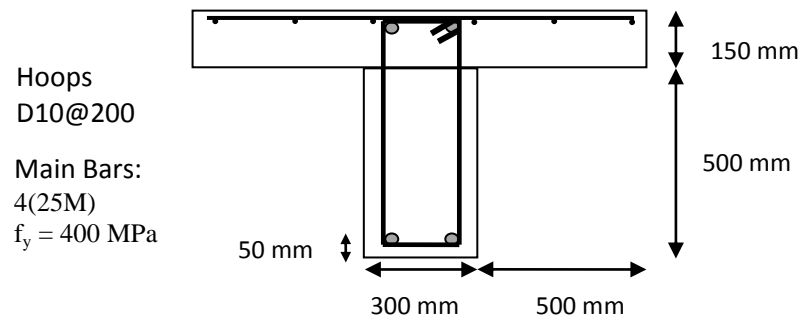
**Figure 4.** Cross Section of Beams for the Main Frames.

The same concrete properties were considered for beams as that for the columns. Figure 4 shows the cross section for the beams of the main frame with material properties of the steel. Figure 5 illustrates the cross section for beams in the secondary frames. In order to include contribution of the floor slabs

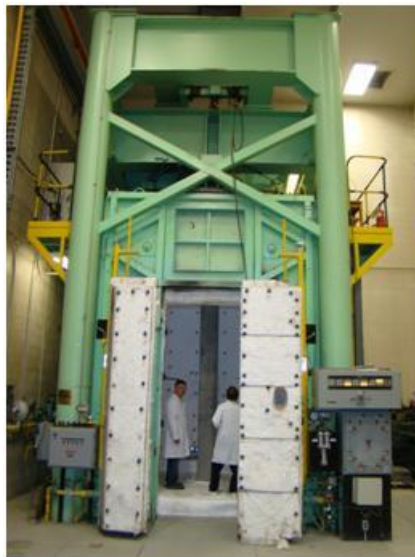
**Figure 7.** NRC's Column Furnace Facility.

The tests were carried out using the NRC's full-scale column furnace facility in Ottawa. The furnace is capable of applying axial loads up to  $9790 \text{ kN}$  (2200 kips), lateral loads up to  $110 \text{ kN}$  (25 kips) in North-South direction, lateral loads up to  $310 \text{ kN}$  (70 kips) in East-West direction with/without fire loads. Further details are provided by Lie (1980).

During the test, the axial load is controlled by servo-controllers and measured with pressure transducers with  $\sim 4.0 \text{ kN}$  accuracy at lower load levels and relatively better at higher loads. Lateral loads are controlled and measured with load cells.

Lateral and axial displacements are measured using transducers with an accuracy of  $\sim 0.002 \text{ mm}$ . The furnace chamber has a floor area of  $2642 \times 2642 \text{ mm}$  and height of  $3048 \text{ mm}$ . The axial loading and lateral loading could be applied to the column specimen during the fire or before and after, without the fire. Figure 7 shows the column furnace chamber.

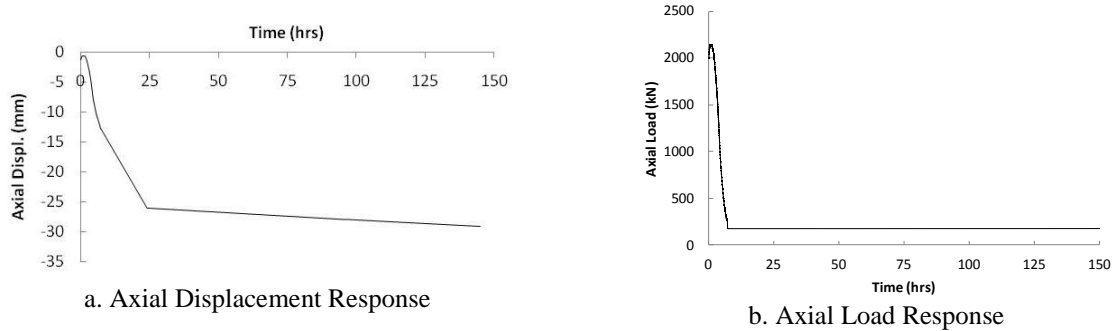
**Figure 8.** Axial Load and Axial Displacement Response of the Column (Test Specimen).

First, structural response evaluation to fire was performed to assess the level of fire damage on the building prototype. This was carried out using the hybrid fire testing, an outline of which is depicted in Figure 6. Figure 8 illustrates the response of axial load and axial deformation of the column during the fire test. The axial deformation is also shown for the cooling phase for up to six days after the fire test. Note that due to the symmetric loading, fire and structural conditions, no lateral deformation interaction was employed between the test specimen and the model component. Hence the results here are shown only for the axial load and deformation interactions.

The results shown in Figure 8b indicate a considerable reduction in the axial load of the column to almost a zero load, during the fire test. In other words, the column did not carry any further load, since it became significantly shorter than its initial length and lost its interaction with the frame. In other words, the frame carried the entire load of the column after the fire. In fact, the axial load continued to drop however, for the sake of testing, a minimum axial load was applied on the column specimen and the test continued for 6 more days. Note that during this period, the minimum axial load was applied only once a day when measuring the corresponding axial displacement. For the remaining time, the hydraulic jack for the axial load was turned off.

In order to evaluate residual lateral load and deformation capacity, the structure prototype was subjected to both axial load and lateral deformation. Figure 8b shows that the axial load of the column after the fire test was reduced to almost zero. However, for the purpose of a comparison, considering a worst-case scenario, the axial load of the column was increased to its initial load applied before the fire test. One may assume that due to the creep in concrete, the beams eventually regain their contact with the column, resulting in recovery of the initial column's axial load, which is 2000kN.

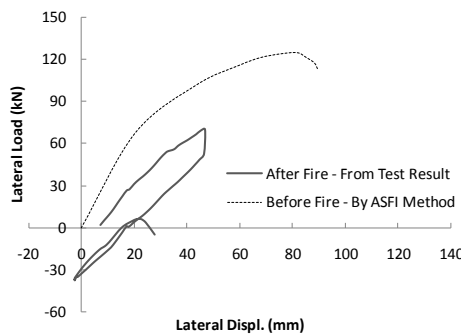
**Figure 9.** Lateral Load Response of the Column Specimen after Fire Test until failure; before and after Fire.

For the purpose of comparison, an analysis was carried out for the column specimen to evaluate its lateral load response before any fire damage, using a simple method called ASFI, (Mostafaei and Hum 2010). Figure 9 illustrates the lateral response of the column specimen before the fire, estimated by ASFI method and that after the fire, obtained from the test. The results indicate a 50% reduction in the column's maximum lateral deformation capacity and about the same reduction in its lateral load capacity after fire damage. For verification of the ASFI results obtained for the column specimen in this study see Mostafaei (2011).

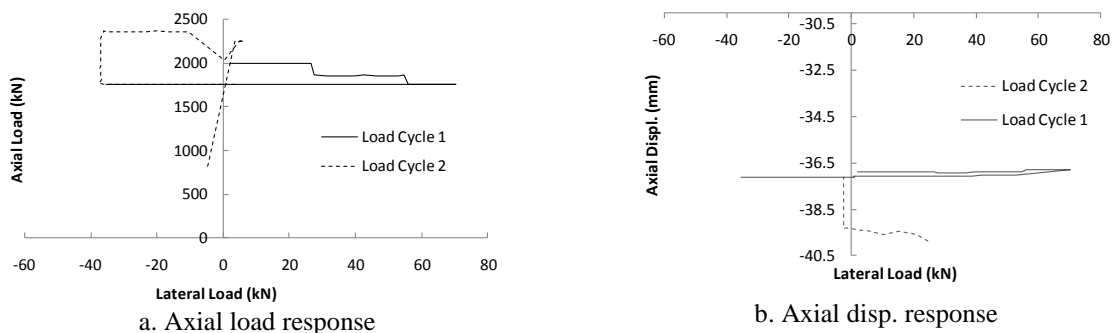
**Figure 10.** Axial Load/Displacement vs. Lateral Load Response of the Fire-damaged Column Specimen.

Figure 10(a) illustrates the axial and lateral load response of the column for two cycles; cycle 1 started with an axial load of 2000kN and cycle 2 started with an axial load of 2350kN. The figure shows that the axial load of the column was decreased from 2000kN at about a zero lateral load to 1750kN at 69kN lateral load in three steps, which indicates the effects from the interaction of the column specimen with the rest of the building, the model component. That could be due to relatively lower stiffness of the column specimen compared to the other columns of the frame, due to the fire damage. Increasing the lateral load resulted in lifting up the other columns of the building, due to their axial-flexure mechanism. However, the column specimen, damaged in fire, had much less stiffness and could not follow the lift up; therefore its axial load reduced as the lateral displacement rose.

Figure 10(b) shows the same results but for axial displacement. It indicates that at the column failure, the column has experimented 39 mm axial deformation, from the time before fire, column shortening, which is about 1% of its height. That is about 400% more than axial deformation failure of a column with no fire damage, which is about 0.25%. However, on the day of the lateral load test, when the

axial load was increased from zero to 2350kN, the failure load, the corresponding relative axial deformation was 12 mm. That is about 0.3% strain of concrete compressive capacity, which seems to be reasonable and very close to that of the concrete with no fire damage.

The numerical simulation of the model component was carried out using a computer software called SAFIR (2005), during the hybrid test. Figure 10 shows that the axial load was changed three times during the load cycle. This means the analysis was carried out at least three times during this cycle. For a smoother response, more analyses can be implemented during each load cycle.

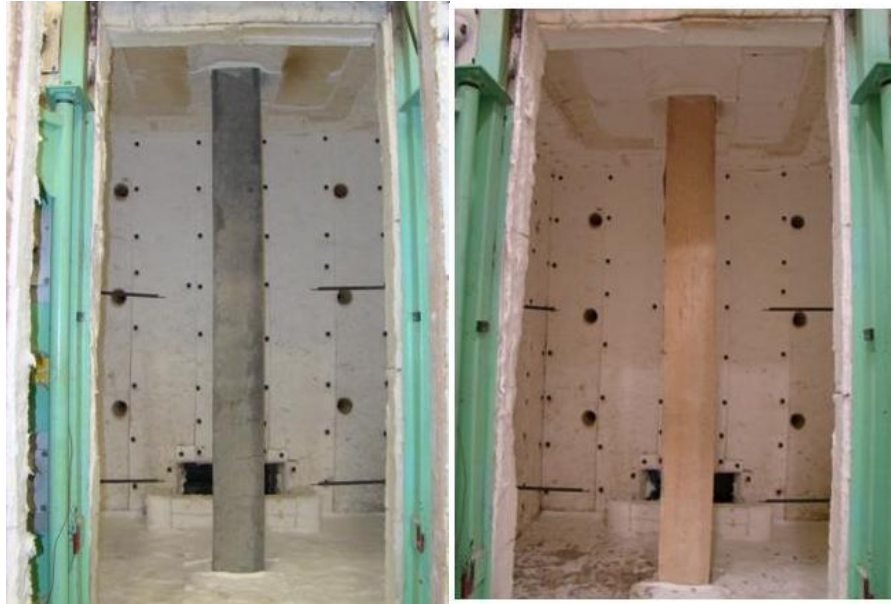
Figure 11 shows the column specimen before and after the hybrid fire testing. Figure 12 illustrates the same column specimen, 6 days later, before and after the lateral load test.

**Figure 11.** Column Specimen before, on the Left, and just after the Fire Test, on the Right.

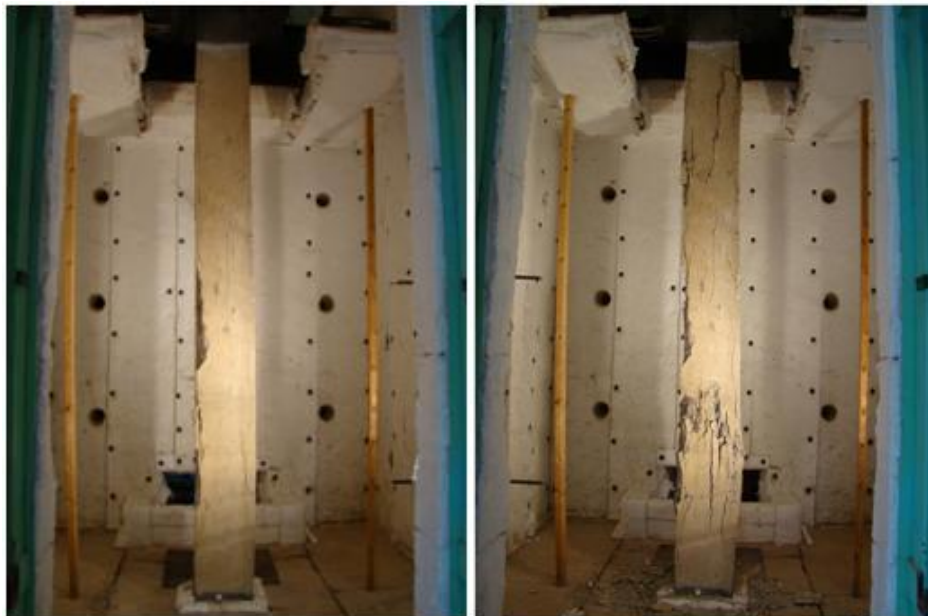
**Figure 12.** Column Specimen Six Days after the Fire Test, on the Left, before the Lateral Load Test, and on the Right, after the Lateral Load Test.

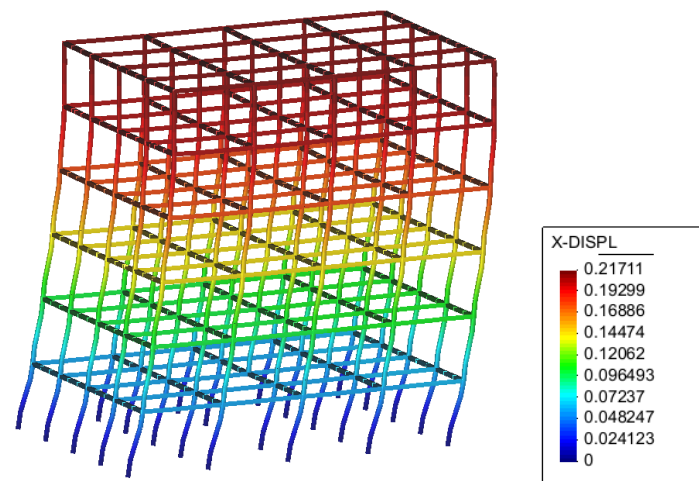
Although, all the performance components for the building structure were calculated during the test, this study focuses more on the application of the hybrid seismic test of fire-damaged buildings. Therefore, only overall results of the structural performance of the building were provided in this paper. Figure 13 illustrates overall lateral deformation of the building at the time when the lateral displacement at the top of the column reached its maximum value. The building experienced 217 mm lateral displacement at the roof level, which is about 1.1% drift ratio.

**Figure 13.** Lateral Displacement Response of the 6-Storey Building corresponding to the Time at which the Column Specimen Experienced Its Maximum Lateral Displacement.
