Damage Survey on Reinforced Concrete School Buildings in Fukushima after the 2011 East Japan Earthquake

SUMMARY:

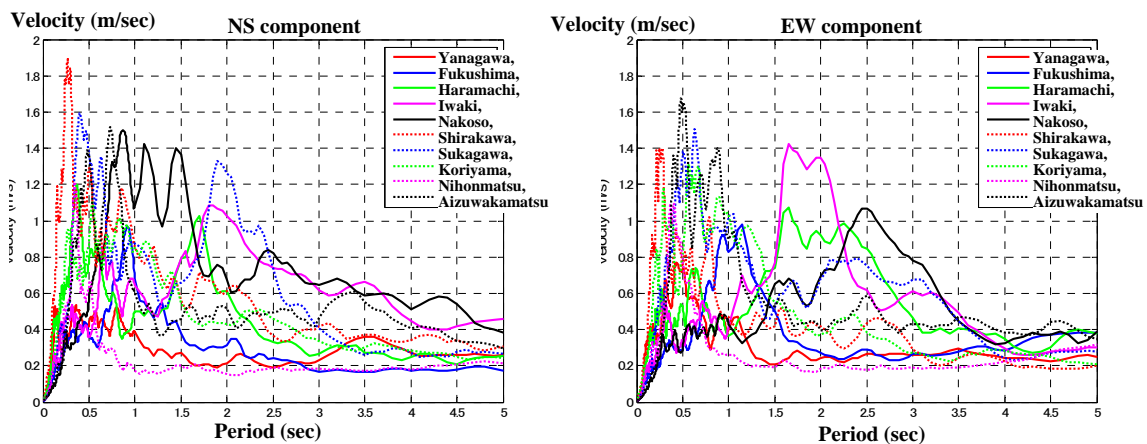
Figure 2. Velocity response spectra by the ground motions recorded in Fukushima

The strong motion network in Japan, called K-Net, had been installed and operated by NIED, National Research Institute for Earth Science and Disaster Prevention, from after the 1995 Hyogo-ken-Nambu Earthquake. The ground motions have been recorded at K-net stations also in the major cities in Fukushima region, by which the velocity response spectra were calculated, as shown in Figure 2, for the main shocks and for selected ten stations, such as in Yanagawa, Fukushima, Haramachi, Iwaki, Nakoso, Shirakawa, Sukagawa, Koriyama, Nihonmatsu, and Aizuwakamatsu. Although the magnitude was 9.0, while the epicentre distances were more than 200km—400km, the intensities were almost close to the design level of very rare earthquake (Level 2) in the building standard law. If these far field motions are compared with near field motions by recent earthquakes of magnitude around 7.0-7.4, such as 1995 Kobe, 2004 Niigata-Chuetsu, 2007 Niigata-Chuetsu-Oki, the far field motions have long duration, more than 120 seconds, and wide range of frequency components, while the near field motions have short duration, and with amplified components in the medium to longer period, so that the near field motions could be much more effective to the inelastic responses of medium-rise RC buildings and low-rise timber buildings. For example, the response spectra of 1995 JMA Kobe and Takatori motions were generally higher by two or three times around the fundamental periods of 1 to 2 seconds than those of the motions by the 2011 East Japan earthquake.

The responses of damaged buildings might be estimated approximately from these response spectra, while it should be noted that large errors could still occur in the estimation because of (1) micro-zone/local site effects, or soil amplifications, and (2) essential difference between the free-field recorded motions and the actual input motions to the structure including non-linear soil-structure interactions.

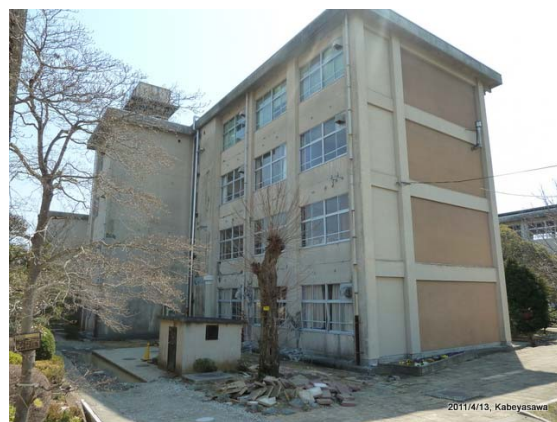
(b) A west overview

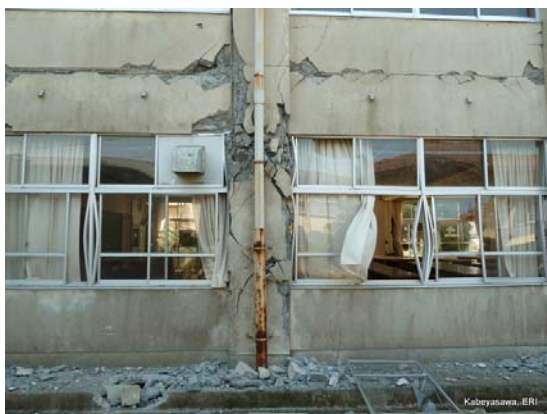
Relatively severe damage or near collapse were observed to the columns in I-high school buildings as shown in Photographs. 1(a) through (d). The school had two typical reinforced concrete buildings with 4-story in north and 3-story in south, the longitudinal direction of which was east to west. The two buildings were connected with two 2-story buildings, the longitudinal direction of which was north to south. These four buildings were isolated to each other with expansion joints. The buildings were constructed from 1973 to 1975, therefore the column hoops of 13mm or 10mm bars were placed at the spacing of 100mm. The seismic performance indices I_s -values of the four buildings had been calculated as 0.59(4-story building), 0.64(3-story), 1.08 and 1.44(2-story). In Japanese practice, if the I_s -value is higher than the standard required level I_{so} , it would be judged that the building satisfies the standard required seismic performance level. I_{so} is taken normally as 0.6 for general buildings and 0.7 for school buildings. Although the I_s -values of I-high school were a little less than I_{so} for school buildings, the I_s -values almost satisfy the requirement for general buildings. Therefore, it was expected from these values that the damages would not be minor or less under the main shock of the 2011 earthquake, the seismic intensity in JMA scale of which was 6+ around there. However, actually observed damages were relatively severe or moderate with the residual seismic capacity of $R=33, 47, 73, 72\%$. One of the reasons for these heavy damages could be estimated that the high amplification of the ground motions might have been induced due to the hill site effect.

(c) Damages to column in north frame

Collapse and severe damages would be induced due to lack of the hoop ratio in the columns, load concentration, long span and high varying axial load by interrupted walls in the old buildings. The current seismic evaluation procedure would efficient to simulate these possible damages. Also engineers should ensure sufficient stiffness of steel members to preserve integral response behaviour.

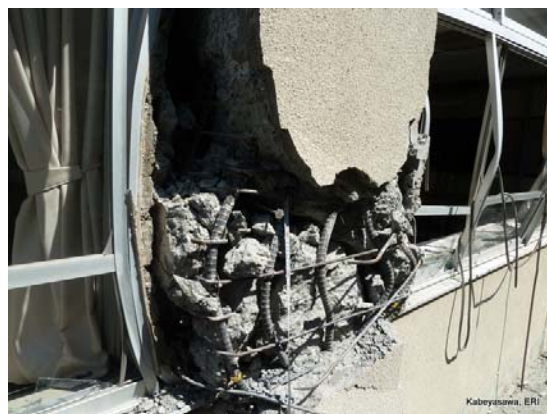
(d) Damages to column in south frame

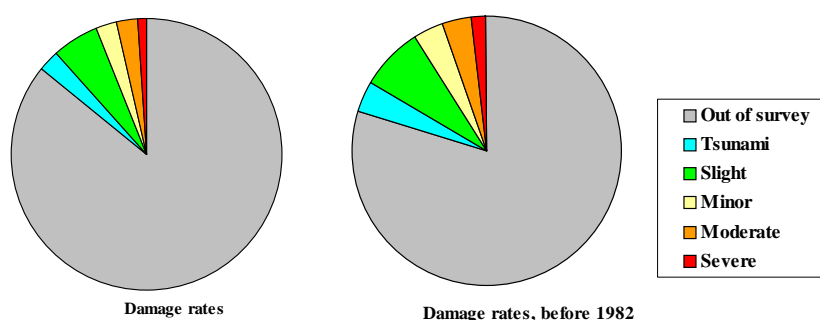
Figure 4. Inventory damage rates for all prefecture school buildings

A set of parameter was as reinforced concrete buildings out of all prefecture school buildings: 440 buildings in total and 307 buildings built before 1982. Damage levels were evaluated for 62 buildings out of them, such as severe, moderate, minor, slight/no damage, tsunami, and out of survey. The damage rates in total are shown in Figure 4, while regional distributions are shown in Figures. 5 and 6. A set of parameter was taken as the RC buildings of 440 above, or the buildings of 307 built before 1982 out of them. Even minor damages were not reported on the RC buildings constructed after 1981, though some damages were reported on steel gymnasiums even constructed after 1981, which will be discussed in detail elsewhere. Although some damages might be overlooked, especially on new buildings, it was much reliable that the data on the school buildings under Fukushima prefecture than the other data.

The ratio of minor to severe damages in total, where the buildings were basically not functional in use, was about 6% to total and 8% to the buildings before 1982. Because these are based with a parameter including Aizu and Soso, therefore if the two regions are excluded from the parameter, then the ratios are 8% and 12% respectively. As for the buildings classified into the grade of severe, which were to be demolished and rebuilt rather than repaired, the ratios were 1.1% to total, 1.6% to pre-1982, 1.5% to those without Aizu and Soso, 2.2% to pre-1982 without Aizu and Soso. Considering the intensities of the ground motions were close to the very rare level of BSL, level 2, in most regions, it may be concluded that these damage rates were satisfactorily low. This was partially owing to the seismic strengthening of school buildings, although it had been behind in Fukushima prefecture, which will be discussed later in this paper. Other reasons also lie in discrepancy with the standard requirement of seismic evaluation and the actual response behaviour.

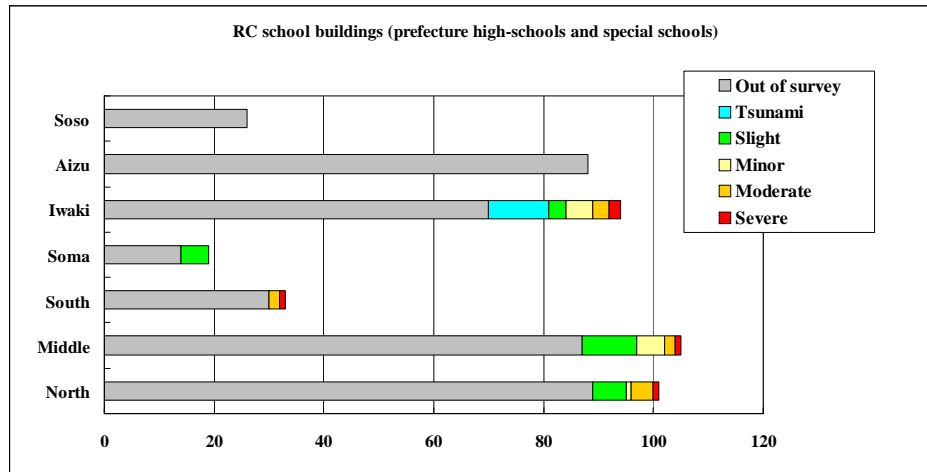
Figure 5. Regional distribution of inventory damage rates for all prefecture school buildings

As for the regional distributions, the damage rate was obviously small in Aizu region while relatively higher in Iwaki region. These are partially because of the earthquake intensity including the site effects and distance to the sources, especially to the Off-Iwaki source, though these were not much clear by K-net motions shown in Figure 2. It is also presumed for another reason of lower damages in Aizu region that the design seismic force is relatively higher including the permanent snow loads in the region.

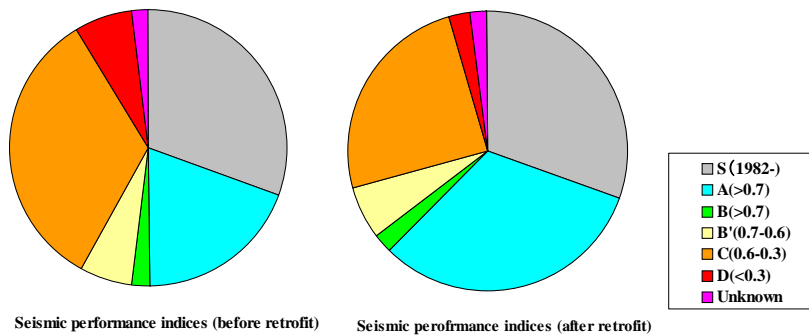
Figure 7. Seismic performance indices before and after retrofit

As for the seismic performance indices I_s of the RC buildings in high schools and special schools in Fukushima prefecture, they have been ranked into the grades of A to D, such as A($I_s > 0.7$) requiring no retrofit, B($I_s > 0.7$), B'($0.6 < I_s < 0.7$), C($0.3 < I_s < 0.6$) and D($I_s < 0.3$) requiring retrofit. The I_s -values of the buildings have been ranked before and after the strengthening for retrofit with the buildings constructed after 1981, which had been regarded as to conform to the current code of practice, and

If the seismic safety ratios of the RC school buildings were defined as the sum of the ranks S and A, then the ratio was around 50% before the strengthening started and had been upgraded up to 62% by the retrofit at the time of earthquake, as shown in Figure 7. The regional distributions of these seismic performance ranks are shown in Figures 8 after retrofit, namely at the Earthquake. It might be concluded that the safety ratios are relatively higher in Aizu, Soma and South regions with few rank D, where the damage ratios in Figures 8 and 9 were generally smaller.

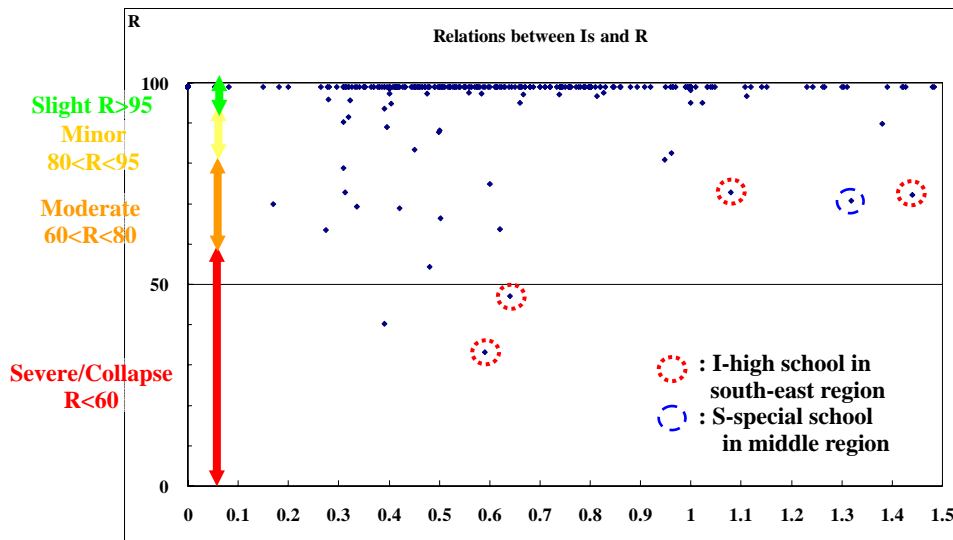
Figure 9. Relations between the seismic performance indices I_s and the damage rates in terms of the residual capacity R (%)

The relations between the observed damage level in terms of the residual capacity R and the calculated seismic performance level in terms of the structural seismic index I_s -value are plotted directly in Figure 9. The unknown R is assumed as 99%, which might not be different much even if evaluated, except for Soso, where the surveyed has not been performed, while the unknown I_s are assumed as zero, which is to be disregarded in the figure. Positive correlations are observed between I_s and R generally.

It should be noted, however, in cases of the marks with dotted circles, that R is lower than 80% even if the I_s -values are much higher or around 0.6. Four of these are the buildings of I-high school on the hill in Iwaki described above, and a building in S-special school in middle region, where the ground motions might have been higher there due to some local site effects and also have peculiar reason with columns in half-basement level. Detailed model and analysis are needed to simulate the damage level in relation with the estimated input motions.
