Amplitude Dependent Dynamic Characteristics of a Damaged 9-story Building During the 2011 off the Pacific Coast Tohoku Earthquake

SUMMARY:

This paper describes the amplitude dependent dynamic characteristics of a 9 story building in Sendai before, during, and after the Tohoku earthquake including a fore-shock and some after-shocks. Dynamic hysteresis characteristic are investigated and the origin oriented type hysteresis and the inverse 'S' type hysteresis in time are recognized. Occurrence of partial uplifting in the transverse direction is suggested by the induced higher harmonics based on the non-stationary spectra using wavelet analysis. The system identification using the extended Kalman filter also performed to determine the amplitude dependency of natural frequency and damping factor. The identified parameters consistent with damage feature. Historical change of the dynamic characteristics is also discussed based on the long term monitoring data.

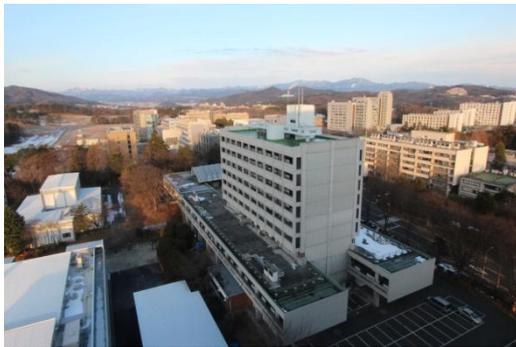
Photo1. Overview of THU building

The THU building is a 9-story SRC (non-full web type) building (ref. to Photo 1 and Figure 2) constructed in 1969 and experienced 1978 Miyagi-ken Oki earthquake. The building was constructed on the slope site and has a foundation with RC cross piles (500φ). Pile length is 12m. Soil profiles at the site are referred to Figure 3.
