Damage to houses in Urayasu due to liquefaction by the Tohoku-Pacific Ocean earthquake

S. Yasuda, K. Ishikawa & N. Ozawa

Tokyo Denki University, Japan

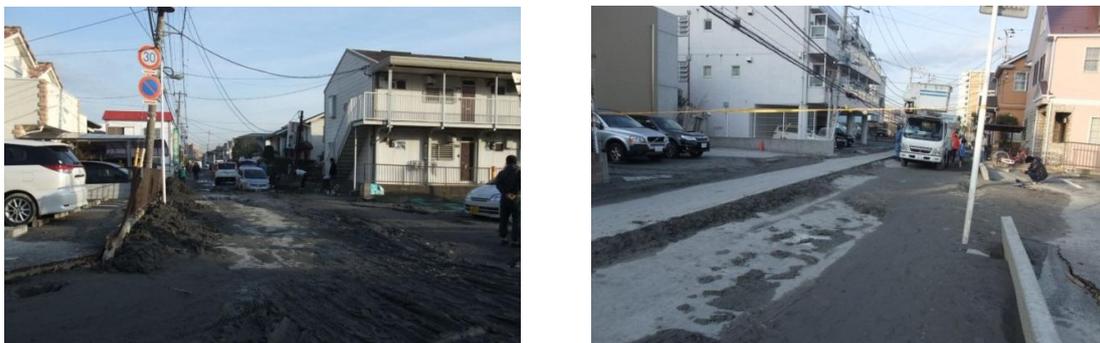
Figure 2 (1) to (2). Damage in Urayasu City in the next day

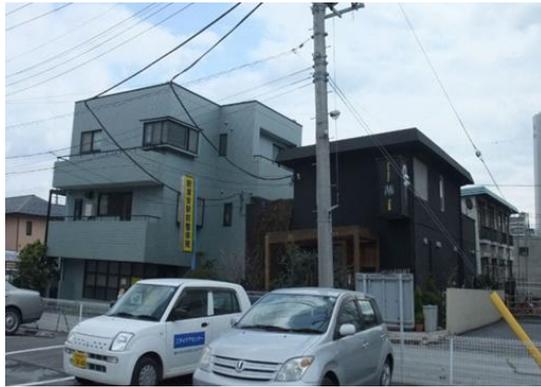
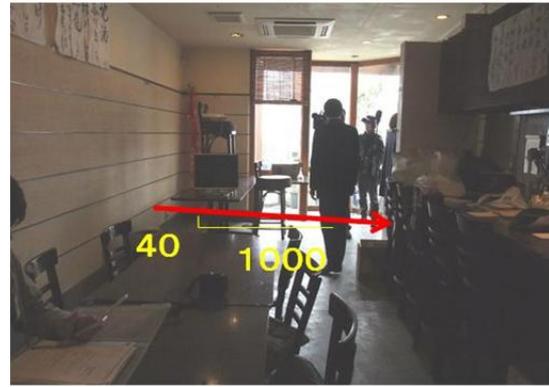
(1) Outside of the tilted house

(2) Inside of the tilted house

Figure 3. Severely settled and tilted house in Urayasu City
