# Dynamic characteristics of traditional adobe-quincha buildings in Peru

## SUMMARY:

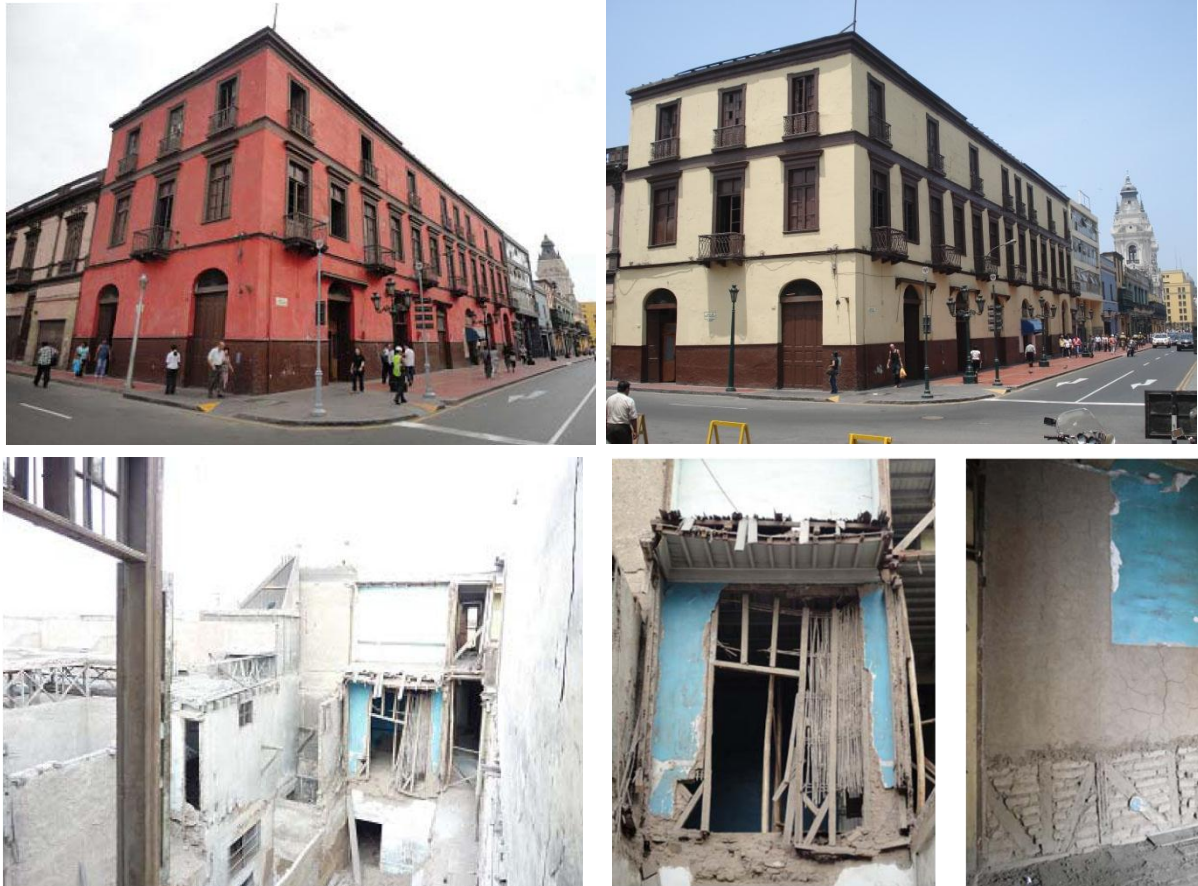
In some cases the adobe-quincha buildings presents good appearance. For example in Figure 2 it can be appreciated the façade of a building located in the historical center of Lima where the color of the walls are changed or re-painted almost every year. However the structural condition of the interior walls is critical as can be observed in the bottom part of the same figure. This deterioration of the structure is due mainly to the aged of the building and due to the action of the humidity that affect the earthen constructions. The humidity also affects the wood frame and the cane mesh of the quincha since they are organic materials.

**Figure 2.** Typical adobe-quincha construction and structural condition details

As example a building that correspond to an old hotel is presented where ambient vibration measurements were performed to estimate its period of vibration. This building was described previously (See Figure 2). Walls of the upper stories (second and third floors) are made of quincha and the first story is made of adobe walls. The building presents some partial collapse of interior walls and serious deterioration of the quincha walls. Figure 8 shows the setup of measurement equipment.

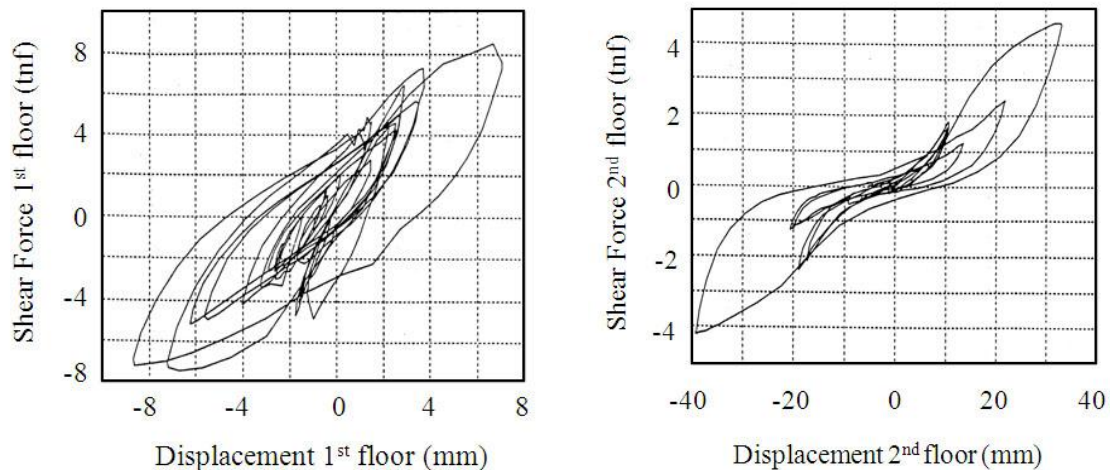
Figure 7 shows the load-displacement curves obtained for the input motion scaled to 400 Gal. It can be observed that the shape of the hysteretic loop shows large energy dissipation. These pattern were observed in all test performed with 100 Gal, 200 Gal, 400 Gal and 600 Gal respectively.

The failure of the specimen was by shear in the walls of the first floor. The adobe-quincha model resisted the 400 Gal earthquake and even the 600 Gal earthquake. However, very large displacement was observed in the second floor with considerable loss of stiffness. This excessive displacement produced during large earthquakes requires additional research to control and keep the lateral displacement of the second floor below a reasonable value.

**Figure 7.** Load-displacement curves (IGP-66, 400 Gal)

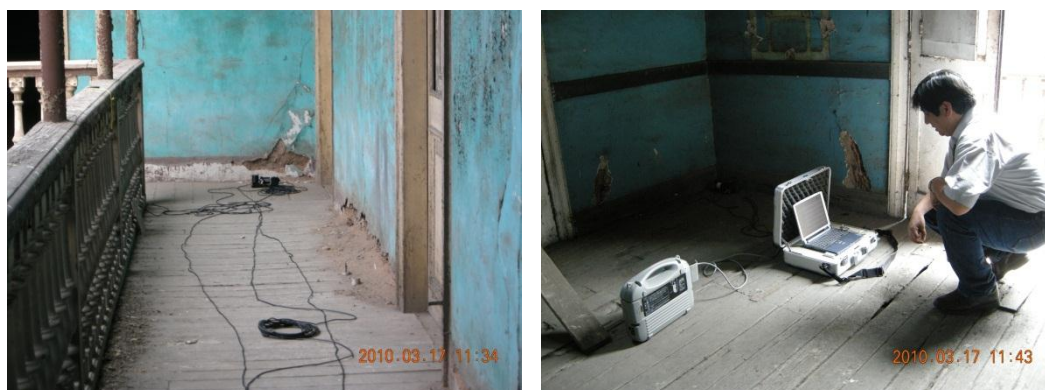
**Figure 8.** Ambient vibration measurements on adobe-quincha building at historic centre of Lima
