Remarkable liquefaction-induced damages along Tokyo Bay during during the 2011 Tohoku-Pacific Ocean earthquake in Japan.

SUMMARY

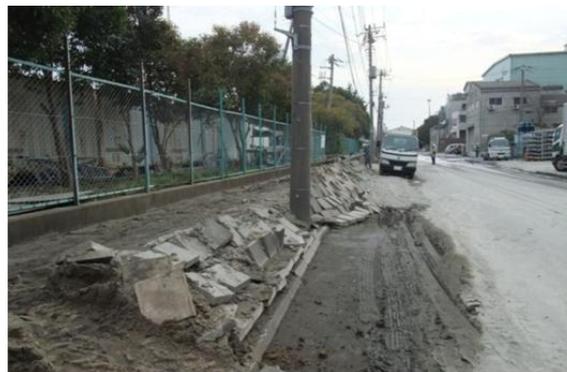
Photo 1. Heaving of a footway at Takahama, Ichikawa City

Miracle phenomena, heaving, buckling or thrust were observed at several footways and alleys as shown in Photo 1 at many sites in Tokyo Bay area. Some thrust might occur at the boundaries due to a kind of sloshing of liquefied ground as schematically shown in Figure 13 (1), because shaking continued for long time after the occurrence of liquefaction. Figure 14 shows heaved footways or alleys in Urayasu City together with contour lines of the thickness of the F layer under the ground water table. It may be said that the heaving occurred at the sites where the bottoms of the F layer, in other word liquefied layer, are sloped. This implies that a kind of horizontal buckling of surface layer might occurred due to the concentration of horizontal compressive stress as schematically shown in Figure 13 (2). However, more studies are necessary on the mechanism of the buckling.
