A Study on the Behaviour of Seismically Engineered Ceiling Systems of Large Open Structures Subjected to Earthquake Excitations

15 WCEE
LISBOA 2012

M.Watakabe, S.Inai & T. Ishioka

Technical Research Institute, Toda Corporation, Japan

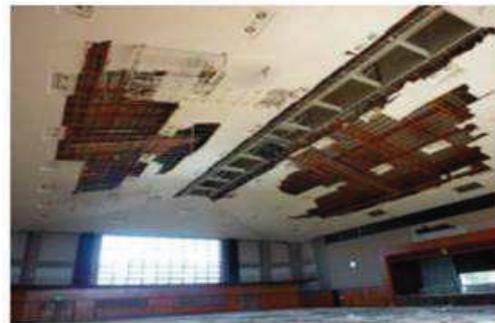
Photograph 1. Damage to metal furring suspended ceiling systems used in gymnasiums

(a) Damage to metal furring suspended ceiling during the 2001 Geiyo Earthquake

(b) Damage to metal suspended ceiling during the 2011 Great East Japan Earthquake

Examples of metal furring suspended ceilings in gymnasiums that were damaged by the 2001 Geiyo Earthquake [Koshihara, 2001] and the 2011 Great East Japan Earthquake [NILIM, 2011] are shown in **Photograph 1**. The photographs show that breakage occurred at the center of the pitched ceiling. These gymnasiums are composed of lower SRC, an RC frame, and an upper steel frame. No damage to the steel roof structures, SRC structures, or RC columns was observed.

It is possible that in certain parts of the hanging ceiling, the fastening bolts came out of the furring-strip receptacles, so that the strips and chalk wall fell separately. This type of damage may originate in the destruction of ceiling junction clips, as was seen during the 2001 Geiyo Earthquake. Such damage indicates that the joint between the M-bar and the channel is a weak point. In addition to such breakage of ceiling clips, there are many other types of damage that cause the furring strips and chalk wall to fall.

In the present study, In order to investigate the collapse mechanism of a metal furring suspended ceiling, as indicated by the red dotted lines in Photograph 1(a), a series of shaking table tests was carried out. The seismic response of gable roofs is known to be amplified in the vertical direction under horizontal input. However, the influence of pitch on the amplification of vertical vibration has not yet been clarified. Thus, in the present study, the damaged gymnasium structure was simulated using these dynamic properties and the relationship between the horizontal and vertical excitation response of nonstructural components was investigated.

An experimental investigation of the damaged ceiling shown in Photograph 1(a) was conducted. The ceiling structure selected for the present study was set on a roof slab in a gymnasium damaged during the 2001 Geiyo Earthquake. **Figure 4** shows the shaking table test results for the metal furring suspended ceiling of the damaged gymnasium. **Figure 4(a)** shows the clip dropout process before the M-bar falls. The metal-sheet clips hanging from the metal furring channels were found to have been

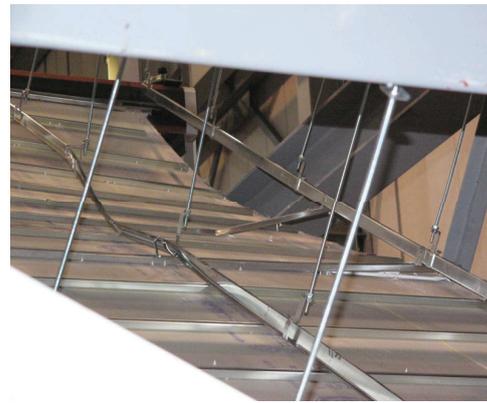
Figure 4. Experimental results for the metal furring suspended ceiling obtained using a shaking table

damaged by the roof motion.

(b) Views of plan and elevation of test specimen
Clip opening damage points (the red ● symbol)

(a) Clip dropout process before falling of the M-bar (c) Failed situations of the ceiling elements

- (2) The dynamic test results for the metal furring suspended ceiling of a damaged gymnasium obtained in shaking table tests confirmed that the metal-sheet clips holding the metal furring channels were damaged by the roof response to the input motion.
