Investigation on the damage cause of the bridge rubber bearings in the 2011 off the Pacific coast of Tohoku Earthquake

Summary

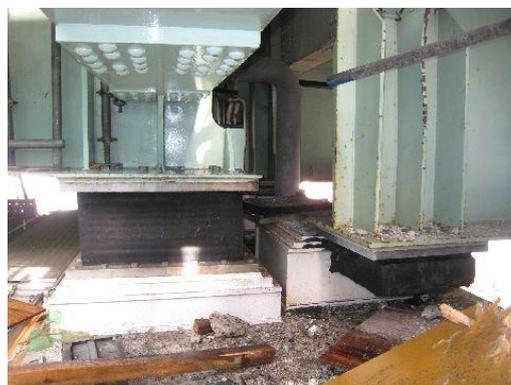
Photo 1.1. Damage of the bridge rubber bearing
(Photo by East Nippon Expressway Company)

In the 2011 off the Pacific coast of Tohoku earthquake, the severe damage of the rubber bearings was confirmed for the first time since the rubber isolation bearings were adopted. Specifically, some rubber bearings of the expressway bridges were broken away in the horizontal direction. In this paper, the cause of the observed damages to rubber bearings is investigated. Firstly, examined are the characteristics of the observed ground motions whose maximum ground acceleration is 300 cm/s^2 or more. From the results, the peak displacement response of structures with a natural period ranging from one second to two seconds under the observed ground motions is turned out to be about 1.5 times larger than that of the design ground motion. Finally, dynamic analysis of bridges with rubber bearings is performed to understand how ground motion characteristics and structural properties of the bridges affected the seismic response of the bridges that led to the damage of the rubber bearings.
