Full scale testing of unreinforced masonry walls with openings

F. Parisi, N. Augenti, A. Prota & G. Manfredi

Department of Structural Engineering, University of Naples Federico II, Naples, Italy

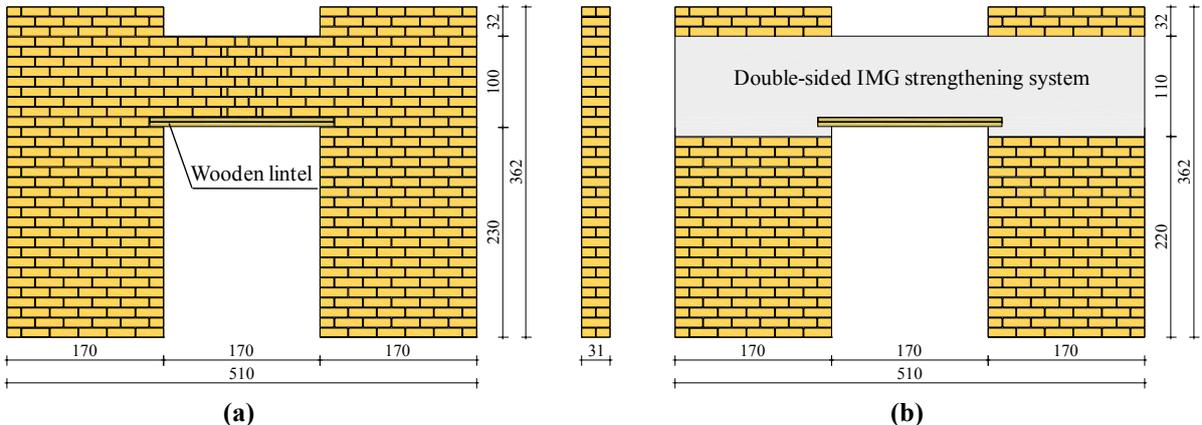
Figure 1. Specimen #1: (a) as-built; (b) IMG-repaired (dimensions in cm)

Figure 1 shows specimen #1 in both as-built and IMG-repaired conditions. Specimen #1 was a single-leaf, running bond, tuff masonry wall with a spandrel panel resting on a wooden lintel. The lintel had an anchorage length of 150 mm in both piers (Fig. 1a). The specimen was globally 5.10 m long, 3.62 m high and 0.31 m thick. To apply axial forces to the piers ensuring structural continuity with an ideal overlying storey, three masonry layers were constructed over the piers. Both piers and the spandrel panel had a length of 1.70 m, while the height of the spandrel panel was equal to 1.00 m. Masonry layers were alternated each other to get discontinuous vertical mortar joints of thickness

10 mm. The IMG strengthening system on specimen #2 was applied on both sides of the spandrel in order to ensure good anchorage to both piers (Fig. 1b). The IMG composite was selected because it does not increase inertia masses, allowing negligible changes in the stiffness distribution of URM buildings. The realization of the IMG strengthening system on each spandrel face consisted of three stages: masonry pre-wetting and first coating with 5 mm thick mortar layer; hand-pressing of IMG system grid into the wet binder with fibres aligned to mortar bed joints of the spandrel (overlapping length of grids set to 100 mm); and second coating with 5 mm thick mortar layer. The nominal thickness of the IMG strengthening system was then 10 mm on each spandrel face.

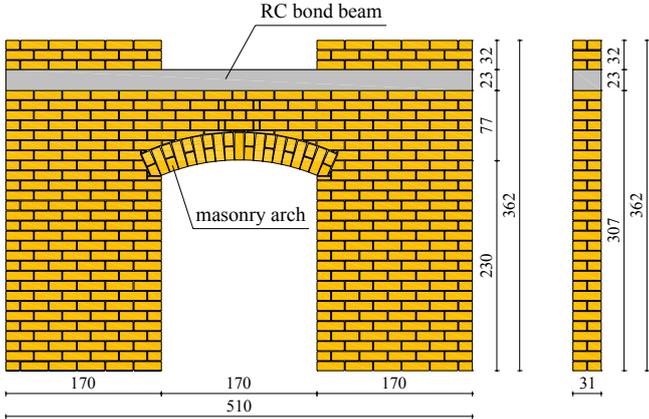
Figure 2. Specimen #2 (dimensions in cm)

Figure 2 shows specimen #2 where a masonry arch, instead of a wooden lintel, was realized over the opening and a RC bond beam was cast in place at the top of the spandrel. Global dimensions of specimen #2 were equal to those of specimen #1. The RC bond beam cross section was 310×230 mm; type C20/25 concrete and type B450C reinforcing steel bars were used (CEN 1993). The beam was reinforced with four 14 mm diameter longitudinal steel bars and 8 mm diameter stirrups with 2 legs and 200 mm spacing.

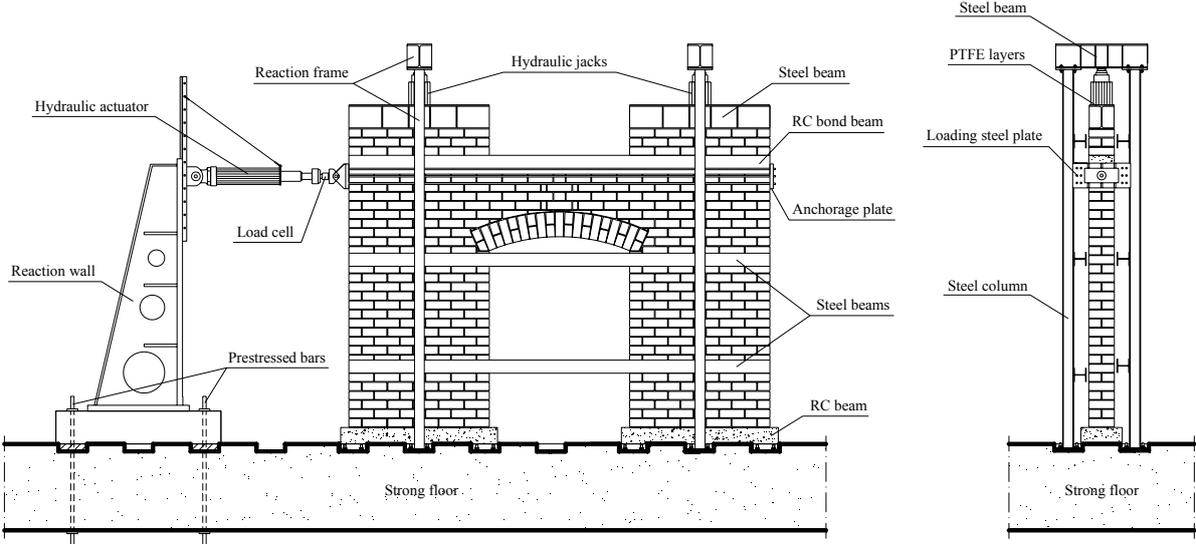
Figure 3. Test setup

Figure 3 shows the experimental setup employed for lateral loading tests. Both specimens were rigidly connected to the laboratory strong floor by means of RC beams with dimensions 1700×310×200 mm, which were cast to Ω-shaped steel plates. The latter were bolted in turn to squared holes of the laboratory strong floor. Transverse frames were installed over the piers to provide reaction against vertical loading applied at the piers' centrelines by hydraulic jacks with 500 kN nominal capacity.

Rigid steel beams were placed above the piers to ensure their uniform loading and then two Teflon, that is, polytetrafluoroethylene (PTFE), layers were installed between hydraulic jacks and rigid beams to minimise friction at their interface. A non-prismatic reaction wall was anchored to the laboratory strong floor to provide reaction against lateral loading. The latter was applied through a servo-controlled hydraulic actuator with 500 kN nominal capacity and ± 250 mm stroke. A suspension system was installed to provide further support to the actuator. Six steel bars (18 mm in diameter) were employed to allow lateral force reversals for cyclic tests only. Finally, steel beams were bolted to transverse reaction frames at both specimen sides to prevent potential out-of-plane failure modes. A load cell with 200 kN nominal capacity and approximately 250 kN maximum capacity was positioned at the actuator end in order to measure lateral force.

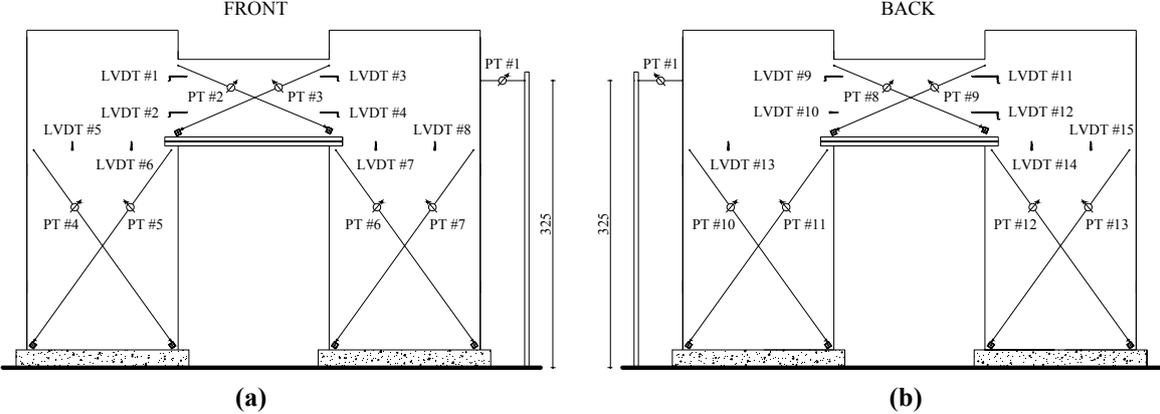
Figure 4. Instrumentation of specimen #1: (a) front side; (b) back side

Linear variable differential transformers (LVDTs) and potentiometer transducers (PTs) were installed. In the case of specimen #1 (Figs. 4a–b), LVDTs were placed at the end cross-sections of the spandrel and pier panels to obtain information about flexural deformations. PTs were mounted along both pier and spandrel diagonals to capture shear deformations. Joint panels were not instrumented as their behaviour was expected to be rigid owing to the specimen geometry (assumption confirmed by tests). Lateral displacements were measured at the opposite side with respect to the actuator through a potentiometer tagged as PT #1. Displacement readings at PT #1 were associated with lateral force readings at the load cell to plot force–displacement diagrams. The aforementioned readings were considered to be more accurate than load and stroke readings at the horizontal actuator.

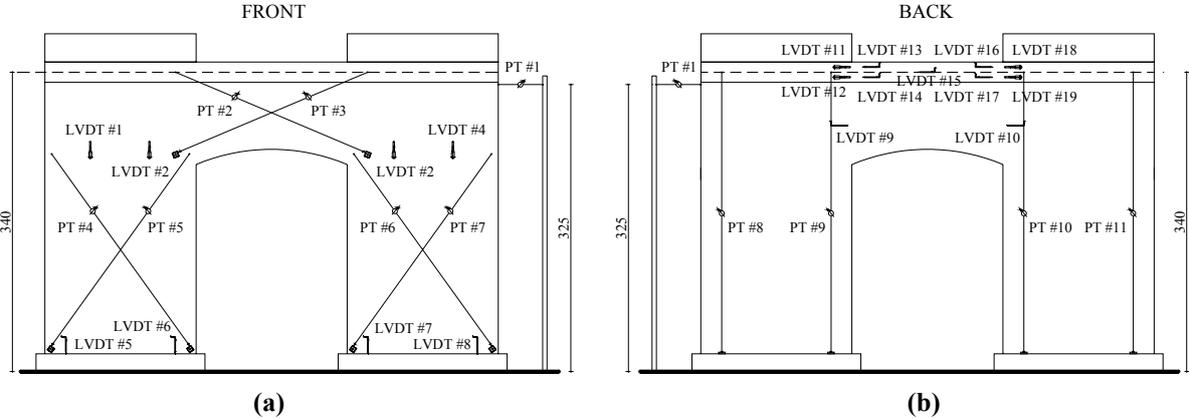
Figure 5. Instrumentation of specimen #2: (a) front side; (b) back side

Figure 5 shows the instrumentation of specimen #2, which was rather different from that of specimen #1 because the authors decided to perform a deeper investigation on rocking-induced displacements of piers and deformations of the RC bond beam. Rocking deformations of specimen #2 were measured through four vertical LVDTs at pier bases on the front side and four vertical PTs on the back side, which were fixed to RC beams to include the width of rocking-induced cracks at the pier bases.

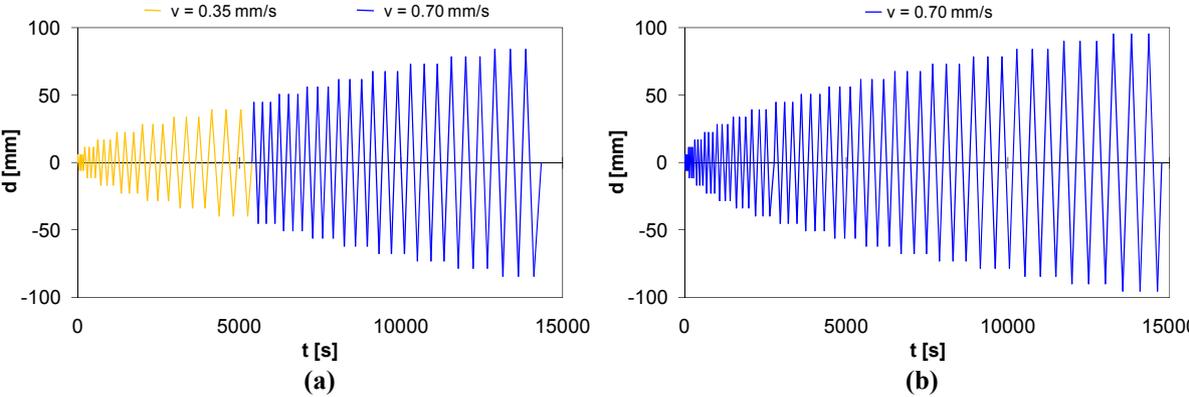
Figure 6. Displacement time-histories of cyclic tests: (a) specimen #1; (b) specimen #2

Lateral loading tests consisted of two stages: application of 200 kN vertical forces over piers; and application of displacement-controlled horizontal force under constant vertical forces. Lateral force was modulated by the computer program of the data acquisition system in a way to obtain the target displacement time-history. All measurements were recorded at a sampling rate of 5 Hz. The as-built specimen #1 was tested under monotonically-increasing displacements, after two initial displacement cycles were applied to get a satisfactory contrast between specimen and actuator. Lateral loading was applied in a way to increase displacements at a constant rate $v = 0.01$ mm/s up to a displacement reading at the actuator of 28 mm (corresponding to an interstorey drift ratio, θ , of about 1% and a first significant damage to the spandrel). The pre-damaged specimen #1 was then tested under cyclic displacements at $v = 0.35$ mm/s in a way to attain increasing amplitudes in seven different blocks and repeated three times at each amplitude peak, up to almost the same target displacement ($d = 39.2$ mm) and drift ($\theta = 1.2\%$) reached in the monotonic test. The displacement increment between consecutive displacement terns was set to 5.6 mm. The IMG-repaired specimen #1 was tested under fifteen cyclic displacement blocks up to $d = 84$ mm ($\theta = 2.8\%$). In that case the displacement rate was set to 0.35 mm/s in the first seven blocks and 0.70 mm/s in the last eight blocks. Figure 6a shows displacement time-histories employed for cyclic tests on specimen #1.

Specimen #2 was cyclically tested under seventeen cyclic displacement blocks (i.e., 51 cycles) up to $d = 95.2$ mm (namely, $\theta = 2.9\%$). The displacement rate and increment were set to 0.70 mm/s and 5.6 mm, respectively, as shown in Figure 6b.

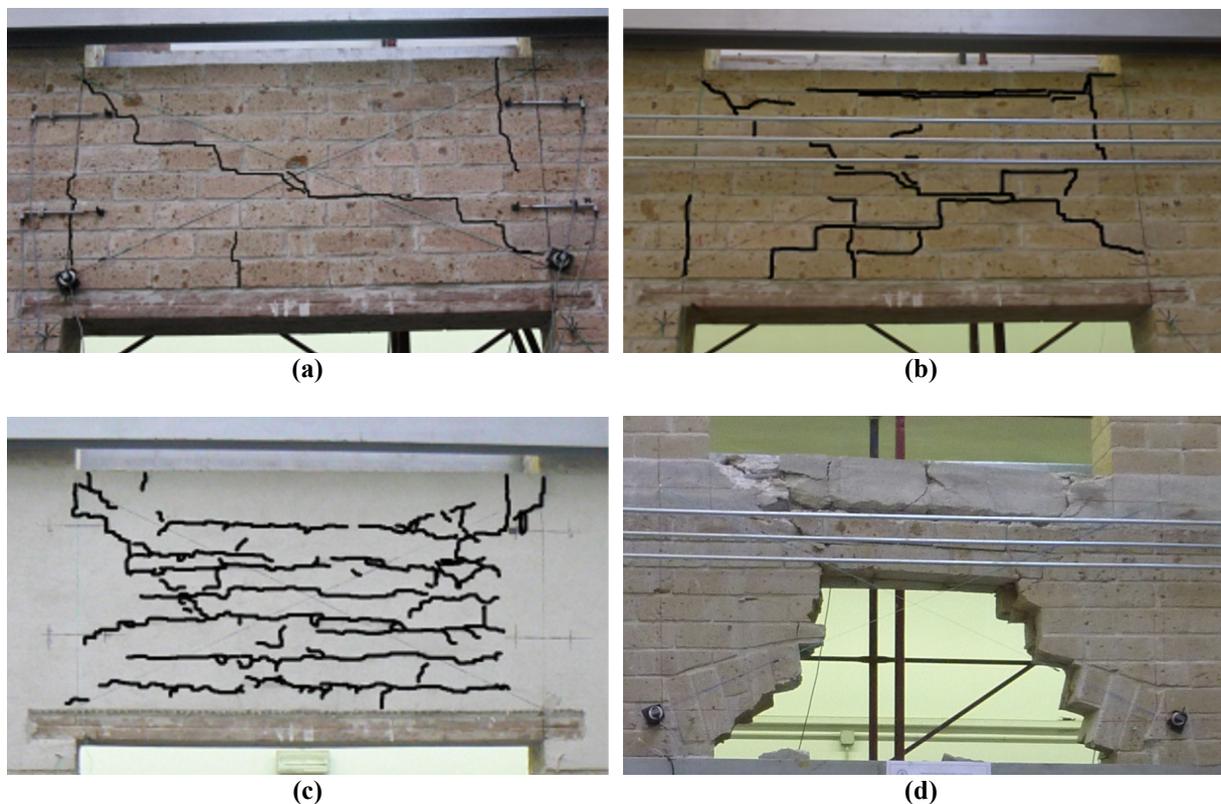
Figure 7. Damage to spandrel panel at maximum drifts: (a) as-built specimen #1 ($\theta_{max} = 0.9\%$); (b) pre-damaged specimen #1 ($\theta_{max} = 1.1\%$); (c) IMG-repaired specimen #1 ($\theta_{max} = 2.5\%$); (d) specimen #2 ($\theta_{max} = 2.9\%$)

Detailed information on damage patterns related to specimen #1 was provided by Augenti et al. (2011). Here the authors recall observed damage to the spandrel panel of specimen #1 to compare it with that observed on specimen #2. The spandrel panel suffered diagonal shear cracking and slight flexural cracks at end sections in both as-built and pre-damaged conditions of specimen #1 (Figs. 7a–b) at θ_{max} equal to 0.9 and 1.1%, respectively. Conversely, extensive horizontal cracking associated with bending and masonry splitting was detected on the IMG-repaired spandrel panel at an actual drift $\theta_{max} = 2.5\%$ (Fig. 7c). Based on experimental-analytical comparisons, Parisi et al. (2011) showed that such a transition from shear to flexural failure occurred because the IMG strengthening system caused a shear strength increase significantly greater than flexural strength increase. Transverse connection between IMG system layers throughout the spandrel panel would have probably increased flexural strength of the spandrel panel, avoiding masonry splitting and resulting in greater load-bearing capacity of URM walls with openings. The masonry arch and RC bond beam in the spandrel panel of specimen #2 induced a considerably different damage at $\theta_{max} = 2.9\%$, which was the result of the following progressive damage: formation of axial cracks in the arch at $\theta = 0.69\%$; collapse of a little arch portion in the middle at $\theta = 0.86\%$; collapse of an arch wedge at $\theta = 1.03\%$ after piers begun to experience rocking rotations; collapse of second arch portion at $\theta = 1.21\%$ along with early crushing and splitting of piers at their base; collapse of fourth arch portion at $\theta = 1.72\%$ along with early cover ejection from the RC bond beam at the upper edge of end section; complete concrete cover ejection at $\theta = 2.58\%$; collapse of first and second masonry layers above the arch at the first and second displacement cycles, respectively, at $\theta = 2.76\%$ together with plastic hinging in the RC beam.

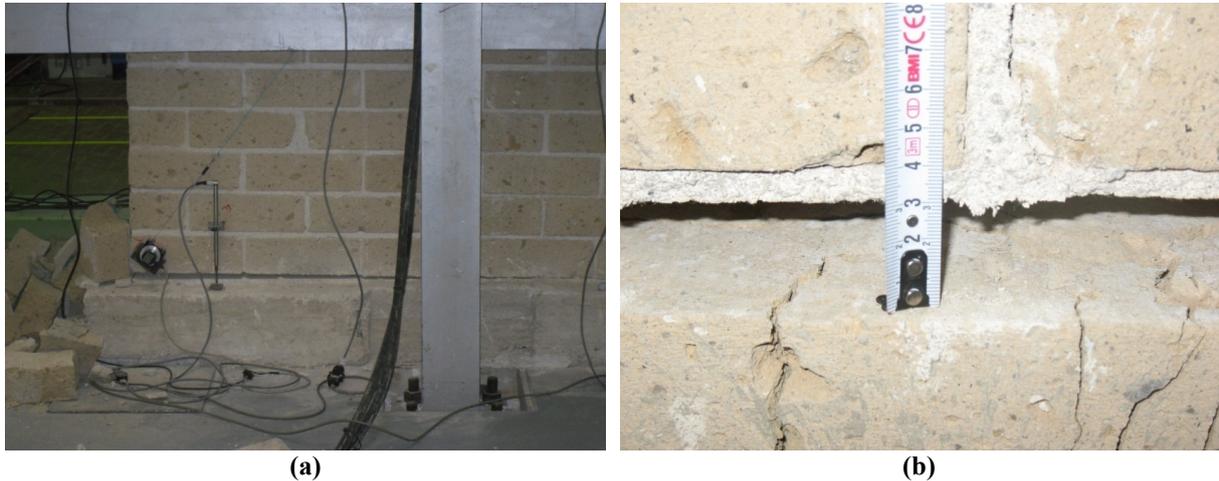
Figure 8. Rocking induced crack at pier base of specimen #2 ($\theta = 2.24\%$): (a) front view; (b) crack width

In all cases rocking rotations of piers increased with the global drift demand on specimens. Rocking-induced horizontal cracks at the pier bases which exceeded 25 mm in the case of IMG-repaired specimen #1 and 30 mm in the case of specimen #2 (Figs. 8a–b). Rocking of piers induced large drift demands on spandrel panels and hence heavy damage to them. Collapse of specimens was thus observed after masonry crushing at the pier bases. Figures 9a and 9b show global damage to the IMG-repaired specimen #1 and specimen #2, where crushing of piers was significant. In the case of specimen #2, progressive damage to the spandrel induced gradual reduction in both height and effective length of the spandrel panel.

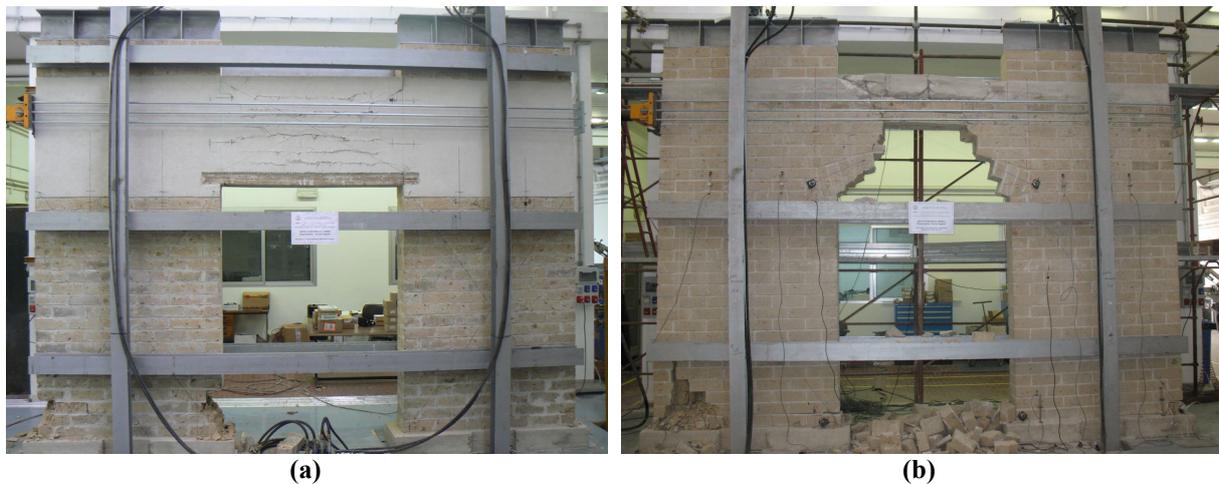
Figure 9. Overall damage at maximum lateral drift: (a) IMG-repaired specimen #1; (b) specimen #2

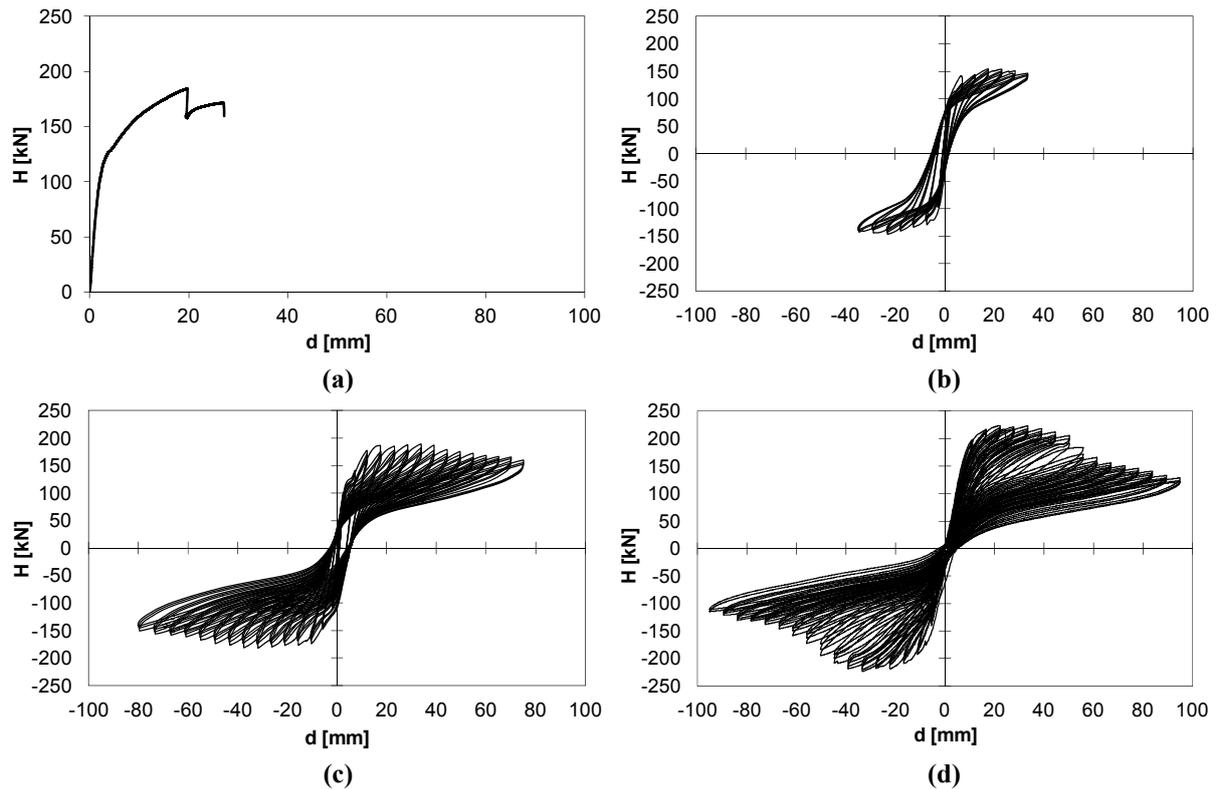
Figure 10. Force–displacement diagrams: (a) as-built specimen #1; (b) pre-damaged specimen #1; (c) IMG-repaired specimen #1; (d) specimen #2

Post-processing of experimental data allowed to obtain force (H) versus displacement (d) diagrams of specimens. A comparative analysis of such diagrams is here performed, whereas additional information on their bilinear idealisation for the computation of overstrength ratio, ductility and force-reduction factor, can be found in the work by Augenti et al. (2011). Fig. 10a shows a bilinear force–displacement behaviour up to a displacement $d = 19.74$ mm corresponding to $H_{max} = 184$ kN and $\theta = 0.65\%$, which caused shear cracking in the spandrel panel and the associated 15% lateral resistance drop. Another strength increase was measured up to $\theta_{max} = 0.9\%$. The experimental lateral resistance H_{max} confirmed the value provided by macro-element analysis of the as-built specimen ($H_{max} = 185$ kN) for the minimum shear strength of masonry ($\tau_{0,min} = 0.05$ MPa). The pre-damaged

specimen #1 had a maximum lateral resisting force approximately equal to that of the as-built specimen #1 at the occurrence of diagonal cracking in the spandrel panel, that is, 157 kN (Fig. 10b). This indicates that previous shear cracks in existing URM walls with openings could considerably affect the residual load-bearing capacity.

All lateral loading tests evidenced that the force–displacement behaviour (be it monotonic or cyclic) was clearly affected by rocking of piers, which allowed both re-centring (i.e., low residual displacements) and large displacement capacities of specimens. The IMG strengthening system let to restore the load-bearing capacity of the as-built specimen #1, shifting strength degradation at larger displacement levels (Fig. 10c). Load-bearing capacity of specimen #2 was $H_{max} = 224$ kN, that is, approximately 22% greater than that of as-built specimen #1 (Fig. 10d).
