Experimental cyclic response of ductile partially-encased composite members

C. Málaga-Chuquitaype, A.Y. Elghazouli & X. Ban

Imperial College London, UK

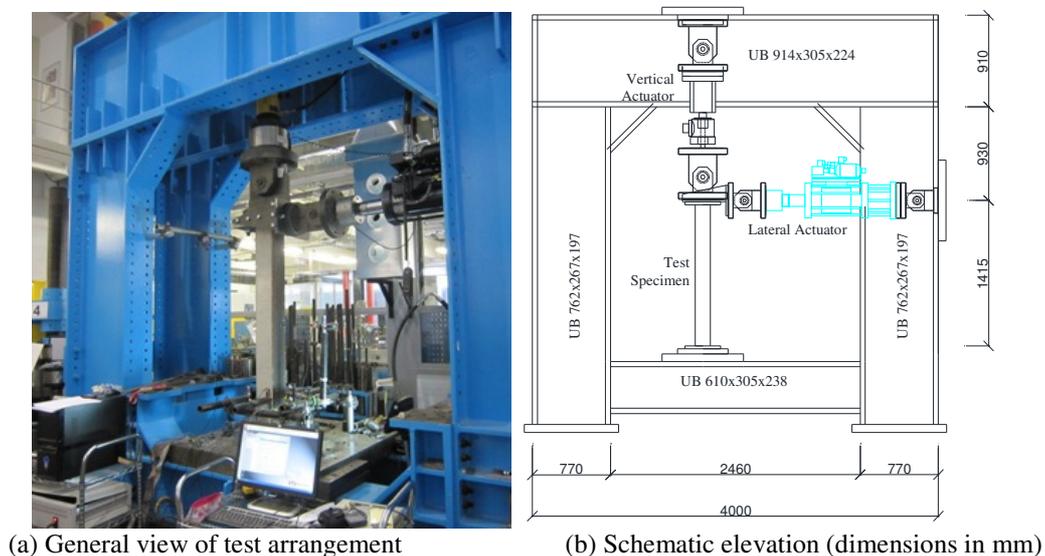
Figure 1. Experimental set-up

The self-reacting test-rig shown in Fig. 1 was used for the experimental programme. The experimental set-up was designed to apply lateral displacement on the tip of a vertical cantilever member while at the same time imposing constant axial loads at the top of the specimen (Ban, 2011). Fig. 1 also presents the dimensions of the set-up employed. The specimens were welded to a bottom plate of size 350x350x30 mm which in turn was bolted to a 500x500x50 mm plate attached to the self-reacting frame in order to ensure a rigid base support.

Displacements were applied at the top of the specimen using a double-acting actuator operating in displacement control. The actuator had a static capacity of ± 250 kN and a maximum stroke of ± 125 mm. The back of the actuator was stressed to a plate of dimensions 500x500x75 mm firmly connected to the reaction rig. Similarly, axial loads were applied through a vertical actuator of 500 kN capacity connected by means of low-friction swivel joints to the reacting frame as depicted in Fig. 1.

Lateral displacements and corresponding forces were recorded by the load cell and displacement transducer incorporated within the horizontal actuator. Likewise, the forces applied by the vertical actuator were recorded by means of a load cell attached to it. The out-of plane deformation of the specimen was monitored through a attached inclinometer while another inclinometer was placed in the member to confirm the angle of rotation. Displacement transducers placed along the height of the specimen were also used to measure member deformations. Strain gauges were used to monitor the strains at specific locations within the specimen. The cyclic testing protocol shown in Fig. 2 was used based on the recommendations provided by ECCS (1986), where Δ_y is the estimated yield displacement. After the maximum displacement was reached, all the specimens were subjected to additional displacement reversals at amplitudes of $\pm 5\Delta_y$ up to the occurrence of fatigue fracture.

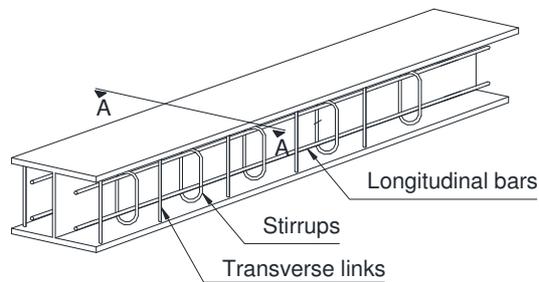
Figure 3. Details of section configurations (dimensions in mm)

In total, seven partially-encased beam-column members were tested. A summary of the test series is given in Table 2.1. Note that UC refers to Universal Column. The constant axial load applied in each test is also given in the Table 2.1. Fig. 3 illustrates the three section configurations utilised. D8 stirrups spaced at 40 mm intervals were employed throughout the height of all specimens. Additionally, buckling-delaying links in the form of bars (Section Type B in Fig.3c) or plates (Section Type C in Fig. 3d) were employed over the plastic zone along 480 mm at the bottom of Specimens PE2 - PE7.

(a) Specimen view

(b) Section Type A

(c) Section Type B

(d) Section Type C

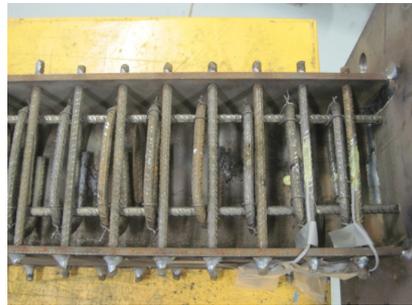
Figure 4. Specimen with additional buckling-delaying bars

The detailing of Specimens PE2 and PE3 included 8 mm steel bars running through purpose-drilled holes on the flange outstands and welded from the outside of the specimen, as depicted in Fig. 4. This additional detailing was provided in order to delay the onset of outward buckling of the steel flanges while at the same time avoiding the premature failure of the links caused by welding difficulties

The effectiveness of the welded bars in delaying local buckling was clearly observed in Specimens PE2 and PE3. Nevertheless, fracture initiated in the holes drilled to accommodate the bars and propagated over the both flanges as illustrated in Fig. 8. This premature fracture prevented any significant enhancement in the ductility of these specimens in comparison with Specimen PE1.

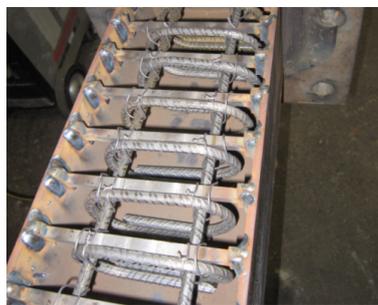
Figure 5. Specimen with additional buckling-delaying plates

(Elghazouli and Treadway, 2008). Nevertheless, as discussed below, the stress concentration in the area around the hole induced fracture of the steel flanges. Therefore, Specimens PE3 - PE7 were re-designed to incorporate an improved detail consisting of 8 mm thick I-shaped steel plates welded to the flange outstands on the inside as depicted in Fig. 5.

In order to avoid the complications associated with outside welding of the buckling-delay links, Specimens PE4 - PE7 incorporated I-shaped steel plates welded on the inside. Fig. 9 presents the failure mechanism observed in Specimen PE4 (with links spaced at 60 mm intervals). It can be observed from this figure that the half wavelength of the flange buckles was determined by the link spacing in this case. It can also be noted from Fig. 9, that the large strains developed in the buckled area lead to low-cycle fatigue fracture in the flange and links. However, as discussed below, it should be noted that this only took place after significant levels of cumulative deformation. A similar failure mechanism was observed for Specimen PE6 in which the axial load was doubled while retaining all other geometric characteristics.

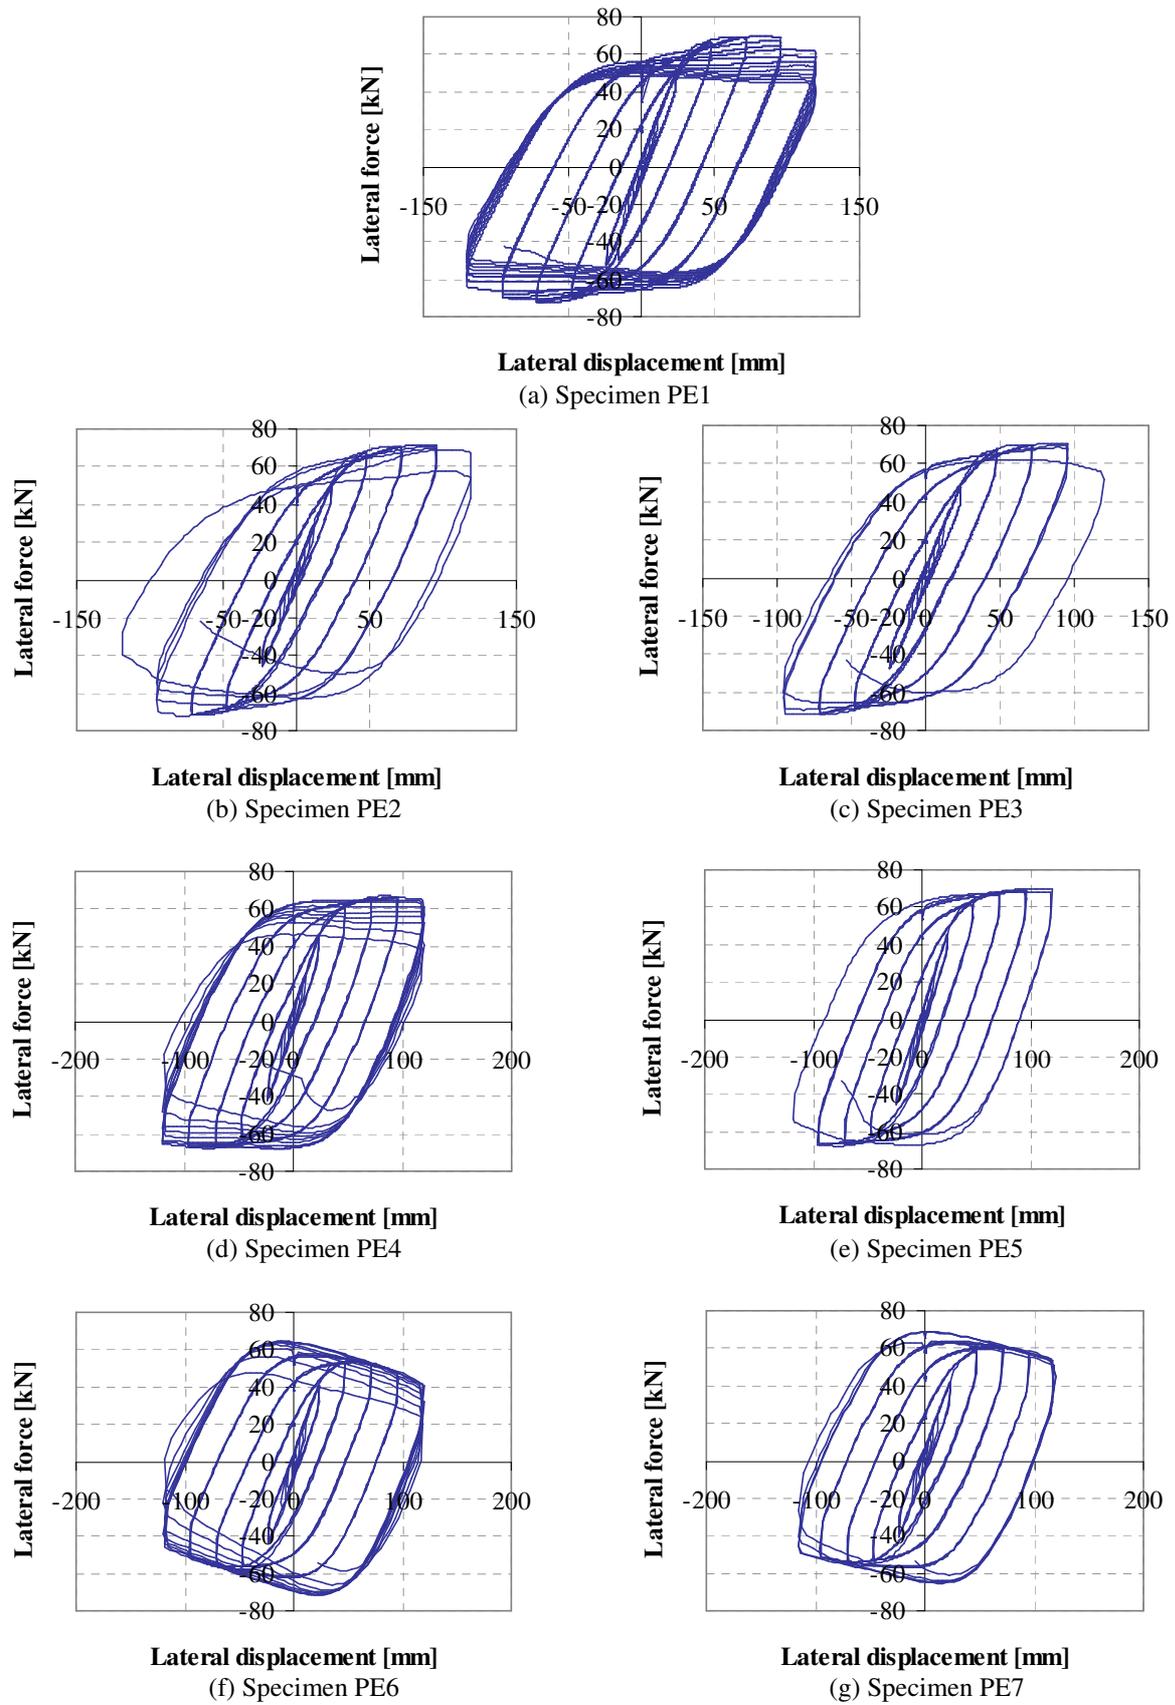
Figure 6. Cyclic load-displacement response

The cyclic response of Specimens PE1 - PE7 is presented in Fig. 6 while the main response parameters are summarised in Table 3.1. It is clear from this figure and table that all specimens exhibited stable hysteretic behaviour with similar rates of energy dissipation. Flange buckling was followed by an immediate release of concrete confinement and gradual strength deterioration in all cases. In subsequent sub-sections, the experimental results and observations are discussed with particular focus on failure mechanisms and overall ductility considerations.

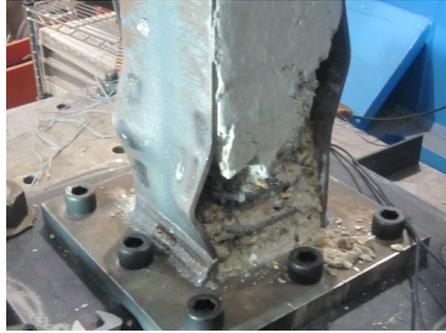
Figure 7. View of Specimen PE1 after testing

Specimen PE1, which presents a conventional European detail, experienced local buckling at the first $4\Delta_y$ excursion. The half wavelength of the flange buckles was approximately 140 mm. Fig. 7 shows the extent of local buckling as well as spalling of the concrete cover accompanied by buckling of the longitudinal reinforcement.

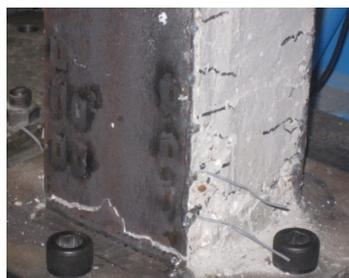
Figure 10. Low cycle fatigue fracture in Specimen PE7

In the case of Specimens PE5 and PE7 where the spacing of the additional I-shaped links was reduced to 40 mm, low-cycle fatigue fracture took place at the fixed end of the specimens within the heat affected area near the welding zone between the member and the rigid plate at the bottom. No significant buckling of the flanges was observed before the occurrence of fracture as depicted in Fig. 10 for Specimen PE7. A similar failure mechanism was observed for Specimen PE5.

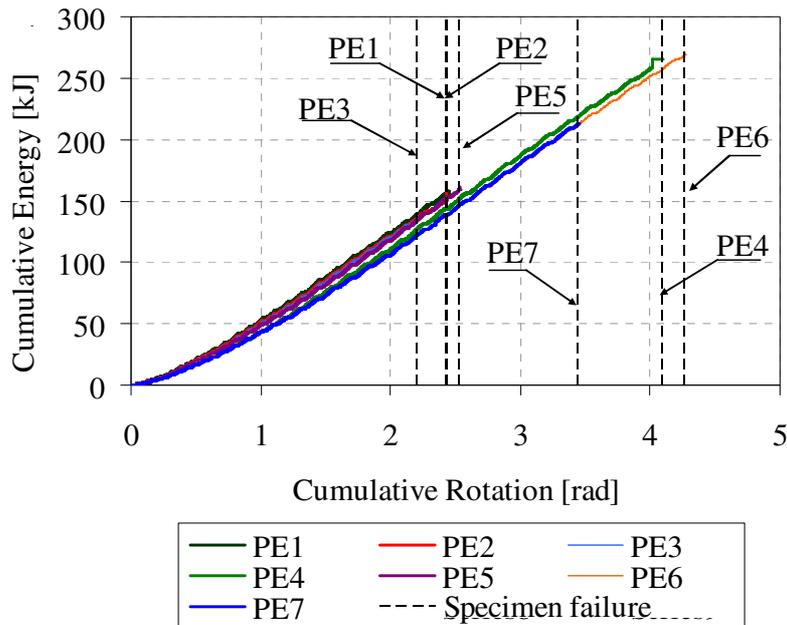
Figure 11. Cumulative energy dissipation

Fig. 11 presents an assessment of the energy dissipation of the tests described above. The curves depict the cumulative dissipated energy versus cumulative rotation, while the rates of energy dissipated per unit rotation is given in Table 3.1. Fig. 11 also shows the cumulative rotations at failure represented by vertical dashed lines. Importantly, failure is defined as the occurrence of fatigue fracture in any component of the specimen or the attainment of a 20% reduction in capacity; whichever occurs first. A summary of the energy dissipation parameters at ultimate is presented in Table 3.2.

It can be observed from Fig. 11 and Table 3.2 that despite the similar energy dissipation rates of all specimens examined, there is a substantial enhancement in the total energy dissipation capabilities of members incorporating improved buckling-delaying links (e.g. Specimens PE4 - PE7) when compared with the conventional partially-encased detail (i.e. Specimen PE1). The provision of I-shaped steel links results in a 70% increase in the total dissipated energy and associated enhancements in the cumulative rotation at failure when an axial load of 10% of the axial capacity of the member is present (Specimen PE4 versus PE1). Furthermore, an increase in the level of axial load (up to 20% of the axial capacity in Specimen PE6) does not affect the energy dissipation capacity of the improved detail, with Specimen PE6 able to withstand 75% more cumulative displacement than its conventional counterpart (Specimen PE1) while simultaneously sustaining double the axial action.
