# Experimental simulation of seismic response of masonry walls

**M. Gams, M. Tomažević**

*Slovenian National Building and Civil Engineering Institute, Dimičeva 12, Ljubljana, Slovenia*

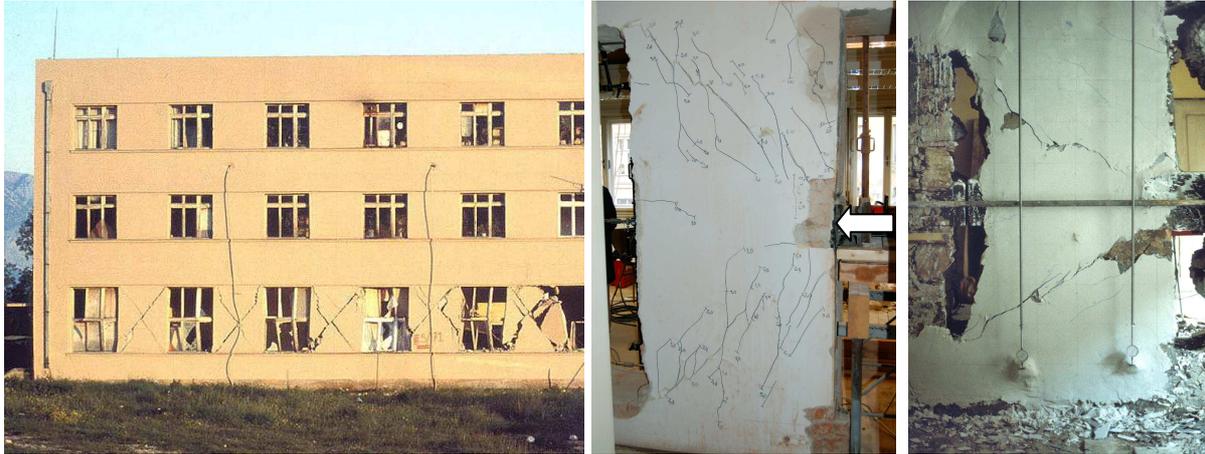
**Figure 1.** Typical earthquake damage of masonry building and in-situ shear test

In terms of boundary conditions simulated in the laboratory, two types are most commonly used: the cantilever type and the fixed-fixed (or symmetrically fixed) type. The term symmetrically-fixed applies to rotations, because one end of the wall must be free to move in horizontal and vertical directions. The other end is completely fixed, usually to the laboratory floor. Cyclic shear test using cantilever type of boundary conditions is easier to perform than the fixed-fixed type and because almost identical results are obtained for many parameters in many cases (Bernardini et al. 1980) this type of testing is often used. In some cases, however, depending on the masonry type, quality of the mortar, dimensions of the wall and also the level of compressive stress, there are significant differences, and fixed-fixed boundary conditions are preferred (compare Figs. 1 and 2).

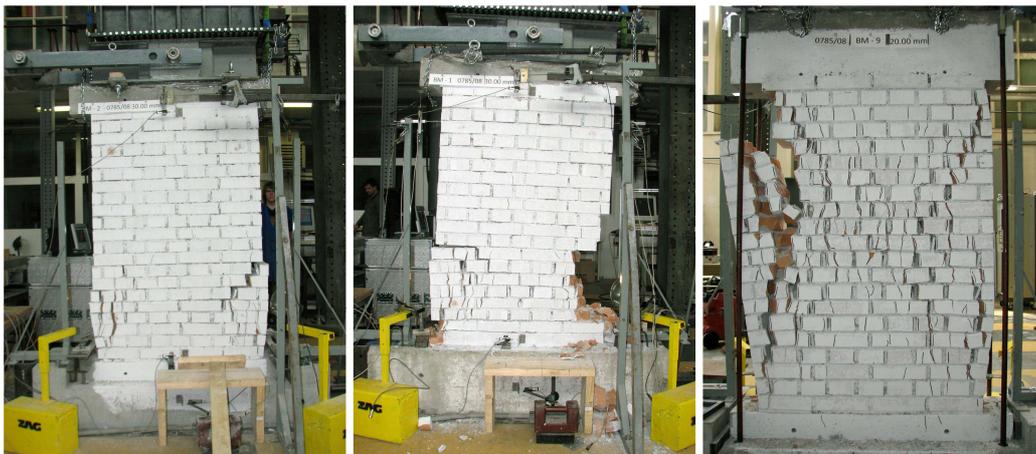
**Figure 2.** Laboratory tests

Many different test setups, which enable testing walls under symmetrically fixed conditions, can be found in literature (van Vilet 2004, Frumento *et al.* 2009), and the earliest such testing was performed already in the seventies (Turnšek and Sheppard, 1980). They can be divided into two groups, based on the way rotations are constrained. Test setups of the first group use strong steel mechanical mechanism to prevent rotations at the free end. The other group relies on hydraulic actuators with regulation algorithm to achieve the same. In most cases walls are tested at constant level of vertical force, but there are also cases with fixed vertical displacement (Vermeltoort and Raijmakers, 1993).
