# Dynamic Response Analysis of A Tall RC Chimney Damaged during 2007 Niigata-ken Chuetsu-Oki Earthquake

Nonlinear dynamic analyses were carried out on a sixty meters high reinforced concrete chimney of an incineration plant in Kashiwazaki, Japan, which was structurally damaged during 2007 Niigata-ken Chuetsu-oki Earthquake, to examine the factors which caused the damage. The effect of the vertical flexural strength distribution of the chimney and the influence of predominant period of the ground motion were investigated. The structural drawings were examined and the failure was found to be occurred at the section where the flexural strength was locally insufficient. In addition to that, the ground motion recorded near the chimney site contained relatively long period component. It is confirmed from the analytical results that a high intensity, long-period ground motion lead the chimney to respond in the high nonlinearity range and the flexural strength discontinuity attracts concentration of inelastic response in the chimney damage mechanism.

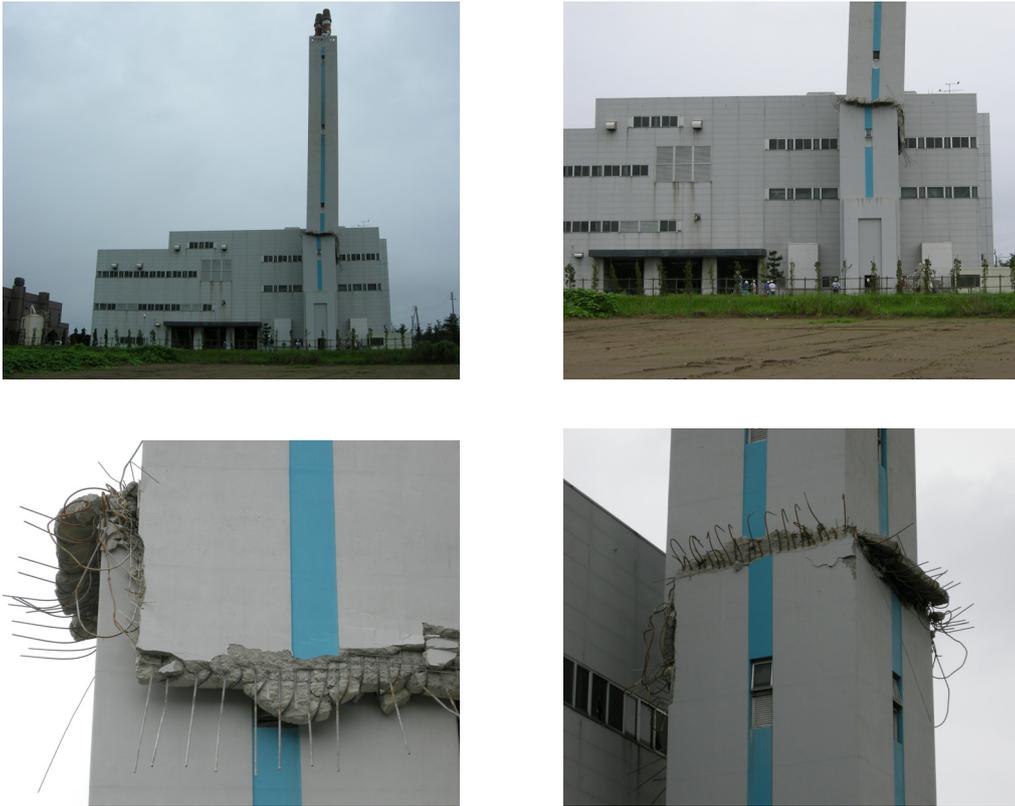
The 2007 Niigataken Chuets-Oki Earthquake ( $M_w$  6.8) on June 16th caused severe structural damage to a tall reinforced concrete chimney of an incineration plant in Kashiwazaki, with a height of about sixty meters. It was one of the most notable damage to reinforced concrete engineered structures due to the Earthquake. Although this damage did not produce casualties, the industrial facility was out of operation for 4 months until it was restored. The photos of the damage of the chimney are shown in Figure1 [Building Research Institute, 2007].

**Figure 1.** Damage of the chimney

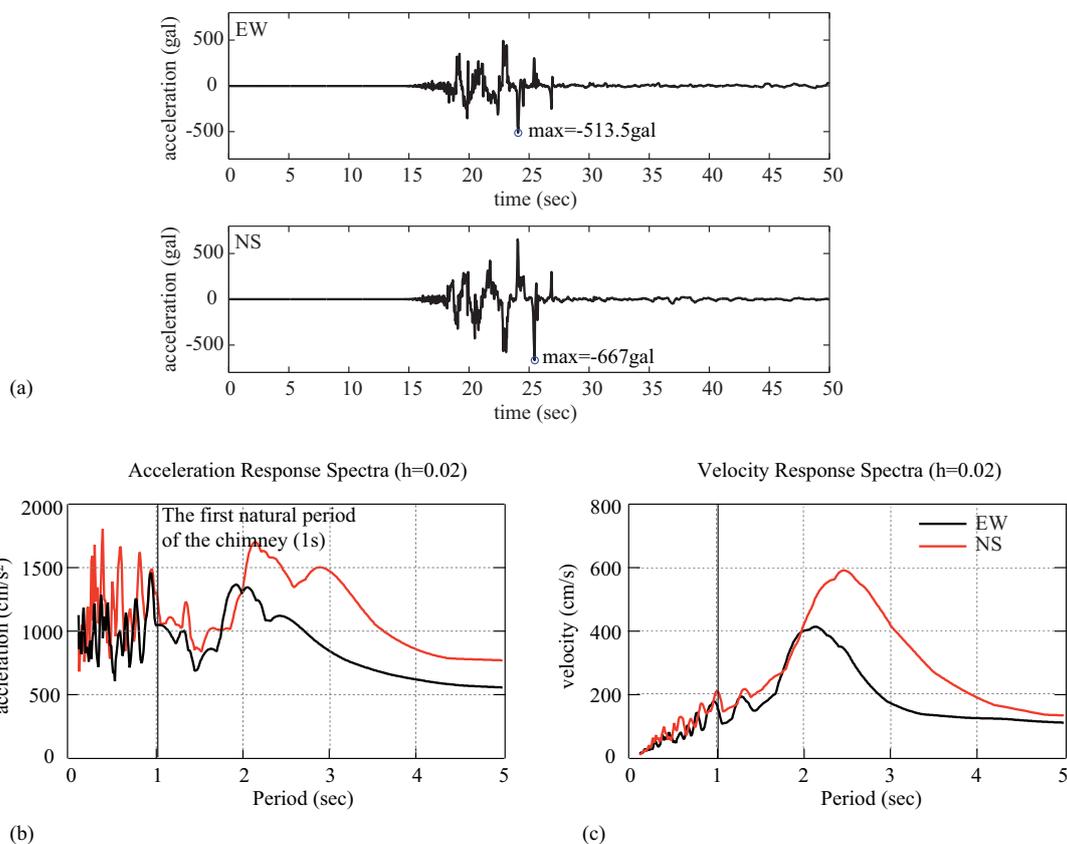
The maximum ground acceleration and velocity of the three components are shown in Table 1. They were recorded at a K-net station NIG018. The wave forms of the EW and the NS components of the ground acceleration and linear velocity response spectra of a damping factor of 2% are shown in Figure 3. From the response spectra, it is seen that the dominant period of the ground motion is relatively long (from 2 to 2.5 second). Significant contribution to the excitation of the first mode of the chimney is anticipated because the linearly elastic natural period of the first mode for the chimney is approximately 1 second.

**Figure 3.** (a) Time histories of recorded ground acceleration (b) Acceleration response spectra (damping factor of 0.02) (c) Velocity response spectra (damping factor of 0.02)

The ground motion that was recorded near the chimney site had a relatively long predominant period of 2-2.5 seconds. The long predominant period of the ground motion is considered to be one of the reasons that caused failure of the chimney which has a long natural period.

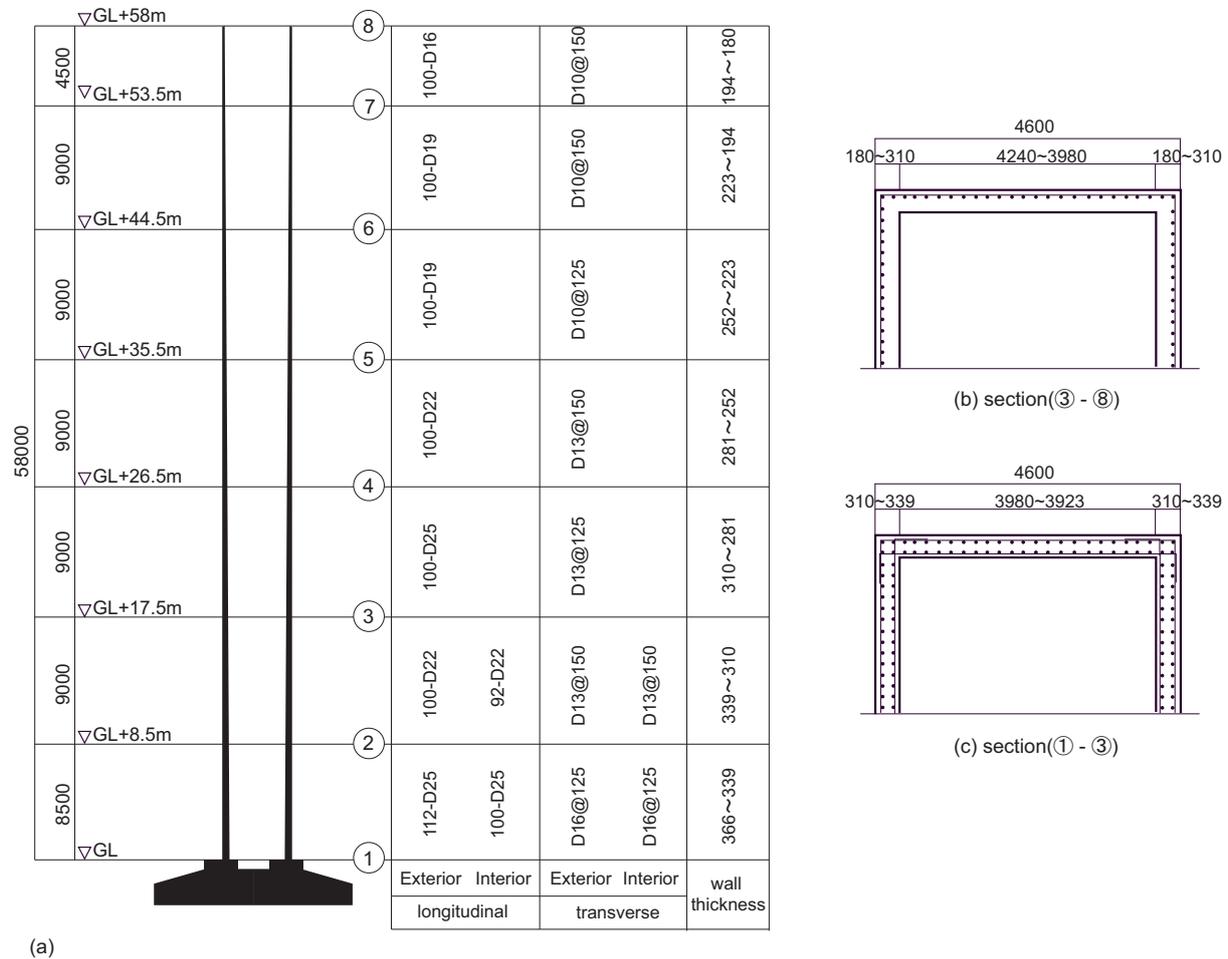
The reinforced concrete (RC) chimney is a cantilever type, and has a box shaped section on the side of which is 4.6 meters long. Two steel air ducts are encased in it. The thickness of the RC box-wall varies from 336mm at base to 180mm at the top. Longitudinal reinforcements are designed to decrease in the height direction. The reinforcements and structural configuration are shown in Figure 4 [Building Research Institute (2007)]. The longitudinal reinforcements are cut-off at six locations; see ② through

⑦ in Figure 4. The chimney damage observed was at a height of approximately 17.5 meters from the ground level, where two layers of longitudinal steel bars (section (a)) were changed to one layer (section (b)). Furthermore, double transverse hoops were changed to a single transverse hoop at the same height. According to construction documents, Table 2 lists the chimney's geometrical properties at each section, including the height  $H$ , average wall-thickness  $t_w$ , and the cross sectional area  $A_c$ , as well as axial load  $N$ , gravity weight  $W_c$ , and designed longitudinal reinforcement ratio  $p_g$ .

**Figure 4.** (a) Chimney geometry and designed reinforcements (b) Section from level ③ to level ⑧  
(c) Section from level ① to level ③

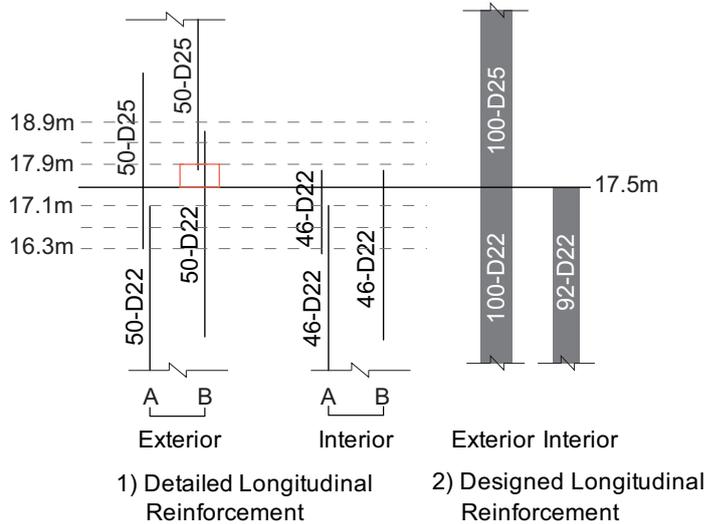
The actual reinforcing detail near the height of 17.5 meters above ground level is shown in Figure 5. It is seen that the locations of lap splice was staggered at this zone. Half of the exterior vertical bars (exterior (A)) were lap spliced at the height of 16 meter while the other half of bars (exterior (B)) were

lap spliced at the height of 17.8 meter. The interior layer of vertical bars was cut-off at the height of around 17.5 meters and no interior vertical bars existed in the upper part. The amounts of vertical reinforcement expected to resist the bending moments at around 17.5 meters are listed in Table 3. The reinforcement ratio at the height of 17.9 meter is lower than those at the other heights above and below. Due to the insufficient development length of the upper 50-D25 steel bars at the region, shown by a square in B layer, calculation assumes that the 50-D25 exterior steel bars in A layer and 50-D22 exterior steel bars in B layer are able to resist the bending moment from 17.5 meters height to 17.9 meters height.

**Figure 5.** Reinforcing detail at around 17.5meters height

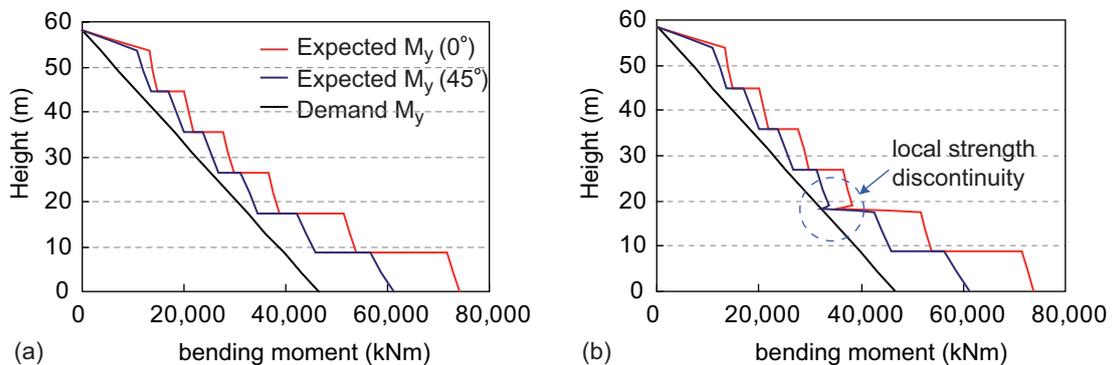
The expected flexural strength of horizontal sections is calculated using the reinforcing detail and is compared with the code demand in Figure 6. The expected flexural strength is calculated at both 0 degree and 45 degree direction of the section. The definition of the flexural strength here is the moment at the first yielding of longitudinal reinforcement in the section. The calculations assumed that the specified concrete compressive is 21MPa and the yield points of reinforcing steel are 295MPa for D16 bar, 345MPa for D19, 22 and 25 bars respectively.

**Figure 6.** (a) Designed flexural strength (b) Flexural strength with sectional deficiency locally at the mid-height.

Two different vertical profiles of flexural strength are shown in Figure 6. One of them is with designed strength profile which considers the six cut-off locations for longitudinal reinforcement (a). The other profile is identical except that the strength of the section is reduced to 90% at the location where the

severe damage was observed (b). This flexural strength is calculated by the reinforcement amount shown in Table 3. Although the flexural strength is still higher than the code demand, the section strength at the 17.5meter height is smaller in comparison with the heights above and below, forming a significant local discontinuity in the strength.

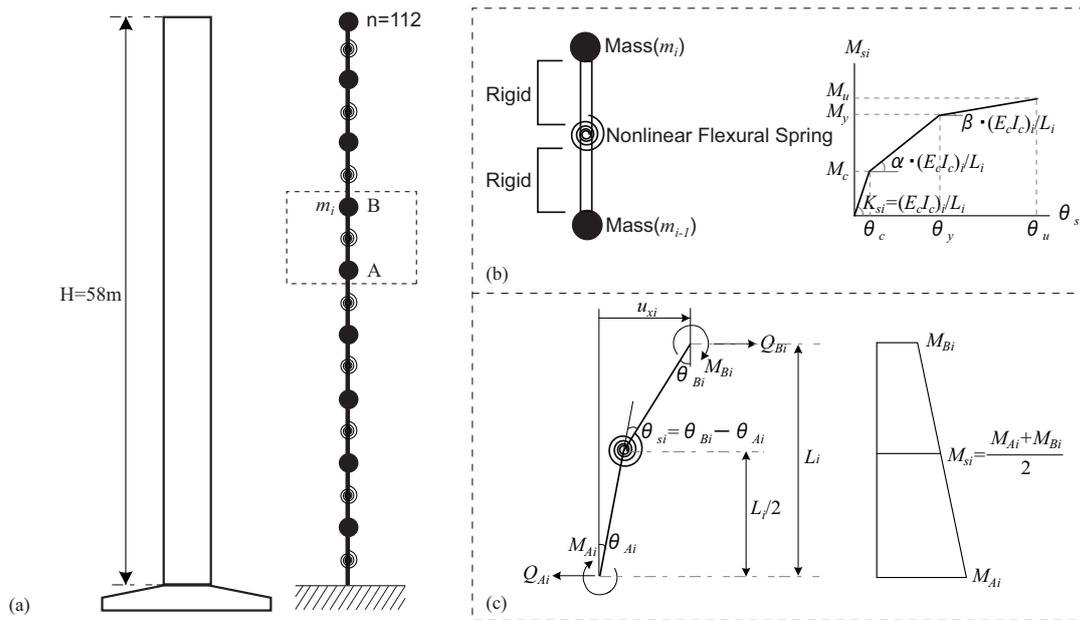
In the analyses, the chimney is modelled as 112 lumped mass elements along the height with connected nonlinear rotational springs to precisely represent the degradation of the stiffness and the strength distribution of the RC cross sections (Figure 7(a)). The elements between mass and nonlinear springs are assumed to be rigid. Tri-linear moment-rotation relationship for the flexural springs determined from sectional analysis and the hysteretic response in the springs is represented by the Takeda hysteretic rule [Toshikazu Takeda et al., 1970]. Table 4 shows the creak moment ( $M_c$ ), yielding moment ( $M_y$ ), and ultimate moment ( $M_u$ ) with according curvature ( $1/\rho_c$ ,  $1/\rho_y$ ,  $1/\rho_u$ ) of each section that used in the analytical model where,  $\alpha$  and  $\beta$  are the post-creak and the post-yield stiffness reduction factors. Figure 8 depicts the moment-curvature relationships. It is also assumed that shear stiffness of the wall is in elastic and the base condition of the chimney is fixed in the analyses. The P-delta effect is considered by taking into account the geometric non-linearity of structures. The nonlinear dynamic response analyses are carried out by the *Newmark- $\beta$*  integration method and Rayleigh viscous damping of 2% proportional to instantaneous stiffness matrix is adopted.

**Figure 7.** (a) Analytical model of the chimney (b) Element model  
(c) Force-deformation relation of an element

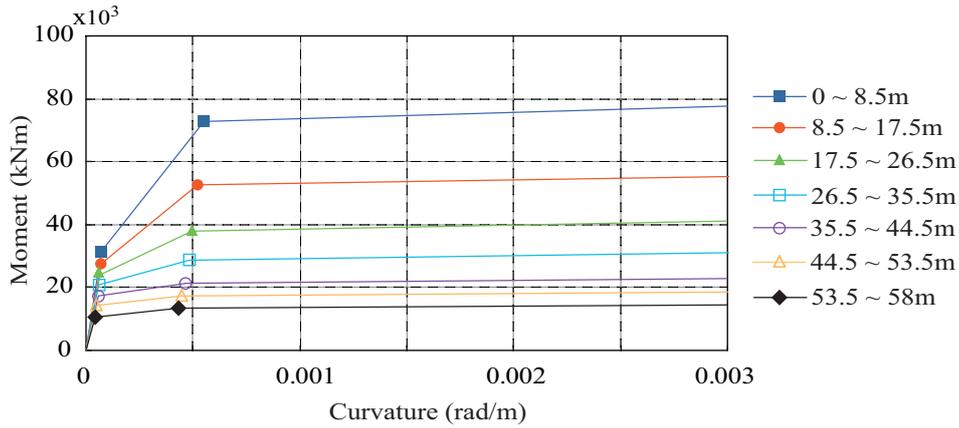
**Figure 8.** Moment versus curvature curve of sections

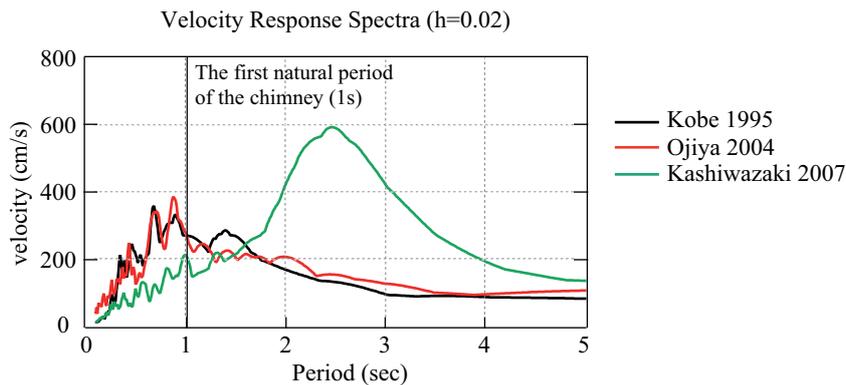
Storing ground motions with different predominant periods are used, including Kashiwazaki 2007 motion. The Kobe 1995 motion was recorded in the  $M_w$  6.8 1995 Great Hanshin earthquake and Ojiya 2004 motion was recorded in the  $M_w$  6.8 2004 Chūetsu earthquake of Japan. The 2% damped velocity response spectra of the ground motions are depicted in Figure 9. These two records have a large spectra velocity less than  $T=1.0s$ , which is the first natural period of the damaged chimney.

**Figure 9.** Velocity response spectra of the input ground motions (with damping factor of 0.02)

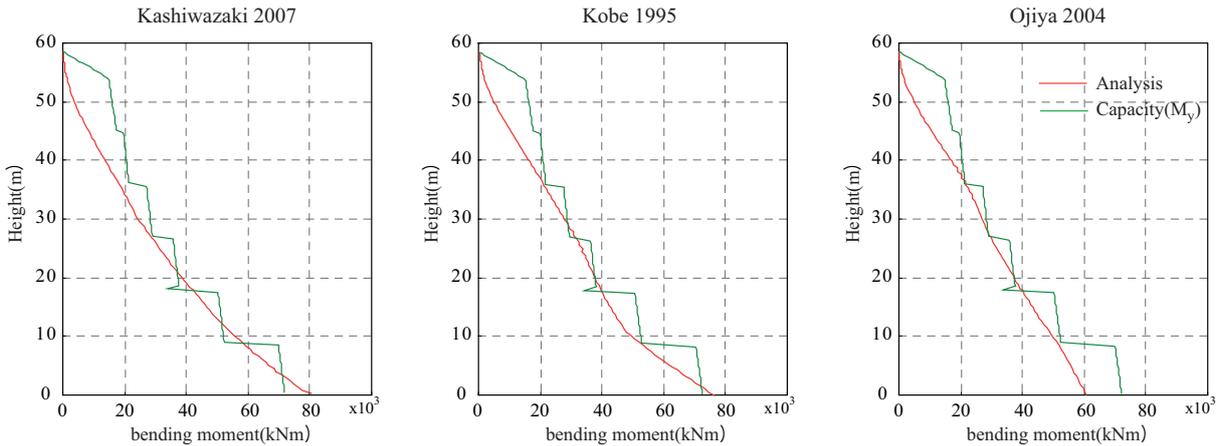
Figure 10 plots the bending moment envelopes obtained from the nonlinear time history analyses for the three ground motions, compared with the capacity. In the analyses, vertical flexural strength capacity that is calculated from the 0 degree direction of the cross-section is used.

It is seen in Figure 10 that the bending moments obtained from the analyses reach or exceed the

capacity in the region of the wall that have flexural discontinuities. The bending moment for the Kashiwazaki 2007 motion shows high demand in the large portion of the wall below mid-height, exceeding the capacity not only at the base but also at around 10 meters and 20 meters height. In contrast, the bending moments obtained for Kobe 1995 and Ojiya 2004 reach the capacity in the upper part of the wall. Considering the predominant periods of the ground motions, the second or higher mode effect is the main reason for the different moment envelope shape. It is observed that the bending moment obtained for all ground motions exceed the flexural strength in the vicinity of the level that has significant strength discontinuity locally.

Figure 10. bending moment envelopes obtained from the time history analysis.

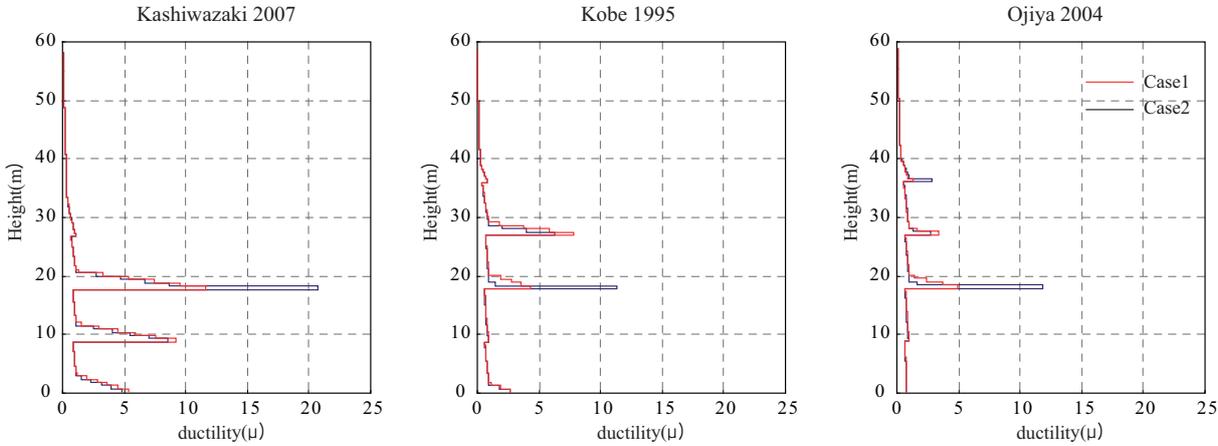
Figure 11 shows the curvature ductility demands for the three ground motions. Each plot in Figure 10 compares the obtained results when two different vertical strength distributions are used. One of them is when the chimney has expected designed strength (Case1) and the other is when there is critical local strength deficiency in the mid-height (Case2).

For Kashiwazaki 2007 motion, section yielding occurred in every longitudinal reinforcement termination zone below the mid-height in both case 1 and case 2. It is observed that the curvature ductility demand for Kashiwazaki 2007 is much higher than that obtained for the other ground motions. For Kobe 1995 motion, the highest curvature ductility is observed at around 27 meters height of the chimney in Case1 and plasticity at the upper part of the wall is also observed for Ojiya 2004 motion, which is a result of the higher mode effect.

Figure 11. Curvature ductility envelopes obtained from the time history analysis.

It is observed that the yielding occurred at the height of 17.5 meters where the two layers of longitudinal steel bars were changed to one layer for all three ground motions even in case1 (without local strength deficiency). The main difference between the results obtained by the two chimney strength profiles is that the one with degraded section strength yielded a much higher plasticity in the critical section, reaching over twice the degree obtained by the model without section strength degradation.

This analytical result indicates that the 17.5 meters height might be the most critical section in this chimney forming flexural strength discontinuity. This attracted concentration of inelastic response when this chimney was attacked by high intensity, long-period ground motion which led the chimney to respond in high nonlinearity range.
