Basic Analysis on Building Damages by Tsunami due to The 2011 Great East Japan Earthquake Disaster Using GIS

SUMMARY:

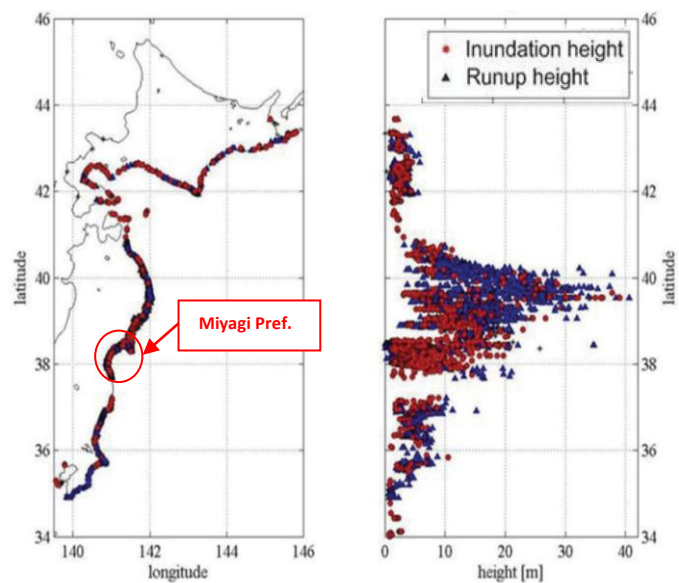
Figure 2 Inundation and runup heights reported by the Tohoku Earthquake Tsunami Joint Survey Group.

Survey Group. The field surveys were mainly conducted along the Pacific coasts from Hokkaido to Okinawa. The survey results all end up on the internet site and are being updated appropriately (see **Figure2**). According to the preliminary survey results, inundation or runup heights were about 5 m in the Pacific coasts of Hokkaido, up to 10 m in Aomori and Chiba prefectures, more than 30 m in some locations along the Sanriku coasts of Iwate, up to 20 m in Miyagi prefecture (NILIM & BRI, 2011).

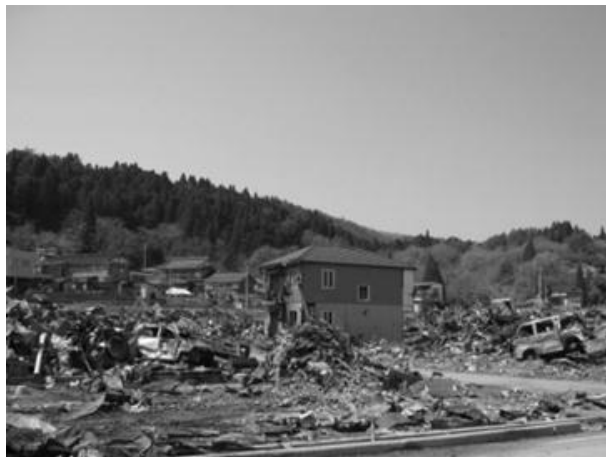
Photograph 1. Damaged wooden buildings due to tsunami

As a result of the offing massive earthquake of the Tohoku district, strong shaking was observed in eastern Japan and a violent tsunami struck the Pacific coast of Miyagi, Iwate, and Fukushima prefectures. The author of this paper investigated part of the coast in Iwate and Miyagi prefectures on April 8 to 10, 2011. It was considered that, the damages caused by seismic motion could be seen only at broken roof tiles of a few houses. And the completely collapsed buildings and overwhelming number of deaths were considered to be due to the tsunami. The state of tsunami damage varied greatly with just a small difference in elevation, and even in areas where most buildings were demolished, buildings considered to be only lightly damaged were found (see **Photograph 1**).

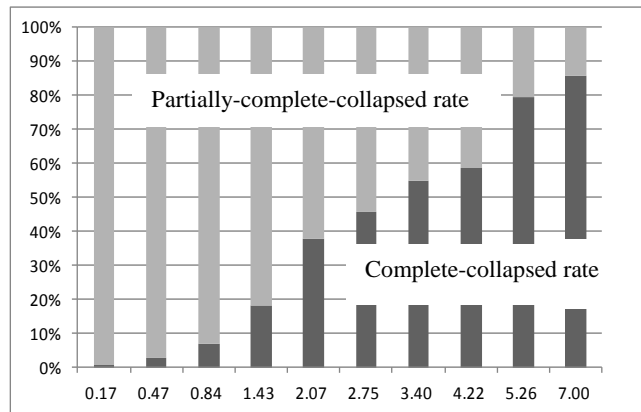
Figure 6 Class values and collapse rates for wooden buildings over entire subject area (flow velocity [m/s])

First, in order to equalize the weighting of building data for each class, building data is sorted into ascending order of hydrodynamic size of tsunami and grouped into a certain number of samples. In this research, damage ratios were found by dividing the data into 10 classes. The index value representing each class is expressed using the average value, and damage ratios are calculated by dividing the damaged buildings belonging to the class by the total number of buildings. As an example, basic numbers for flow velocity over the entire subject area are shown in **Table 4** and damage ratios found from these flow velocities are shown in **Figure 6**.

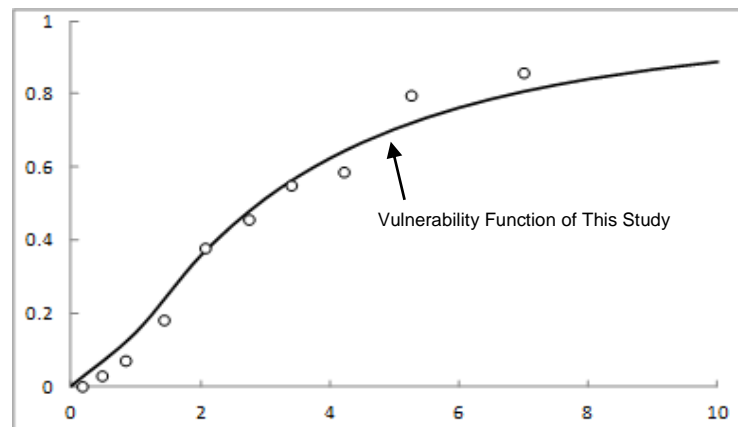
Figure 8 Vulnerability function for wooden buildings in entire subject area (tsunami flow velocity) [m/s]

As an example of a vulnerability function obtained from regression using the lognormal distribution function of Equation (2), the vulnerability function for wooden buildings in the entire subject area is shown in **Figure 8**.

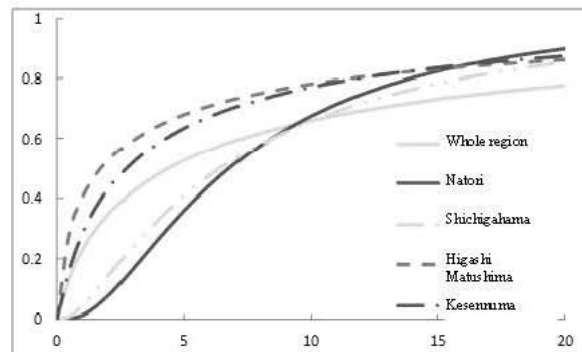
Region	R^2	λ	ζ
Region whole region	0.978	1.480	1.970
Natori	0.896	1.810	0.540
Shichigahama	0.959	1.860	1.080
Higashi Matushima	0.967	0.556	2.230
Kesenuma	0.944	1.010	1.740

(c) Damage ratio and Tsunami external force [KN/m²]

Figure 9 Summary of vulnerability functions for wooden buildings

(a) Overall, the coefficients of determination for inundation water depth are lower than those for flow velocity and tsunami external force, and correlation between inundation water depth and collapse rate is considered to be low. In regard to tsunami external force, the coefficients of determination are all above 9.0, and a high correlation is seen. Also, there is quite a difference in collapse rate of wooden buildings according to area. In Shichigahama-machi and Kesennuma, where the topography of the coast is complicated, it can be seen that the collapse rate increases in an earlier class than in the other two areas. And, from a tsunami flow velocity of approximately 4 m/s and above, a fairly gentle gradient is shown. In contrast, in Higashimatsushima and Natori, the vulnerability functions show a fairly gentle gradient up to a tsunami flow velocity of approximately 2~3 m/s, and from there also the

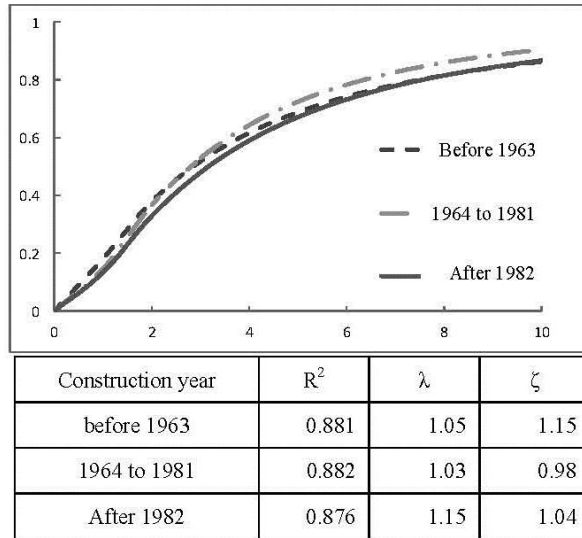
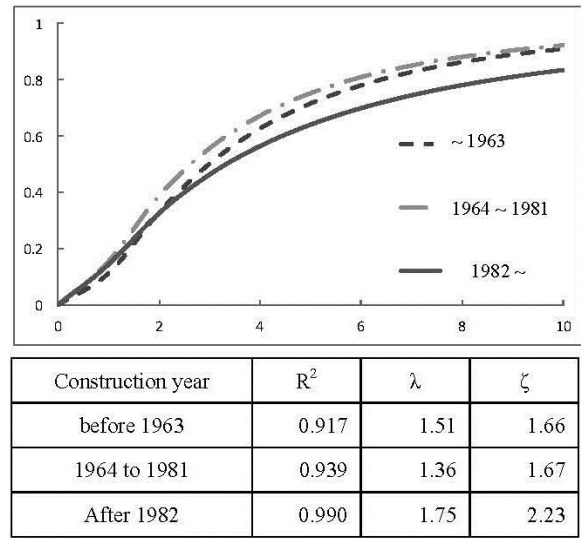
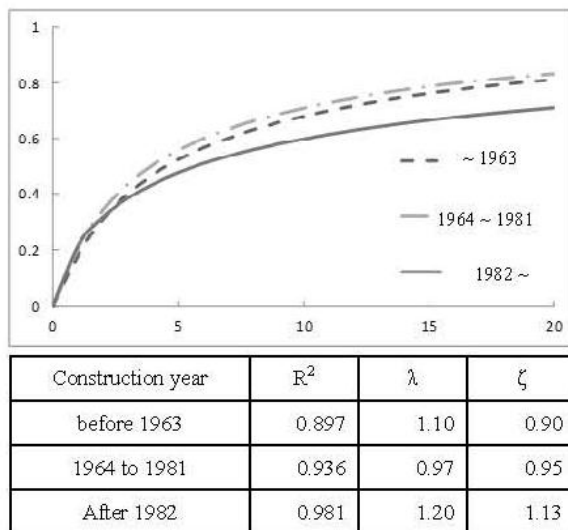
(a) Damage ratio and Inundation depth [m]

(b) Damage Ratio and Tsunami Flow velocity [m/s]

(c) Damage ratio and Tsunami external force [KN/m²]

Figure 10 Vulnerability functions and damage ratios for wooden buildings according to period

(b) A slight difference can be seen in the collapse rate of wooden buildings according to construction year. Buildings constructed before the 1981 revision of the Earthquake Resistant Standards have, overall, a higher collapse rate than buildings constructed later. The coefficients of determination for inundation water depth are inferior to the others in this case as well.

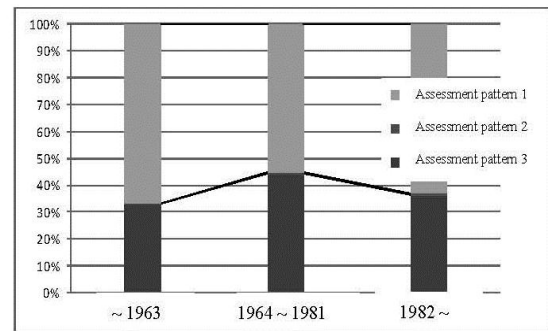
Descriptions	Before 1963	1964 to 1981	After 1982	Total
Assessment pattern 1	1,105	1,910	1,765	4,780
Assessment pattern 2	4	16	18	38
Assessment pattern 3	547	1,535	1,021	3,103

(d) No. of wooden buildings damaged and damage ratio for construction year

are shown (See **Figures 9 and 10**). Construction periods are divided into 3 groups: 1963 and earlier, 1964~1981, and 1982 and later. The damage ratios for wooden buildings according to period are shown in **Figure 10(d)**.
