Seismic Vulnerability of Buddhist Monasteries: Evidences from the 2011 Sikkim Earthquake and Dynamic Analyses

T. Pradhan, V. Singhal, G. Mondal, N. Parool & D.C. Rai

Dept. of Civil Engineering, Indian Institute of Technology Kanpur, India

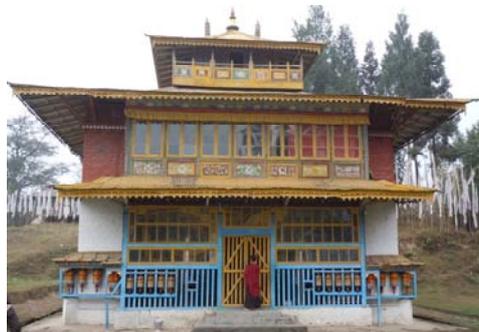
The main temple is a two or three storey structure with load bearing exterior walls and an inner timber frame which supports the wooden diaphragm. Fig. 2.1 shows an exterior view of a typical main temple in a monastery. The exterior walls are thick, tapered and built using dressed or semi-dressed or random rubble (R/R) stone masonry laid in mud or lime or cement mortar. The thickness of the wall varies from 0.5 to 1 m which gradually reduces in the upper stories. Doors and windows are an important part of the Buddhist construction from both functional and religious point of view. Openings are provided on all the three sides except on the side opposite to the main entrance where the idols of the deities are placed. These openings are large in size and number, and significantly influence the overall strength of the wall.

Figure 2.1. View of main temple at Pubyuk monastery

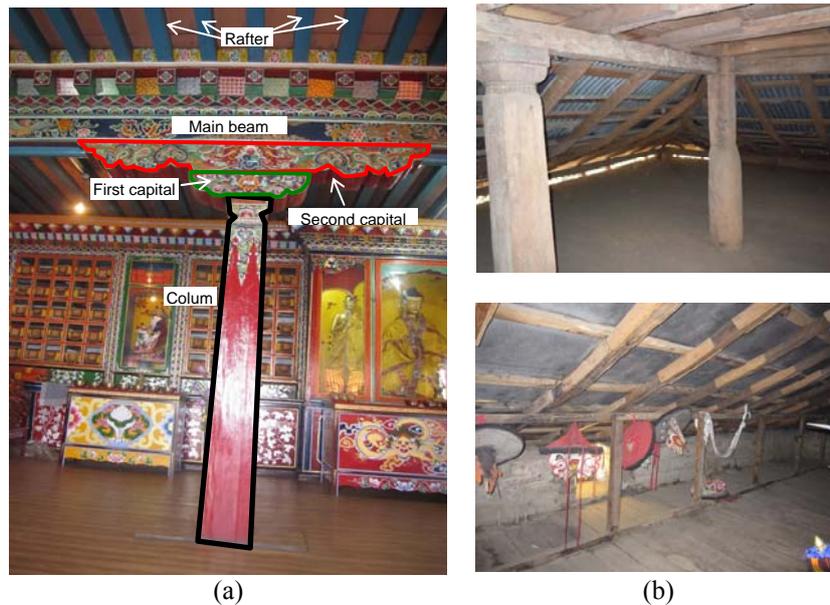
The timber framing system comprises of grid of columns and beams arranged in the central portion of the room. The main beam runs from one wall to the other in the direction parallel to the main entrance or *Tsomchhen*. The columns are not continuous from bottom to top in a multi-level frame but they are constructed in such a manner that their centre-line is maintained at all the floor levels. These columns are tapered and made from solid timber logs which extend from the base of the floor to the capital (Fig. 2.2a). The capitals known as bows have elaborate carvings and are placed in either two or three layers depending upon the height of the floor. The floor is made of wooden planks placed on wooden rafters supported between the main beam and the wall (Virtanen, 2001). Hipped timber roofs covered with corrugated galvanised iron sheet are provided at one or multiple levels resting on trussed rafters as shown in Fig. 2.2b.

Figure 2.2. Details of (a) wooden timber frame and floor diaphragm supported on rafters and (b) hipped roof construction.

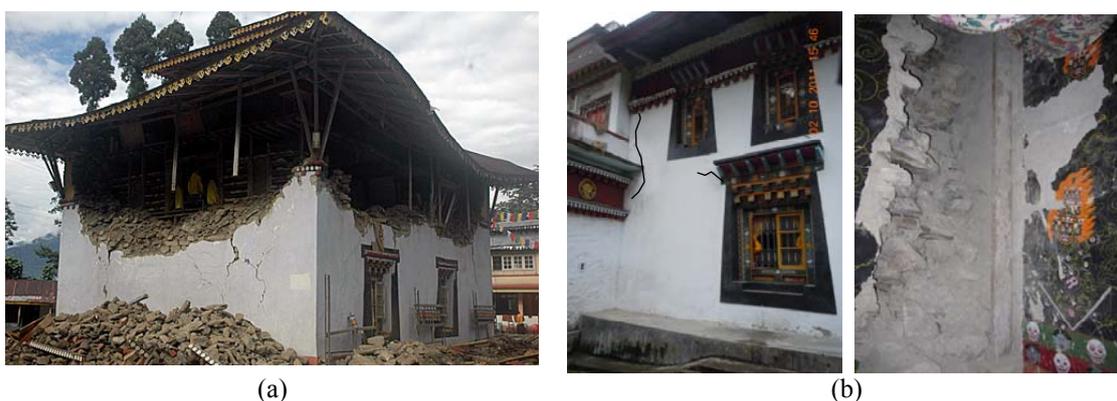
In the September 18, 2011 event several monasteries suffered varying degree of damages ranging from cracked walls to total collapse. Heavy damages were observed to exterior walls at several monasteries, e.g., total collapse of a village temple at Lachung, partial collapse at Ringhem Choling monastery at Mangan, delamination of walls and cracks in Samten Choling monastery temple, Lachung (Fig. 3.1).

Figure 3.1. Common damages observed (a) Partial collapse of wall of Ringhem Choling monastery due to forces imposed by the roof deflection and (b) Shear cracks and delaminated wall painting at Samten Choling monastery.

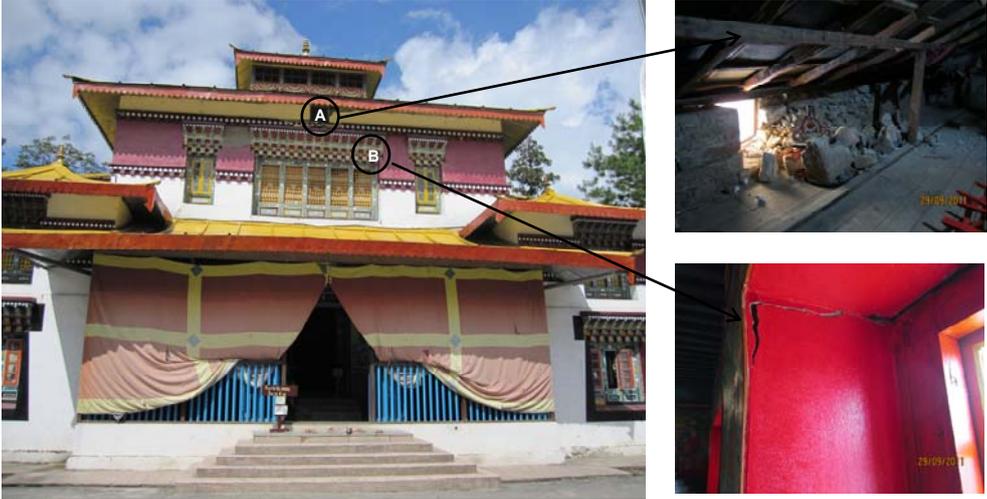
Enchey monastery at Gangtok, retrofitted after the 2006 Sikkim Earthquake (Kaushik et al., 2006; Dutta et al. 2006) suffered moderate damages in the 2011 event. The out-of-plane failure around the opening was observed in the unretrofitted portion of third-storey wall as shown in Fig. 3.2. Similar

Figure 3.2. Damages observed on the front wall of third storey at Enchey monastery

In order to identify the stress critical zone in the structure, a uniform static horizontal load taken as 20% of the weight as per the Indian seismic code was applied in both the directions. Table 5.2 summarizes the stresses obtained by response spectrum analysis and lateral load analysis. The maximum tensile stresses observed at the corner of openings exceeded the lower bound permissible value of 0.08 MPa (Tomažević, 1999) (Fig. 5.5). The location of maximum stresses was same as the location of damage observed during the 2011 earthquake (Fig. 3.2).

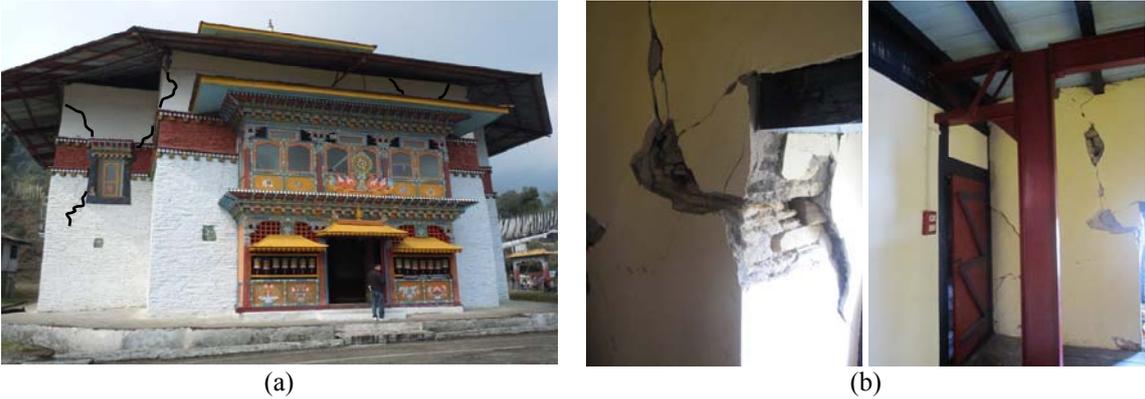
damage to the exterior wall built in stone laminates was also observed at Labrang monastery (Fig. 3.3). After the 2006 earthquake, the collapsed roof was replaced by a truss roofing system supported on steel columns erected around the shrine room. Steel joists connected to columns were also inserted below the timber floor to relieve the load on the timber beams and walls.

Figure 3.3. (a) Cracks on the exterior wall of Labrang monastery and (b) Exposed stone laminates during the recent damage and steel columns and joists used in the retrofit

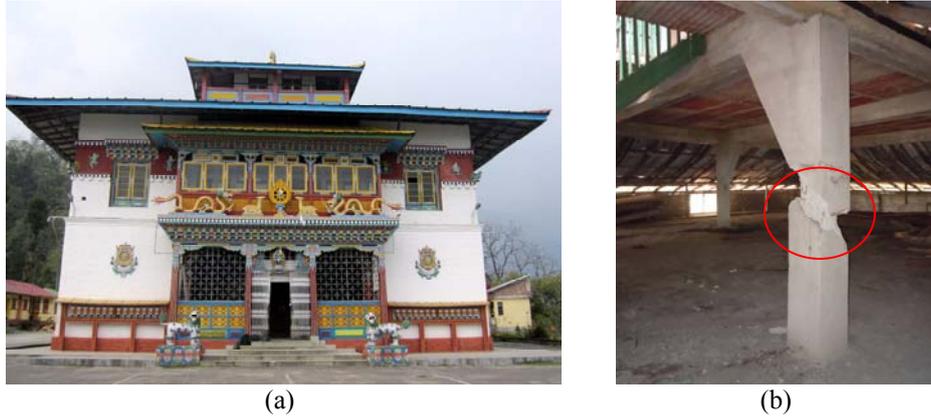
Phodong monastery which is a mixed construction of RC frames and load bearing masonry walls suffered no damages to the exterior walls (Fig. 3.4a). However, the RC columns were severely affected because of short-column effect due to the presence of deep haunches at the beam-column junctions as shown in Fig. 3.4b. The modified configuration which were supposedly provided to increase the lateral load resisting capacity of the frame, in turn created a short-column effect causing brittle shear failure of the columns.

Figure 3.4. (a) Phodong monastery, interior RC frame with exterior stone masonry wall and (b) Damaged column due to short-column effect induced by the presence of deep haunches at beam-column junctions.

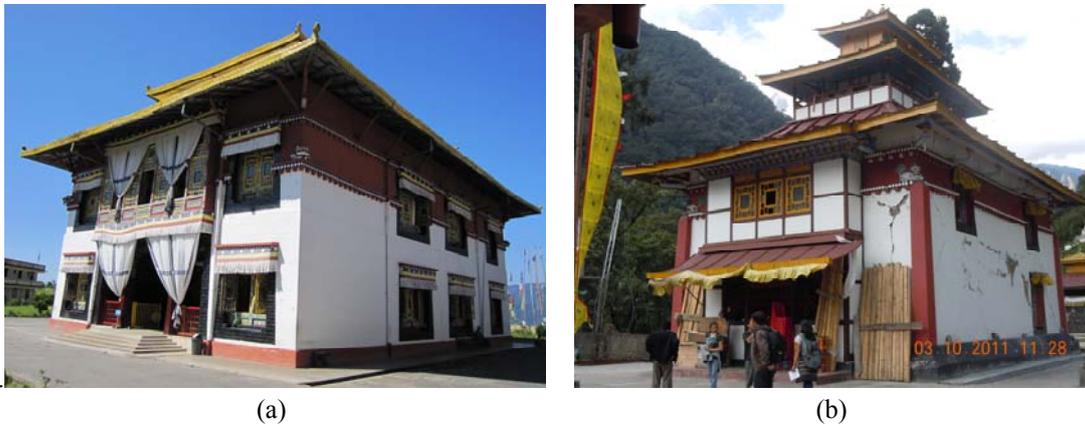
Tsug-lakhang also referred to as the royal chapel, a two storey building with a regular plan area, constructed in dressed stone masonry, is a hallmark of excellent workmanship and building technology of the Buddhist architecture (Fig. 3.5a). No significant damage was observed to the structure during the Sept. 18, 2011 earthquake. In the Rikzing Choeling monastery, strengthening of the existing masonry walls by constructing RC columns at the corners prevented the walls from complete collapse (Fig. 3.5b). These efforts can be expanded into a comprehensive strengthening and retrofitting measures of such structures so that their performance is satisfactory in future earthquakes.

Figure 3.5. (a) Tsug-lakhang monastery and (b) Rikzing Choeling Monastery with RC confinement at corners

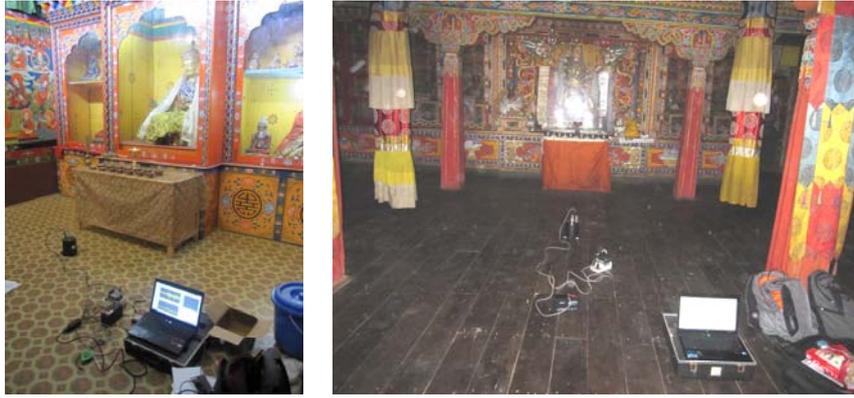
Ambient vibration measurements of main temple were made at three monasteries namely Enchey, Labrang and Phodong to obtain the dynamic properties of these structures. The vibration measurements were performed in two directions, i.e., parallel to the main entrance (x -direction) and perpendicular to the main entrance (y -direction), using SS-1 Ranger seismometer (Kinemetrics, USA). The set up of sensor and data acquisition system at Enchey monastery and Labrang monastery are shown in Fig. 4.1. The measurement was taken at every floor and at different locations, chosen depending on the ease of placing the sensor. The sampling frequency was 2000 Hz which was recorded for about 150 s each time. The recorded time-history in both the direction and its corresponding Fourier spectrum is shown in Fig. 4.2. The data are filtered and re-sampled to remove the high frequency content. The frequencies of the three temple sites as obtained from ambient vibration test are listed in Table 4.1. It was observed that all the three temples were short period structures and fall in the acceleration sensitive region of the seismic design response spectrum. In addition the floor vibrations were also measured by placing the seismometer in upright position and creating vibration by tapping the floor.

Figure 4.1. Experimental setup consisting of seismometer and data acquisition system at Enchey monastery and Labrang monastery.
