Seismic Performance Evaluation of a Six Story Inner Frame Supported Masonry Building Based on In-Situ Impact Test

Peizhou Zhang, Shuang Hou & Jinping Ou

School of Civil Engineering, Dalian University of Technology, Dalian, China

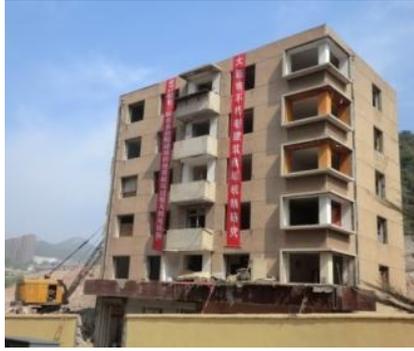
The six-story structure was built in 1980s, and located in Dalian, China. The first story is 3.5 meters high, with cast-in-place R.C. slab, supported by R.C. frames inside and brick walls outside, mainly used for business purposes; other stories are 3.0 meters high, with precast R.C. slabs, supported by only brick walls, mainly used as residences; as shown in Fig. 2.1 and Fig. 2.2.

Figure 2.1. Inner frame-supported masonry structure

Measured data shows the average of concrete strength is only 20 MPa, the stirrups are $\Phi 6$, and at the stirrup densified regions the stirrup spacing is 200mm. Both the concrete compressive strength and the stirrup ratio are fairly low, which don't meet the demand of current Chinese seismic code (GB 50011-2010, 2010).

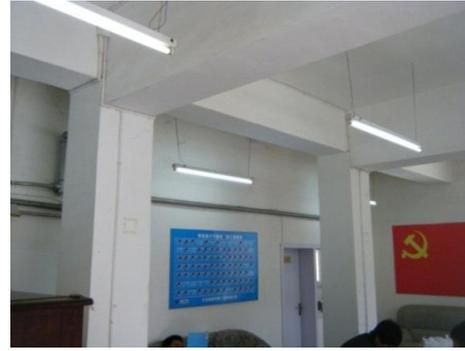
Figure 2.2. Columns of the inner frame

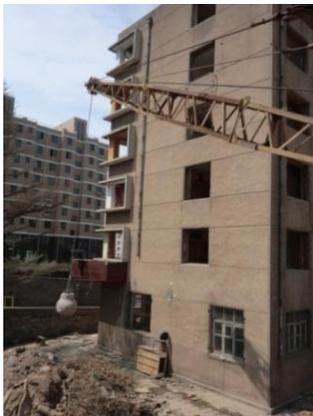
The horizontal impulse load is applied by a gravity hammer at the height of the first floor as shown in Fig. 2.3. During the whole test process, the load mentioned above has been applied first to the left side of the structure several times, then to right side, at last to the back of it until it collapses. Fig. 2.6 describes several test conditions of the experiment. The measuring instruments include smart aggregates (SA), accelerometers and dynamic inclinometers. SA, which made of piezoelectric material, is developed by our research group to monitor the value of concrete stress changes under dynamic load (Hou et al, 2010). In the test, 2 SAs are used to measure shear stresses of beam-column joints, 14 SAs for normal concrete stresses at the ends of column 3 and column 4; 3 accelerometers for horizontal accelerations of the joints and the impact point; 5 dynamic inclinometers for the rotation angles of the joints and the cross sections at the ends of columns. The layouts of all sensors in the structure are shown in Fig. 2.5, Fig. 2.7 and Fig. 2.8. Data acquisition equipment is located about 30 meters away from the structure for safety, and about 1200 meters wires are used as shown in Fig. 2.4.

Figure 2.3. Impulse load

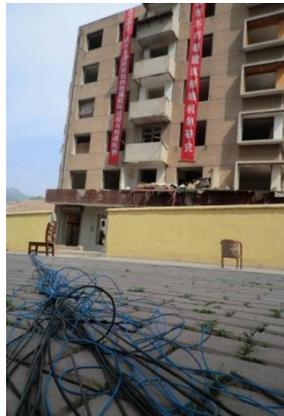
Figure 2.4. 1200 meters wires

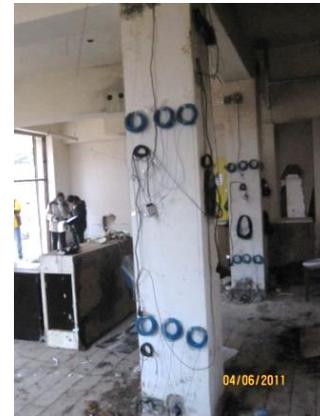
Figure 2.5. Sensors in the structure

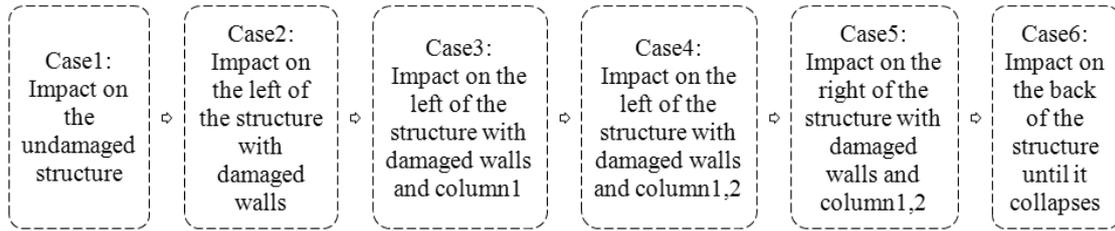
Figure 2.6. Description of test conditions

The structural frequencies of test condition case1 to case4 (Fig. 2.6) are shown in Fig. 4.7 and Fig. 4.8, which are obtained with transfer function method based on the SA data. The figures show that when the damage is small or local, the changes of the damage won't cause serious impact on structural frequency, which changes no more than 3.6% before and after the failure of column 1.

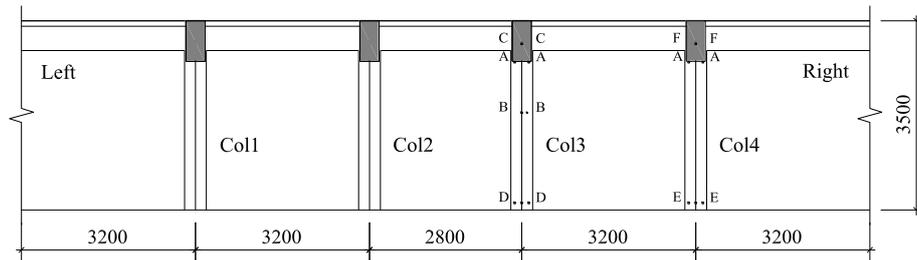
Figure 2.7. Sensors on the inner frame (Section 1-1 in Figure 2.9)

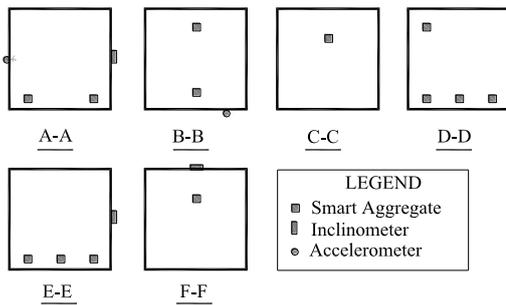
Figure 2.8. Sensors in the cross sections

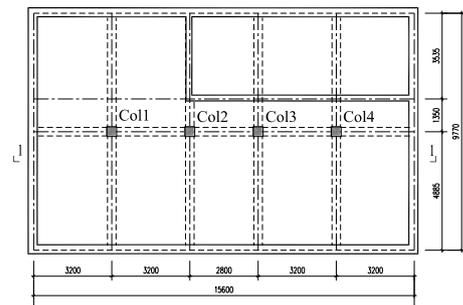
Figure 2.9. Structural plan of the first floor

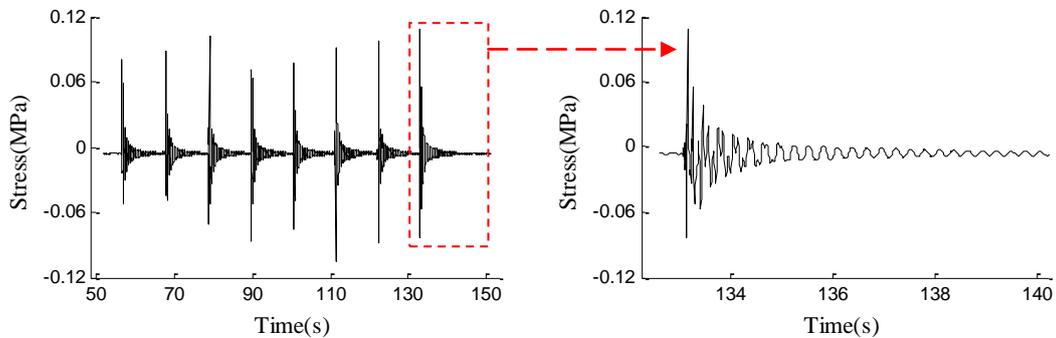
Figure 3.1. Values of stress changes measured with SA in the joint of column 3

This part focus on study the damage evolution process with measured data of the structure under all damage states from the test mentioned above. Fig. 3.1 shows the values of stress changes measured

with SA in the joint of column 3 during multiple impacts.

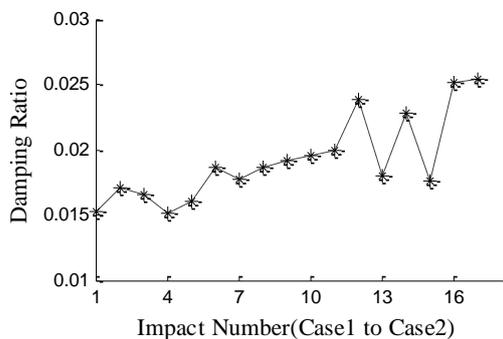
The structural damping ratios during the multiple impacts from test condition case1 to case2 are calculated according to the formulation above, and shown in Fig. 3.2. The figure shows that with the damage increases, the overall trend of damping ratio is increasing gradually, while the jagged fluctuations are due to experimental errors and the discreteness of selected data. To the undamaged structure, damping ratio is only 1.6%, very different from the commonly used 5%, which may cause great difference on the results of structural seismic response analysis.

Figure 3.2. Trend of structural damping ratio from test case1 to case2

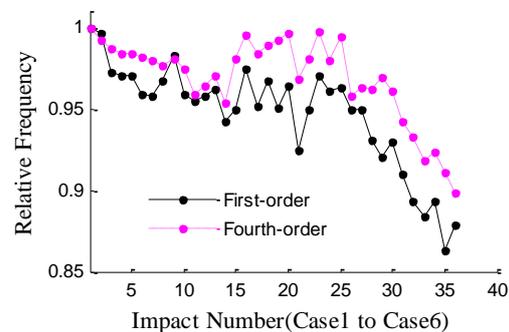
The structure has been hit more than a hundred times during the entire experiment, and each time the structural damage increases. The trend of structural frequency during the first 40 impacts is obtained through frequency recognition and is shown in Fig. 3.3, where ordinate refers to the ratio of the structural frequency after certain impact to that of the undamaged structure, and abscissa refers to the number of impacts. The jagged fluctuations are caused by experimental errors. The figure shows that the natural frequency of structure decreases when the damage increases, but within a small range. The results can be applied to update the finite element model.

Figure 3.3. Trend of structural frequency during the first 40 impacts

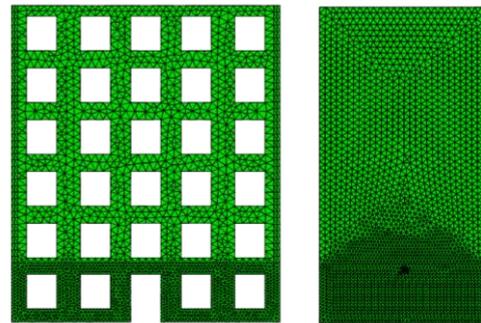
Figure 4.2. Mesh of structure

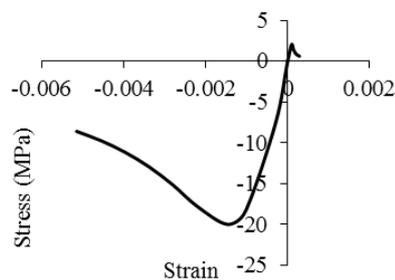
The constitutive relationship recommended by Chinese Code for Design of Concrete Structures is applied to simulate concrete, while the constitutive relationship in Zheng's paper is used to simulate brick walls. Fig. 4.3 and Fig. 4.4 show the stress-strain relationships of concrete and brick walls respectively.

Figure 4.3. Stress-strain relationship of concrete

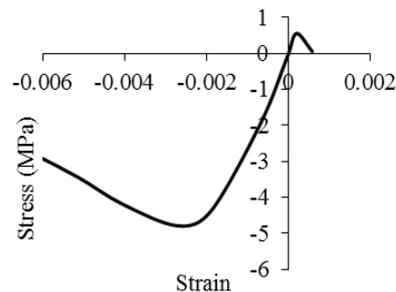
Figure 4.4. Stress-strain relationship of brick walls

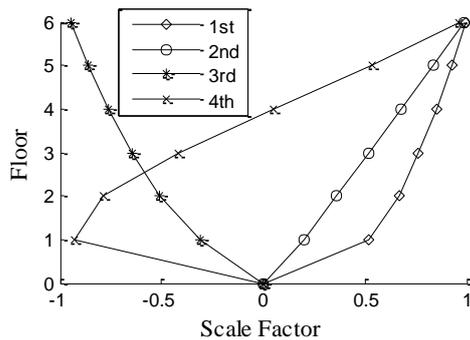
The structure is modeled in ABAQUS based on its actual information from the site survey, and then a modal analysis is conducted. The first four mode shapes are shown in Fig. 4.5. Compared with the

measured frequencies mentioned above, the conclusion can be drawn that the modes excited during the test are the first and the fourth order mode.

Figure 4.5. First four order mode shapes of the undamaged structure (case1)

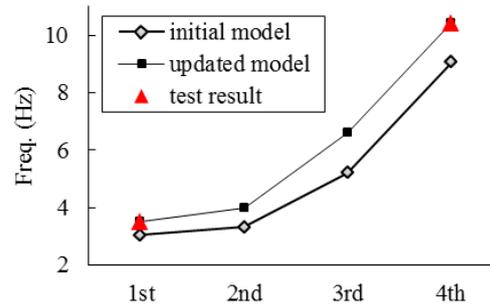
Figure 4.6. Frequencies of the test results, updated model and initial model under undamaged state (case1)

The results of the initial model in Fig. 4.6 represent the first four frequencies calculated with the initial model, which have significant differences compared with the test results. One possible reason is that from the second story to the top the structure is residentially used with more complicated situation, so the site survey may not be detailed enough for an accurate simulation. Moreover, the discreteness of the masonry materials may lead to inaccurate material parameters in modeling. So under the certain structural mass, the numerical model could be updated by changing the stiffness matrix and the material parameters on the basis of experimental data under undamaged state, until structural natural frequency agrees well with the experimental result (shown as results of updated model in Fig. 4.6). Finally the updated model can be validated by frequency comparison between test results and simulation results under other damage states.

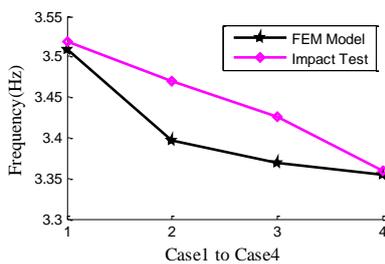
The objective of updating the model is to make it closer to the actual structure and to do further structural analysis with it. To illustrate the effectiveness of this method, the first and fourth frequencies of the test results and updated model under different damage states are shown in Fig. 4.7 and Fig. 4.8. In Fig. 4.7, the first frequency of the test results under undamaged state (case1) is the reference used to update the model, and we can see from Fig. 4.8 the model's fourth frequency automatically matches with the test result. The model's frequencies under other damaged states (case2 to case4) are gained through simulation to the impulse load process. The figures show that the model's frequencies match well with the test results, with the error less than 5%, which is shown in Fig. 4.9.

Figure 4.7. First-order frequency under different damage states

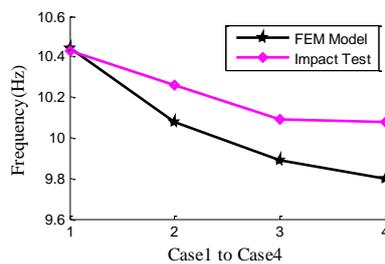
Figure 4.8. Fourth-order frequency under different damage states

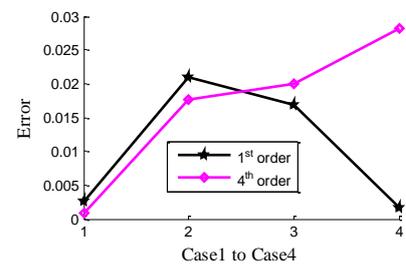
Figure 4.9. Errors of first and fourth order frequencies

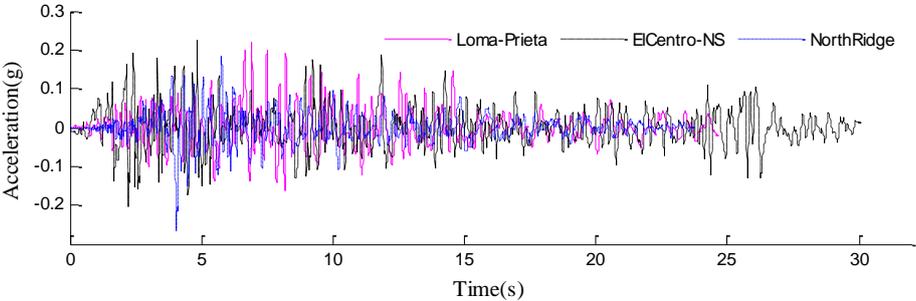
NorthRidge wave, El-centro_NS wave and Loma_Prieta wave are modified with SeismoMatch to fit

the code response spectrum as shown in Fig. 5.1, and then applied to the model as input ground motions. In this case, the structure is built at field sort II, designed to resist 7 degrees intensity earthquakes, so the parameters of the code response spectrum (GB 50011-2010, 2010) are as followed: the horizontal seismic coefficient is 0.5; the characteristic period of the field is 0.35s. The comparison between the modified waves spectrums and code response spectrum is shown in Fig. 5.2, from which we can see the mean response spectrum of the three waves agrees reasonably well with the target one.

Figure 5.1. Modified time-history curves of selected earthquake waves

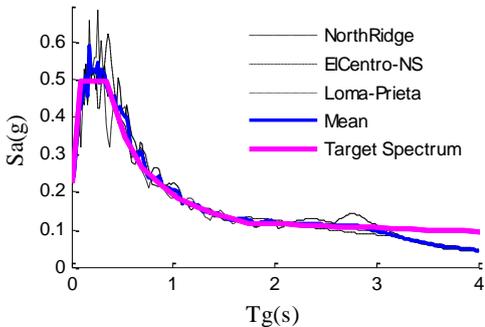
Figure 5.2. Modified response spectrum of selected earthquake waves compared with the target one

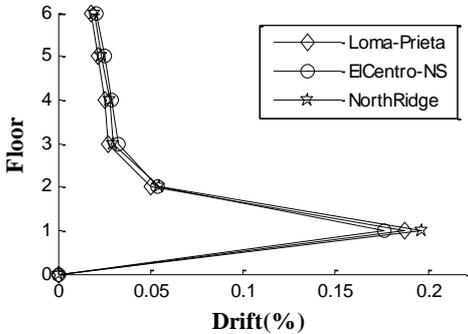
Figure 5.3. Distribution of maximum story drift under earthquakes

From the preliminary analyses, the maximum displacements of the structure, the order of plastic hinges, their location on the inner frame, and the distribution of the story drifts along the height are all similar under three waves. The maximum story drift is 0.002 at the first story as shown in Fig. 5.3. Through the paper we conclude that such type of structure's weak story is the first story, and its

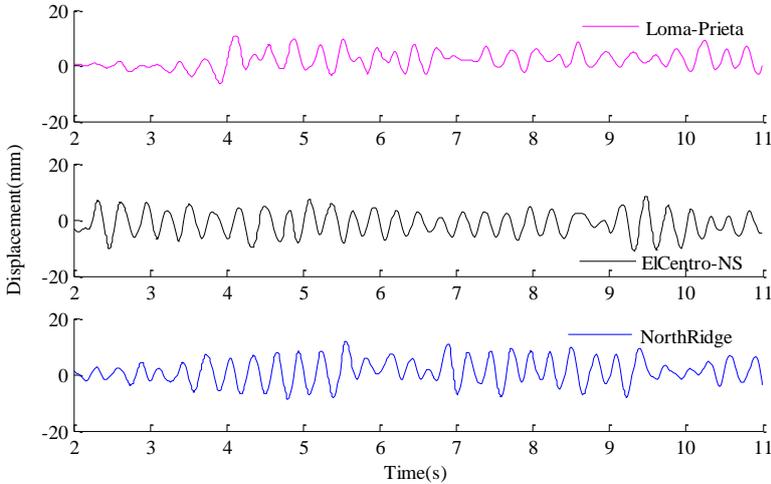
The time-displacements (2s~11s) at the top of the building from nonlinear time-history analyses with Rayleigh damping are shown in Fig. 5.4. The maximum displacements of the structure under three seismic waves are 11.02mm, 11.92mm and 11.83mm.

Figure 5.4. Time-displacement of the structure under seismic waves

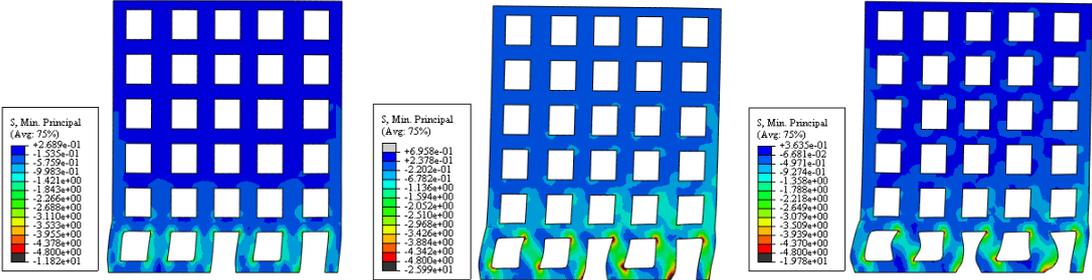
Fig. 5.6 are the stress contours of the external walls under three earthquake waves at the onset of maximum stress in the wall. The figures show that the external walls of the first story and the walls between windows have all been damaged to some extent, where the maximum stress has reached the walls' compressive strength.

(a) Loma_Prieta wave (at 11.2s) (b) El-centro_NS wave (at 10.47s) (c) NorthRidge wave (at 8.0s)

Figure 5.6. Stress contours of the external walls under three waves
