Seismic Response and Damage of High-Rise Buildings in Tokyo, Japan, during the 2011 Tohoku Earthquake

SUMMARY:

We report seismic response and damage of high-rise buildings in the Shinjuku Station area in Tokyo, Japan, for the 2011 Tohoku Earthquake (Mw 9.0). The strong motion data of Kogakuin University, which is the steel frame building of the 29-stories and 143 m height, showed that the maximum amplitudes of accelerations and displacements were amplified from 1 m/s/s and 0.1 m for, at the ground level, to 3 m/s/s and 0.37 m at the top floor, respectively. Not only the 1st mode (about 3 s), but also the 2nd higher mode (about 0.9 s) were well excited. Those results agree with the damage distribution where the falls and movements of ceiling boards and unsettled objects were occurred from middle to the top floors. An elevator stopped for more than 3 weeks, because of tangles of the main cables. The similar damage occurred in the other high-rise buildings in the area.

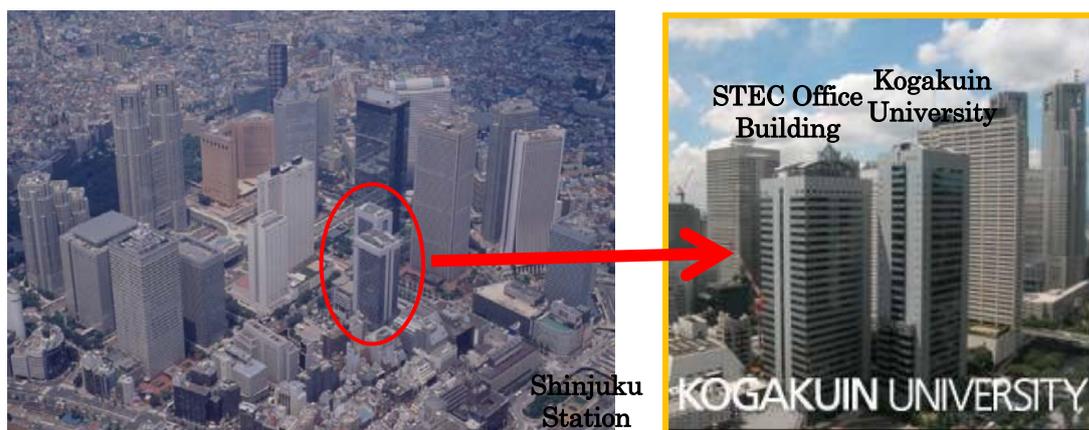
Figure 1. The Shinjuku station Area (Left) and the campus building of Kogakuin University and STEC office building (Right)

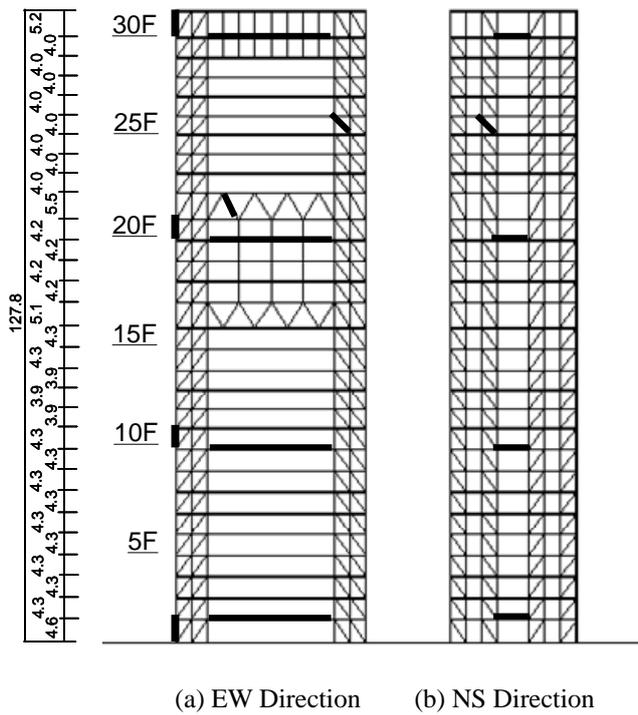
Figure.3. Structural elevation of Kogakuin University building

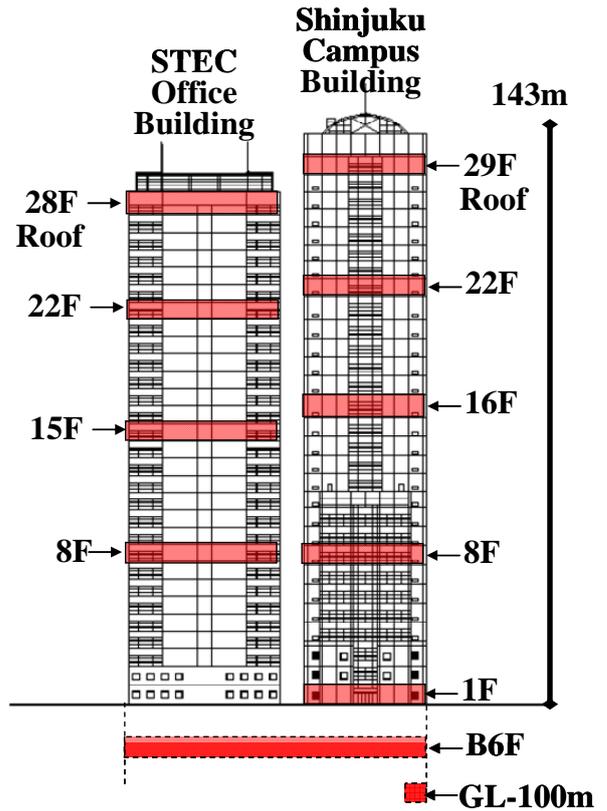
Figure.4. Location of strong motion sensors

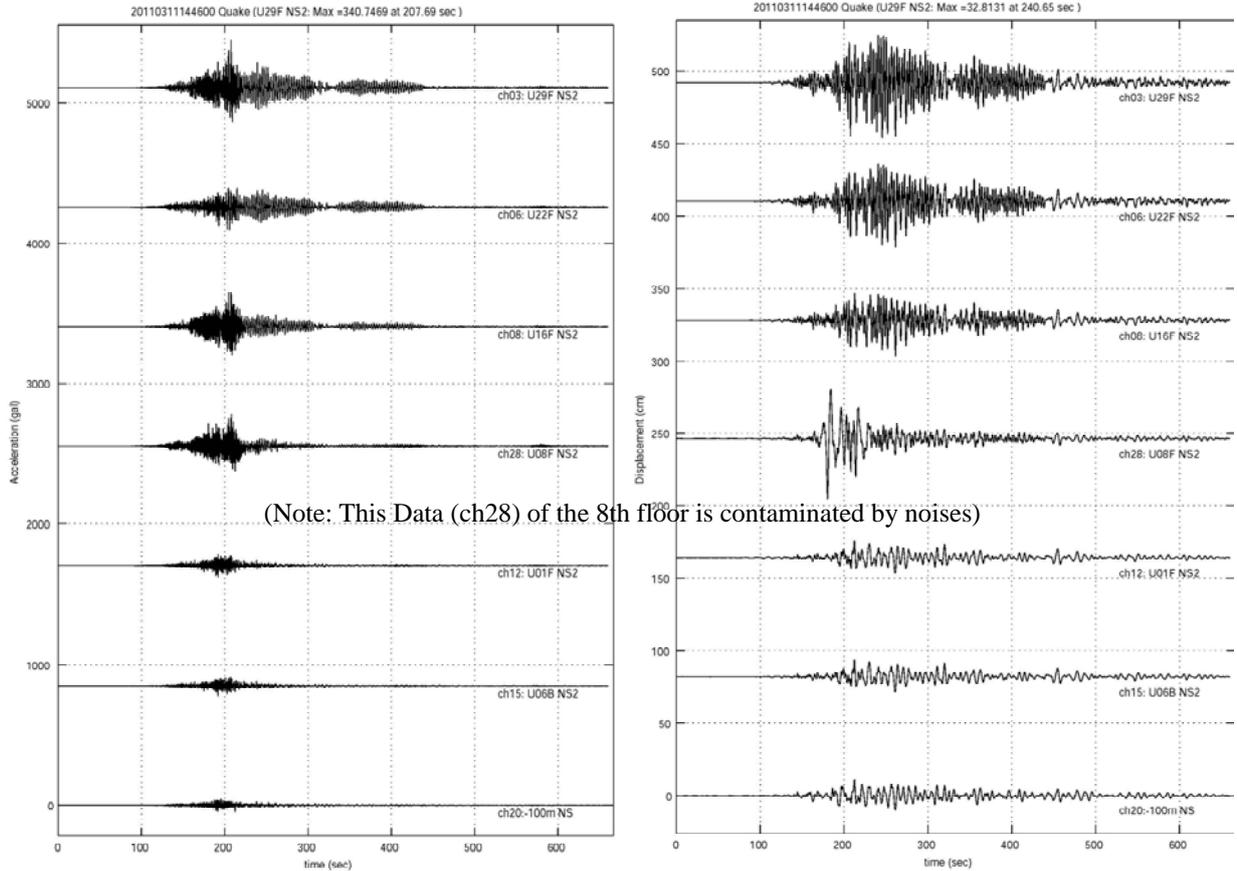
Figure 5. Accelerations (left) and displacements (right) of NS components from GL-100 m to the Top Floor

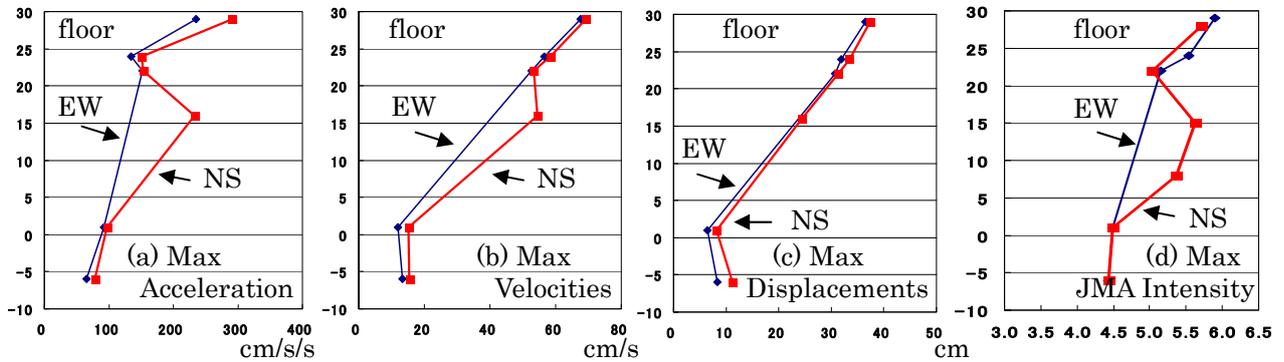
Figure 6. Maximum Accelerations, Velocities, Displacements, and the JMA Intensities of Kogakuin University.

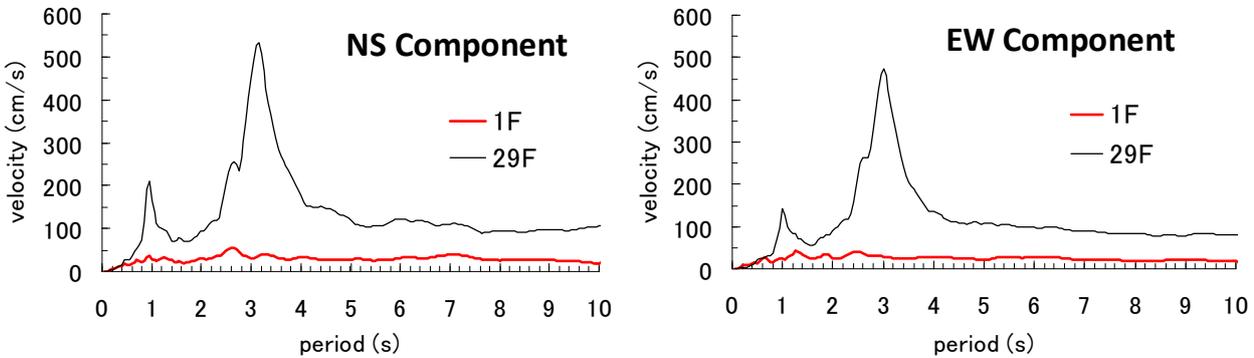
Figure 7. Velocity response spectra (h=5%) of the campus building of Kogakuin University

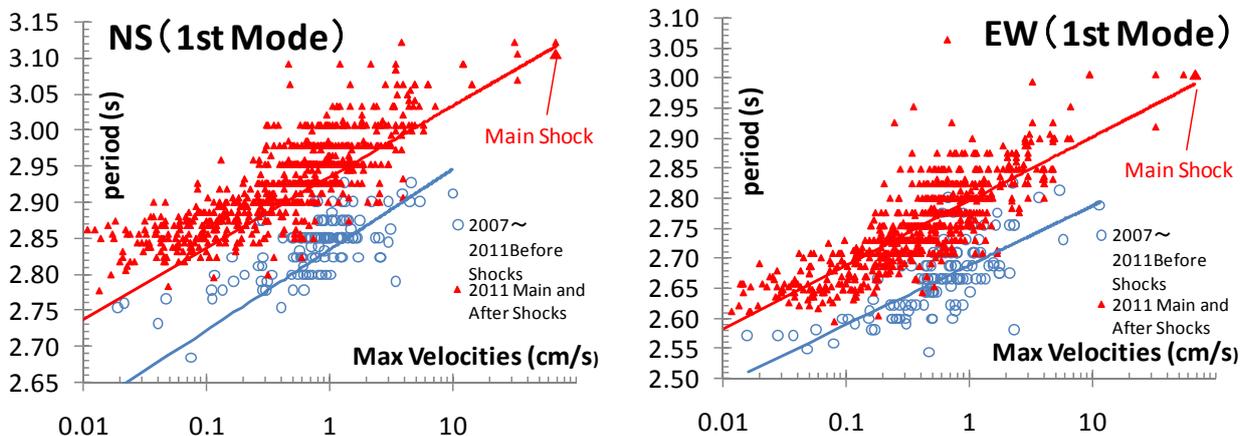
Figure 8. Dependency of natural periods on the maximum velocities of the 29th floor of the university building

We checked the dependency of the natural period on the maximum amplitude of the building response. **Figure 8** shows the natural periods of the 1st modes versus the maximum amplitudes of velocities of the 29th floor. We used the two data sets: one for small earthquakes before the 2012 main shock, and the other for the main-shock and after-shocks. The larger the building response is, the longer the natural period becomes. In particular, the former dataset from small earthquakes shows shorter natural periods than those of the latter including the main shock. This is probably caused by relaxing non-structural elements, such as partitions and curtain walls during the main-shock.

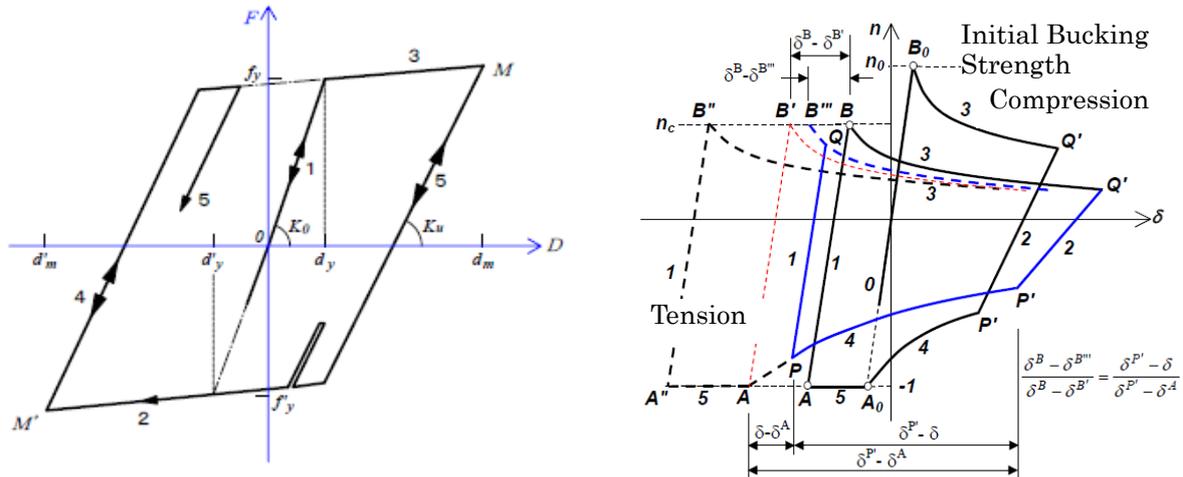
We simulate numerically the seismic response of the Kogakuin building, using a 3D non-linear moment frame model. Since the stiffness of columns is much larger than that of beams and braces, we assumed that plasticity occurred in beams and braces, but not columns. **Figure 9** shows the non-linear hysteretic models for the beams and the braces. In addition, we assumed the rigidness of the floors and the panel zones between column and beam. We also assumed the fixed columns by neglecting the soil-structure interaction. We use the Rayleigh-type damping factors of 1 % for the 1st and 2nd modes, which values were estimated from the forced vibration experiments. The natural periods of the simulation model are about 2.8 s and 0.9 s for the 1st and 2nd modes, respectively, which are slightly shorter than those during the main shock.

Figure 9. Non-linear hysteretic models for beams and braces of the 3D structural model of Kogakuin University

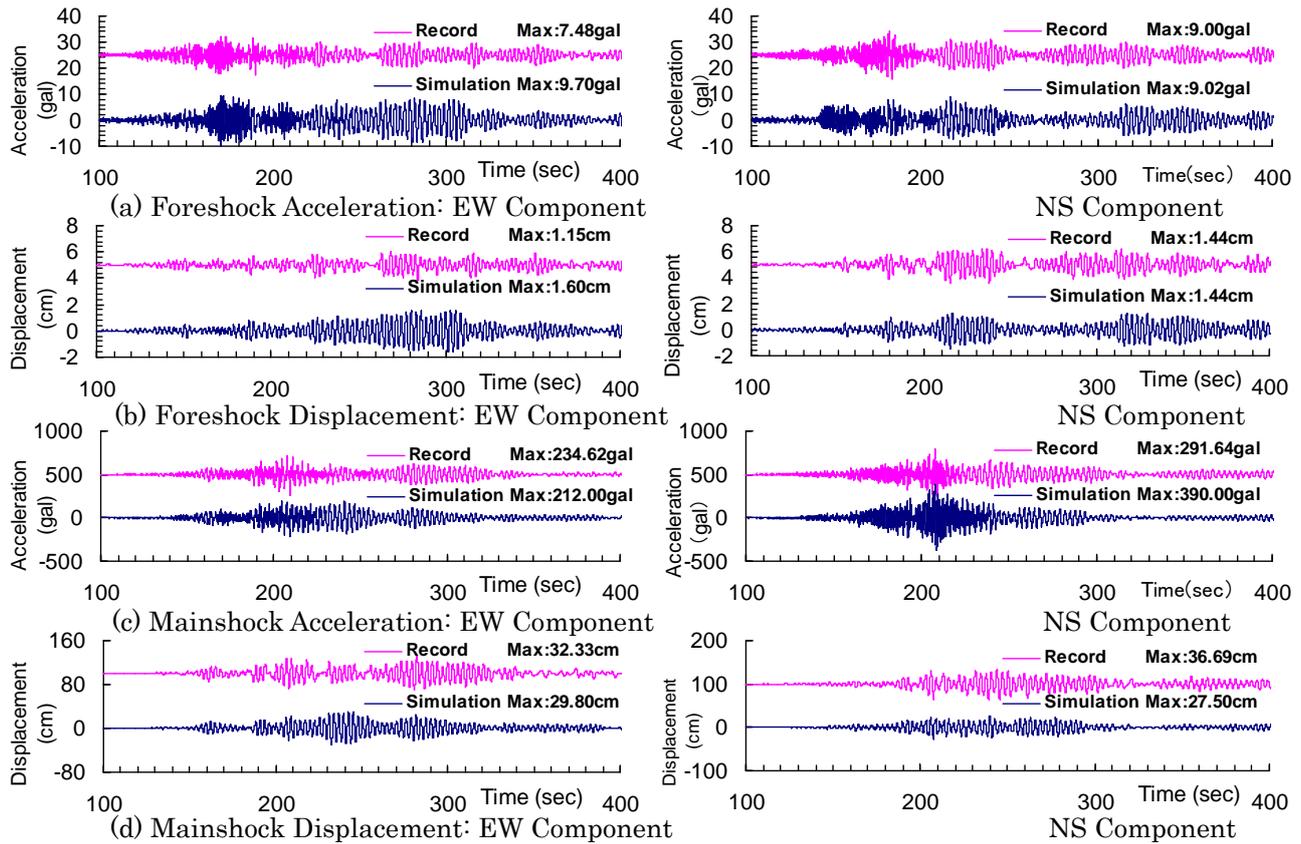
Figure 10 shows the comparisons between the recorded and simulated waves (accelerations and displacements), for the foreshock (2011/3/9 Sanriku-Oki EQ, M7.3) and the main shock. Since the natural periods of the simulation model are close to those of the building during the foreshock, the results by the foreshock show good agreements with the observations. On the other hand, the simulated results for the main shock show larger accelerations and smaller displacements than those of the observations, because of the discrepancy of the natural periods between the simulation and the observations.

Figure 10. Observed and simulated accelerations and displacements of the 29th floor for the fore- and main-shocks

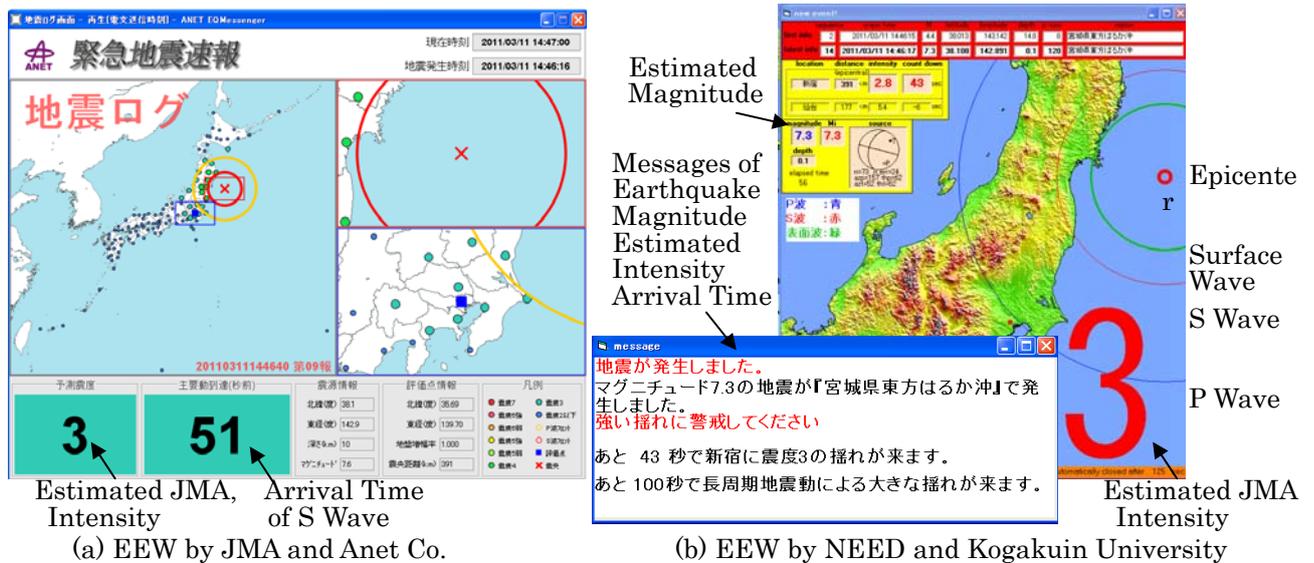
We report emergency response systems, initial response of people, and damage of high-rise buildings in the Shinjuku station area. As the case of Kogakuin University, **Figure 11** shows screenshots of the two EEW (Earthquake Early Warning) systems after the 2011 Tohoku earthquake, whose data are

provided by NIED (National Research Institute for Earth Science and Disaster Prevention) and JMA (Japan Meteorological Agency through Anet Co.). Since the initially estimated magnitude was small (7.6 and 7.3 by JMA and NIED, respectively), and the epicentral distance was large (about 390 km), the estimated JMA intensity was 3 (the actual intensity was 5). Therefore, the automated warning message was not issued. Even this limitation of accuracy, we believe that the systems are useful for initial response, especially for the long-period ground motion from far and large earthquakes. **Figure 11(b)** shows 100 s of the arrival time for the long-period ground motion (surface waves: Kubo et al., 2011), which is enough time for initial response, such as the emergency stop of elevators and issuing warning announcements

Figure 11. EEW (Earthquake Early Warning System) after the 2012 East Japan earthquake at Kogakuin University

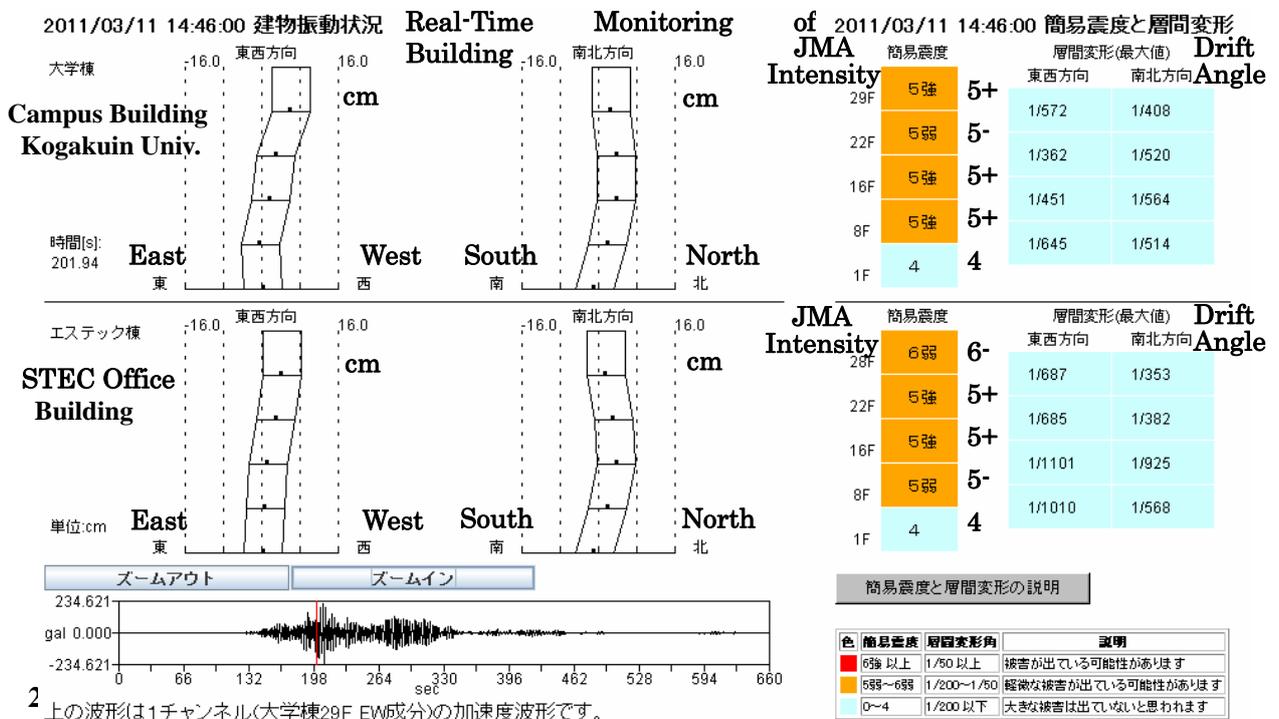
Figure 12. RMS (Real-Time Strong Motion Monitoring System) after the 2012 East Japan earthquake at Kogakuin University

Figure 12 shows the screenshot of the RMS (Real-Time Strong Motion Monitoring System) of Kogakuin University, which shows the real-time information of the building response: the arrays of estimated JMA intensities, and drift angles (Kubo, 2011). Using this system, the emergency control center quickly knew that the building was structurally safe, and made prompt announcements to stay at safe places.

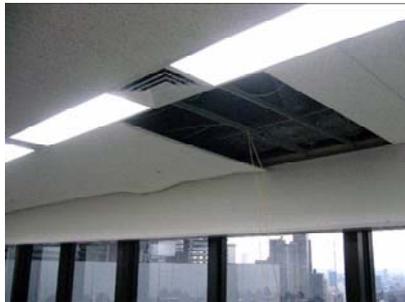
Even though there was no severe damage in the university building, several non-structural elements and equipments suffered damage, as shown in **Figures 13**: fall and deformation of ceiling panels and plaster boards, deforming of partition walls, fall of unsettled objects, and so on. In addition, an emergency elevator stopped the service for about three weeks, because the main cables were twisted, and it was difficult to obtain the replacement parts.

(a) 28F (Fall of Ceiling Panels)

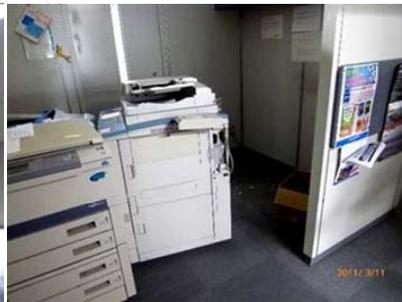
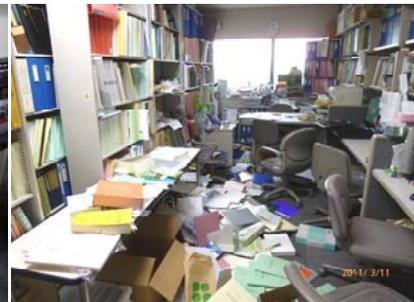
(b) and (c) 25F (Movement of Copy Machine, and Fall of objects)

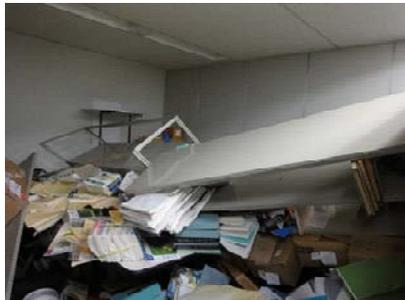
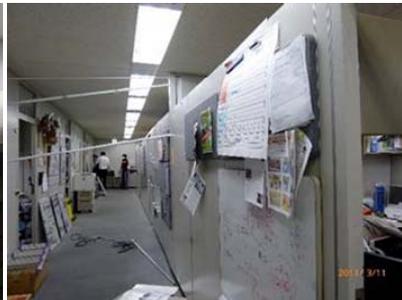
(d) and (e) 24F(Fall of Bookshelves, and Deformation of Partition Wall)

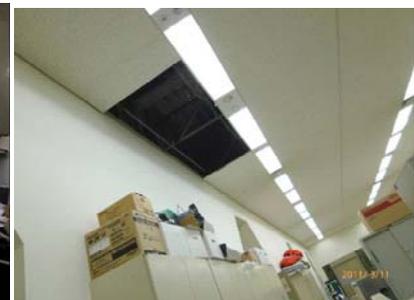
(f) 21F (Fall of Ceiling Panels)

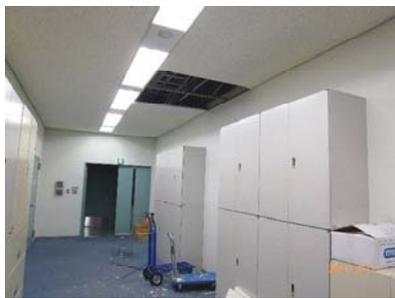
(g) 14F (Fall of Ceiling Panels)

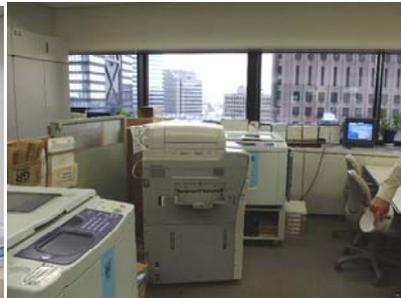
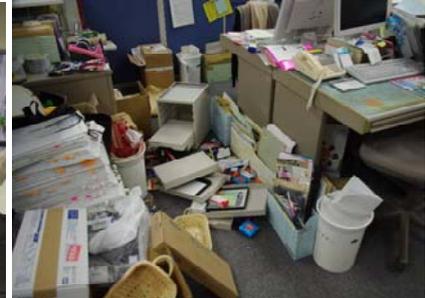
(h) and (k) 12F (Movement of Copy Machine, and Fall of Objects)

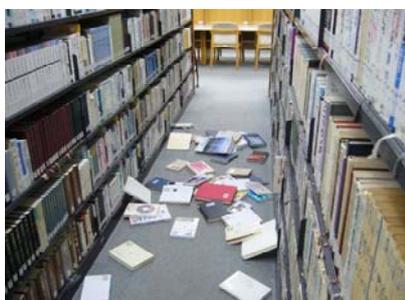
(l) 2F (Library: Fall of Books)

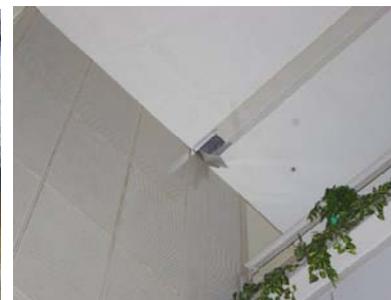
(m) 1F (Hall: Loosen EJ Cover)

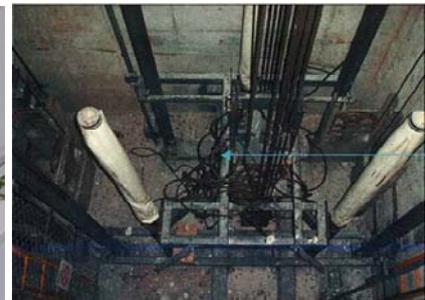
(n) Tangled Elevator Cable
(not Kogakuin buildings)
