Soil-structure interaction effects on the excitation and response of a low-rise RC building subjected to near- and far-fault earthquakes

J.Th. Snæbjörnsson & F.G. Sigtryggsdóttir

SUMMARY:

Earthquake induced acceleration data has been systematically collected in the Town Hall of Selfoss, Iceland, over a ten year period. The objective is to analyse and compare the seismic behaviour of the Town Hall during two large earthquake events that occurred in the vicinity of the building on June 21, 2000 and May 29, 2008, with magnitude of 6.5 and 6.3 respectively. The ground underneath the building is expected to consist of at least three different soil and rock layers. The behaviour of these different layers needs to be understood in order to be able to explain the different response characteristics observed from the two earthquakes. The material properties of the soil layers will change in terms of shear strength and damping as a function of the intensity of the excitation. However, for exploratory purposes the soil/rock layers were modelled with a linear model for each event. The procedure provides an indication of how the soil-structure interaction affects the earthquake response chara

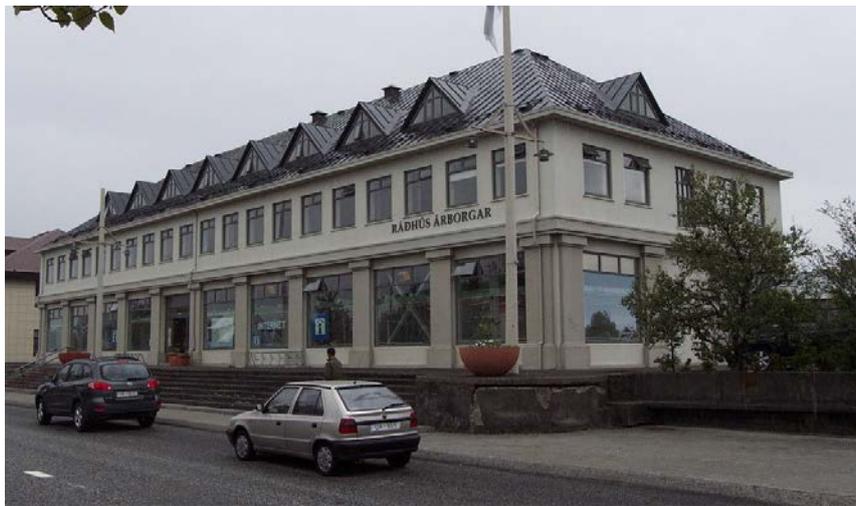
Figure 1.1 The Town Hall at Selfoss, view from Northeast.

The Town Hall at Selfoss (see Fig. 1.1) is a cast-in-place reinforced concrete building with 3 stories and a basement. It is about 11 m high from ground level to the rooftop, and about the same distance from the basement floor to the top floor, with the basement reaching 4 meters below ground level. It is rectangular in plan, about 41 m long (east- west direction) and 13 meters wide (north-south direction). The structural system is composed of outer shear walls and a shear core around the stairway and elevator shaft. In addition there are two rows of interior concrete columns and interconnecting floor beams that carry the slabs (see Fig. 1.3). The orientation of the building is such that the length of the building approximately aligned along an ESE-WNW axis. As the building was built in wartime conditions structural drawings are only partially available and do not indicate exactly the location or the amount of reinforcement. The building was retrofitted and renovated during the period 1997 to 2001. The EQ retrofitting included additional concrete shear wall units strategically placed to improve the structural behaviour and enhance and improve the balance of the overall resistance of the building.

Two steel cross-braces were also inserted into the window frames at ground level on the north side. The layout of these additional structural elements is partly shown in Fig. 1.1 and 1.3. Fortunately this work was finished before the occurrence of the large earthquakes in 2000. After the earthquakes in June 2000, the top level was renovated. A 2.5 cm concrete levelling layer was removed and a 5 cm layer of reinforced concrete was added to strengthen the floor. Then the top floor was partitioned with double gips walls. This work has added significant mass to the top floor in addition to providing an increased diaphragm stiffness of the floor. Therefore, in many ways the available database for this building is composed of subsets for at least 3 somewhat different structural conditions depending on observation period.

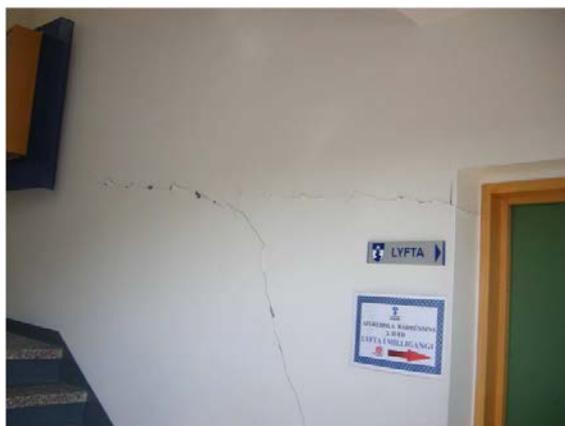
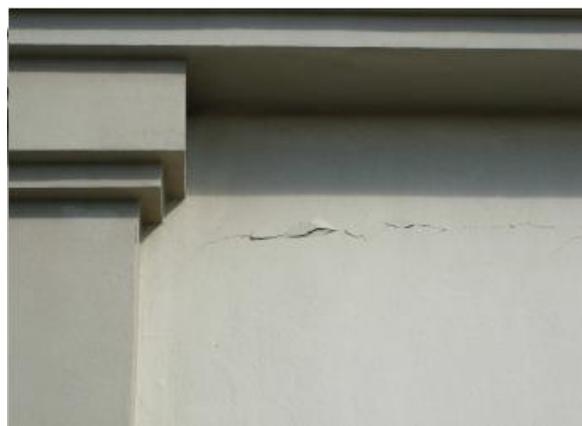
Figure 1.2. a) Observed cracks in the building walls after the earthquake on May 29th in 2008: (a) In the stairwell wall; (b) in the outside wall.

During the earthquake in 2008 the Town Hall suffered some minor structural damage and cracks could be observed in the concrete walls. Two examples of these cracks are shown in Fig. 1.2. In Fig. 1.2a one can see the crack has propagated through the wall along the stairwell. Fig. 1.2b shows a crack in the outside wall.
