In situ tests for the assessment of seismic strengthening historic brick masonry walls with carbon fiber fabric

M. Lutman, U. Bohinc, M. Gams and M. Tomažević

Slovenian National Building and Civil Engineering Institute, Ljubljana, Slovenia

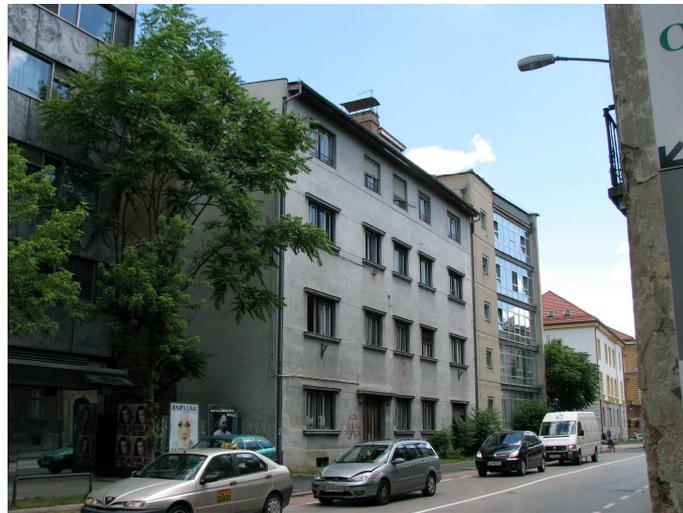
Figure 1. Typical multistorey residential building from the period between WWI and WWII in Ljubljana, where the in-situ tests were carried out

While the foundations and basement walls were constructed out of concrete, all other walls were built of solid bricks of normal size. The brick walls had been constructed with a lime mortar with a small amount of cement. There were reinforced-concrete slabs above the cellar and timber floors above ground floor and upper floors, respectively. Timber joists were laid in the transverse direction of the building and mostly loaded longitudinal load-bearing walls. These were arranged in two lines of the road façade and courtyard façade, and one inner line. Since they were loaded with floor structures, the longitudinal walls were thicker than the transverse ones. While the internal longitudinal walls were 51 cm thick in all floors, the outer longitudinal walls were 51 cm thick in the ground floor and 38 cm in the upper floors. The main transverse walls were 38 and 25 cm thick. Transverse partition walls, which were also built of solid bricks, were 12 cm thick. Typical view to the road façade and typical floor plan are given in Figs. 1 and 2, respectively.

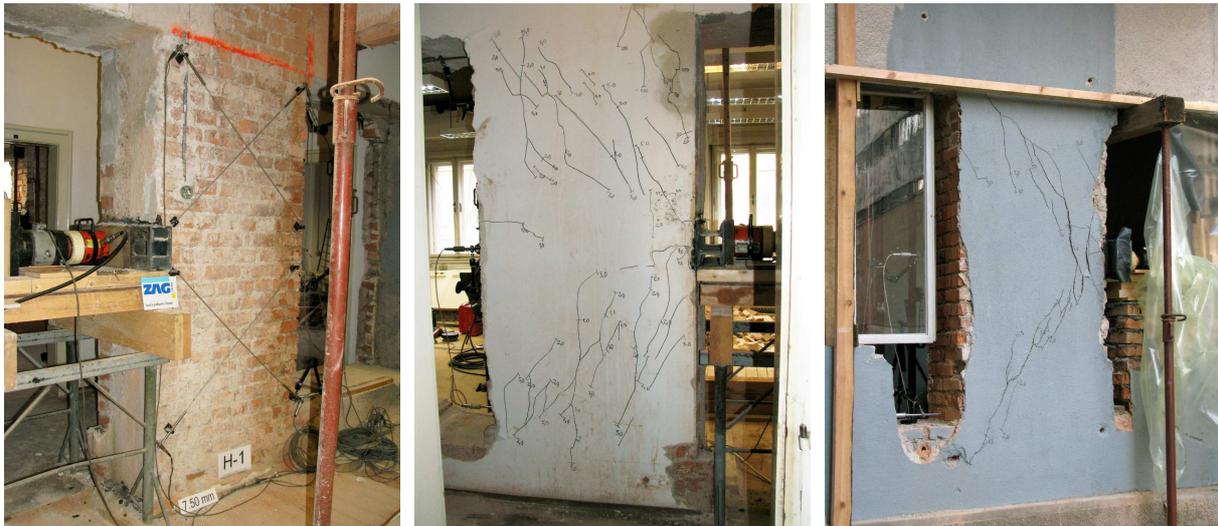
Figure 6. Arrangement of hydraulic jack and instrumentation of specimen H1 (left) and typical crack pattern at maximum resistance on the rear surface of specimen H1 (middle) and specimen H2 (right)

Typical views and crack patterns of specimens H1 and H2 at maximum resistance are shown in Fig. 6, while the relationships between lateral load and displacement, obtained by testing are shown in Fig. 7. Due to some uncertainties in the measurements of lateral displacement in the initial stages, the lateral displacement was evaluated from the measured values of diagonal strains. However, the amplitudes of the derived lateral displacement are of the same scale as the measured ones.

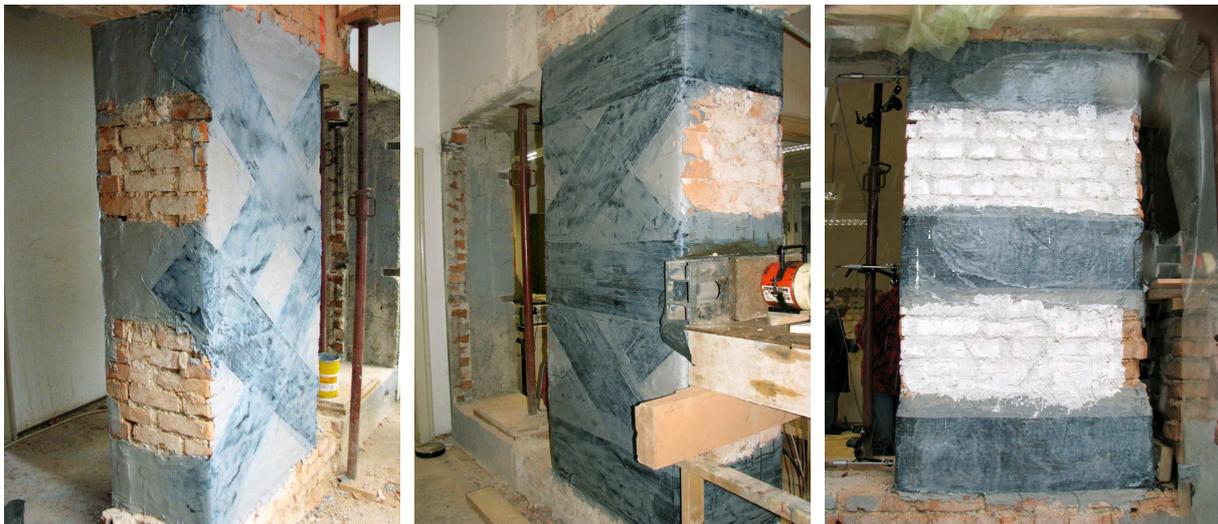
Figure 8. The application of carbon fiber fabric in epoxy resin: specimen H1w after placing the inclined strips on one side (left), complete specimen H1w with inclined strips and horizontal strips, equally on both sides (middle) and the outer side of specimen H2w only with horizontal strips (right)

In the case of specimen H1w, inclined strips were placed first, separately to both sides of the wall. These strips were applied in diagonal direction between the level of the applied load and the corners of the specimen, forming a cross-like pattern in the upper and bottom halves of the specimen (Fig. 8 left).

Additionally, horizontal strips of the fabric were applied at the top, middle and bottom of the specimen, which fully wrapped the wall. Strengthened wall H1w is shown in Fig. 8 middle.

The second specimen (H2w) was strengthened using the same materials. The inclined strips were applied only on one side of specimen, while the three horizontal strips of fabric were applied around the wall as in the case of specimen H1w. The side without inclined strips is shown in Fig. 8 right.

In order to evaluate the effectiveness of strengthening of historic brick masonry, both wall specimens, previously tested with lateral load in original condition, were strengthened and tested afterwards in-situ. They were strengthened with unidirectional woven carbon fiber fabric in epoxy resin. First, the surfaces of the wall, where the strips of fabric were intended to be applied, were levelled with thin layer mortar containing epoxy resin and fillers, without previous repair of cracks.

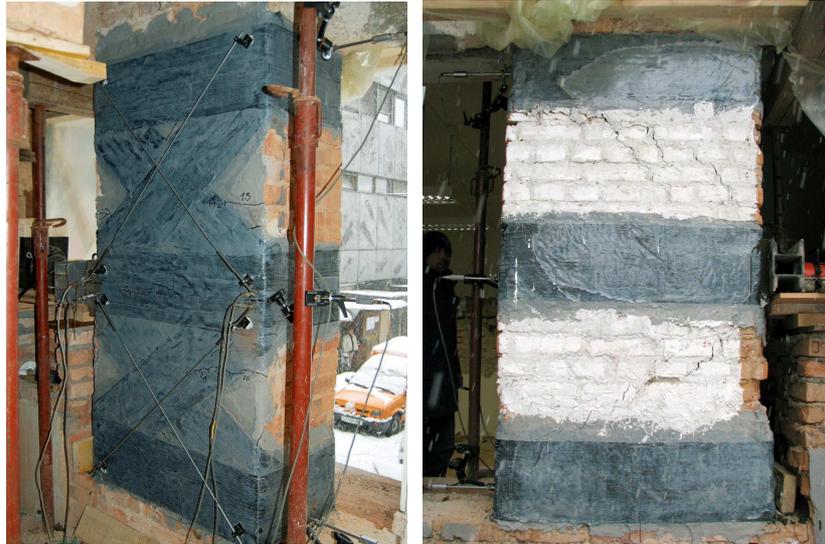
Similar crack propagation was observed on the inner surface of specimen H2w (Fig. 10 left), which was covered with diagonal strips of fabric. Horizontal cracks in the bed joints developed in those tensile areas which were not covered with the fabric. All such cracks propagated through fabric. In the compressed zones vertical cracks developed on the uncovered side surfaces above and below the point where lateral load was imposed. At the end of the test, one crack developed within one of diagonal strips along its fibers.

Different crack pattern was observed on the outer surface of specimen H2w, where only horizontal strips were applied (Fig. 10 right). It was more similar to shear mechanism, with diagonally oriented cracks, limited to the area between horizontal strips of fabric and therefore less steep in comparison with shear cracks of the original specimen.

Figure 10. Specimen H2w: distribution of cracks on the inner surface (left) and on the outer surface (right)
