REPORT
on the
LAR EARTHQUAKE OF 24th APRIL 1960

H. K. Afshar*

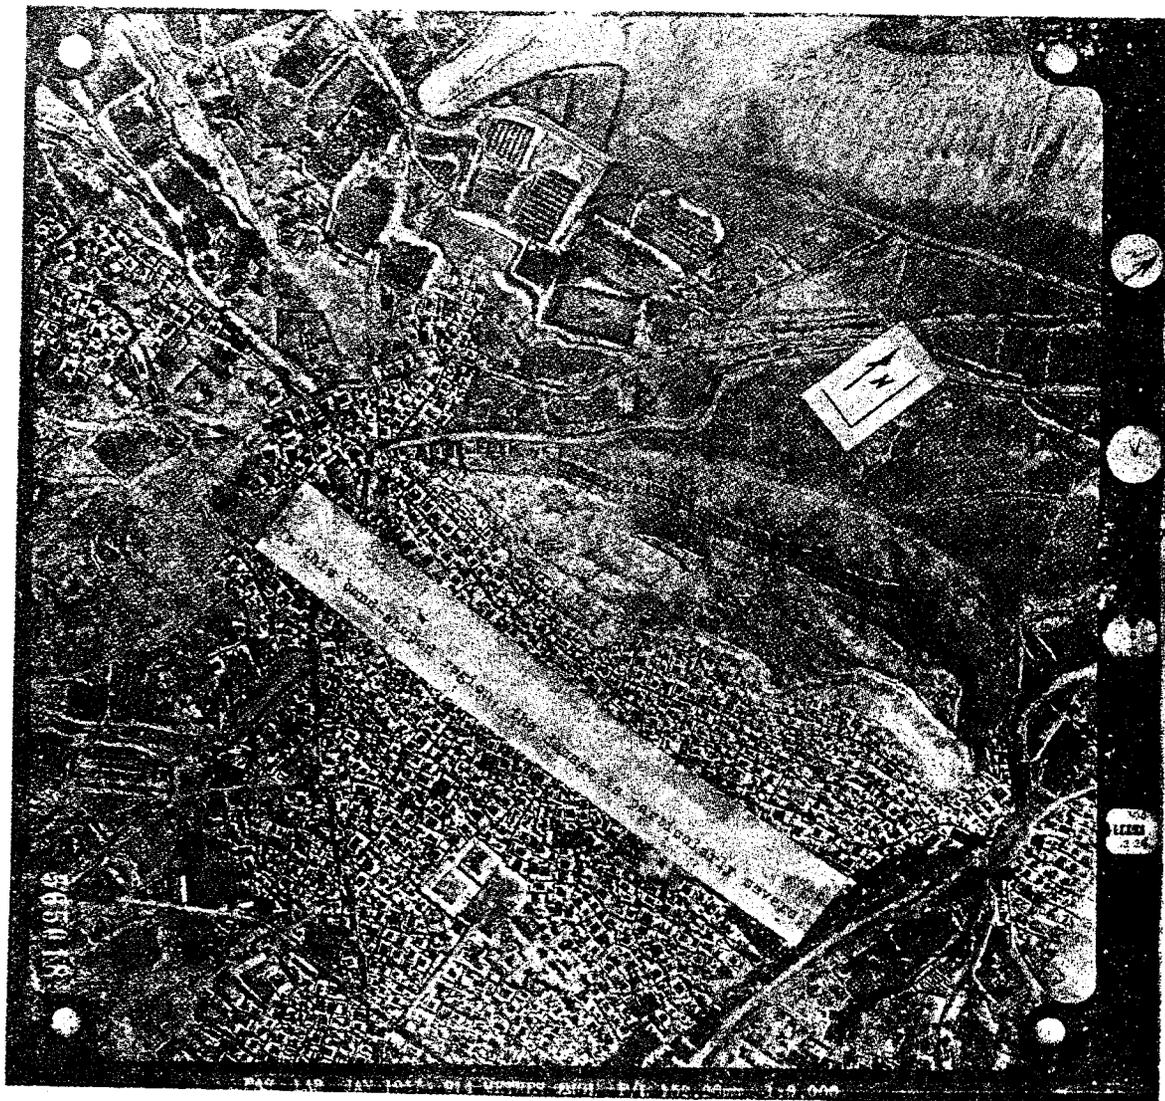
Photo. №. 1
Aerial photograph of the city of Lar before the shock.
The photograph was taken by the Iranian Air Force.

The valley extends in the east-west direction and is bordered by hilly formations in its north and south edges. The geological formation of the northern hills is oligo-miocene composed of conglomerates, calcareous, marn, argil, and gyps. The height of this part is 1020 meters from the sea level. The formation of the Lar valley is alluvium, the thickness of which is about 50 meters, and the height of this plain is 900 meters and the width is 5 kilometers. The geological formation of the southern hills is calcareous Eocene, and the height of this region is 960 meters. An aerial view is shown in the accompanying photograph No. 1.

A thorough investigation revealed the most significant point that the total destruction took place in a rather narrow region of the city, which is shown in the aerial photograph. The population density has been greatest in this region. Outside this totally collapsed region only cracks on the walls have been noticed. The foundation of the buildings in this narrow strip is on very soft alluvium formations, while the houses and buildings on the rocky mountain side have only suffered small cracks. None of the villages outside the city of Lar exhibit signs of damage.

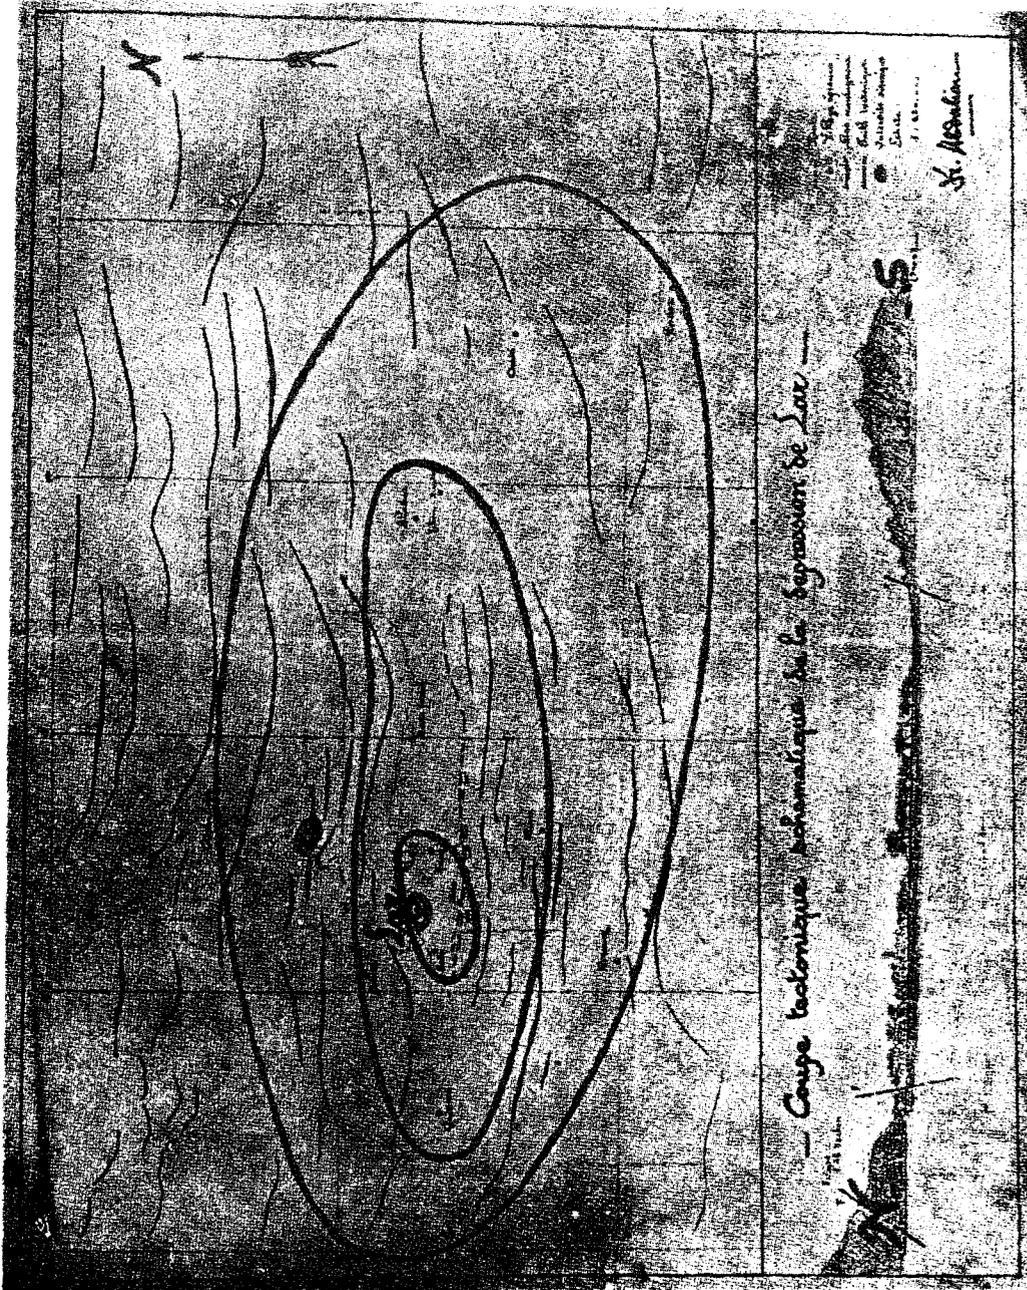
Fig. 1
Isoseismal lines of the Lar Earthquake of 24th, April 1960, and the geological cross-section of
the Lar Valley.

The distribution of seismic intensities is shown in Fig. 1. The intensity scale of Mercalli has been employed.

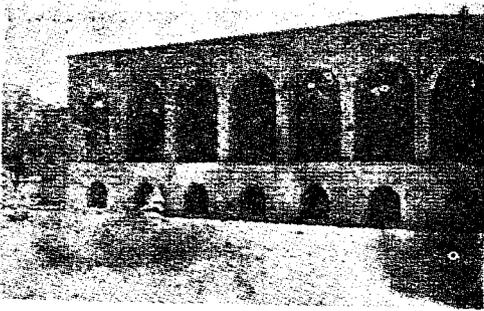
Example of the buildings which were properly constructed and have survived the shock.

The third type is the building with properly furnace baked bricks. The buildings of this type are most resisting and have shown the least damage.

Metallic beams are used for the third type and are arched by bricks in between the beams. It has been this third type of building with proper foundation that has survived the severe shocks.

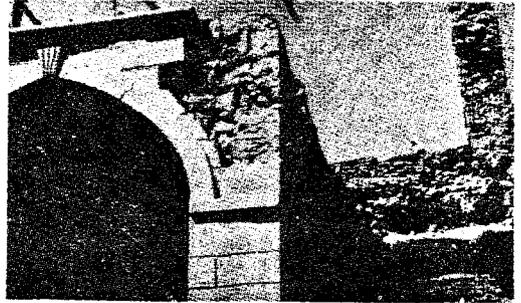
Example of the buildings which were properly constructed but damaged.

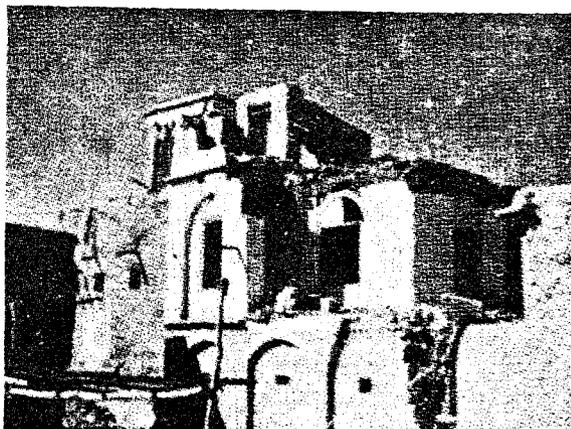
Example of the buildings which were poorly constructed and severely damaged.

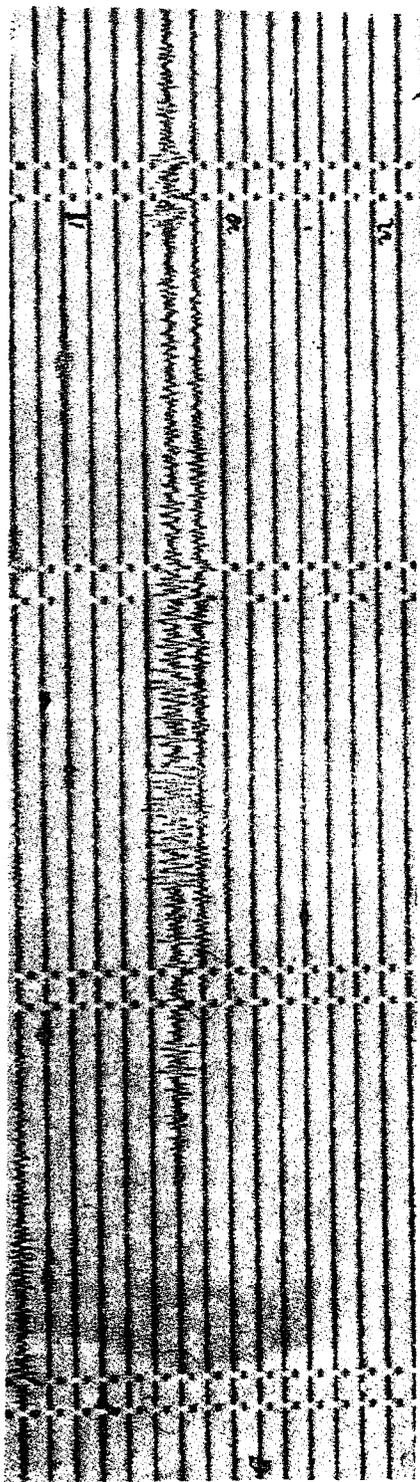
Example of Aftershocks registered at Shiraz Station.

Δ is about 280 km. Seismometer: Electromagnetic type.

T_0 and T_g : 1.1 sec and 0.45 respectively

Maximum magnification: 94,000. Size reduction to original size: 1:1

Component: N-S. Magnitude of the first shock in this seismogram: 4.0

Magnitude of the second shock: 3.7

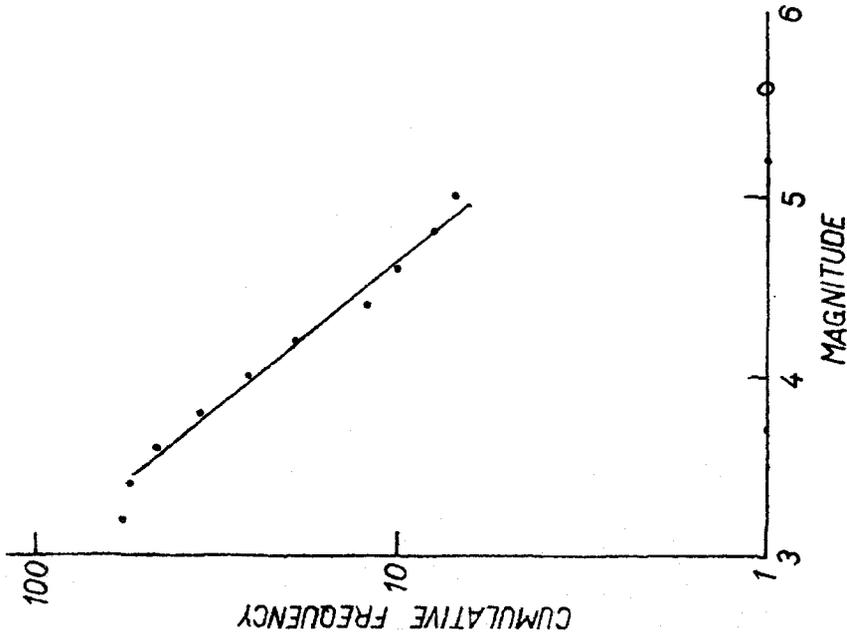
Fig. 2
Cumulative frequency of aftershocks with respect to magnitude. Material used covers only till 18th of May. White circle shows the magnitude of the main shock.

The cumulative frequency of aftershocks against magnitude is shown in Fig. 2 and the summation curve of the number of aftershocks is shown in Fig. 3. Both figures have been drawn from the data up to 18th of May.

The gradient of the curve in Fig. 2 is about 0.77 which seems to be quite normal, except for the fact that the aftershocks, of magnitude about 5, had a greater frequency than expected.

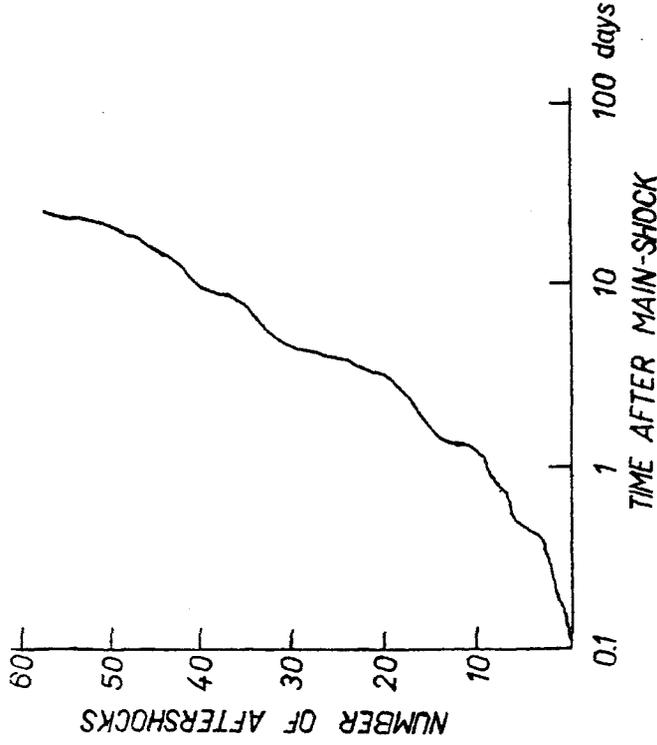
Fig. 3
Summation curve of the number of aftershocks. Material used covers only till 18th of May.

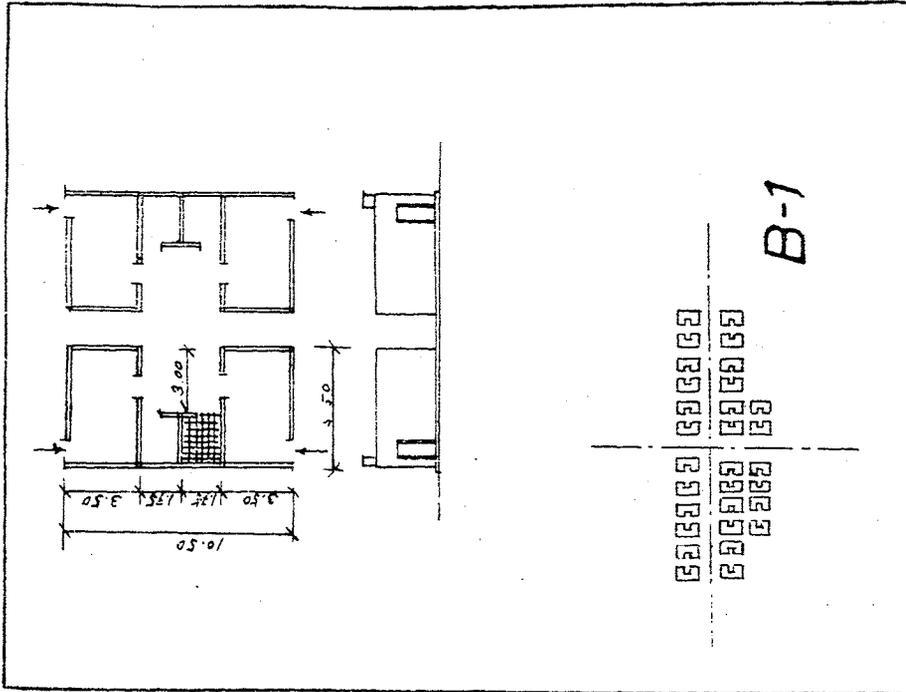
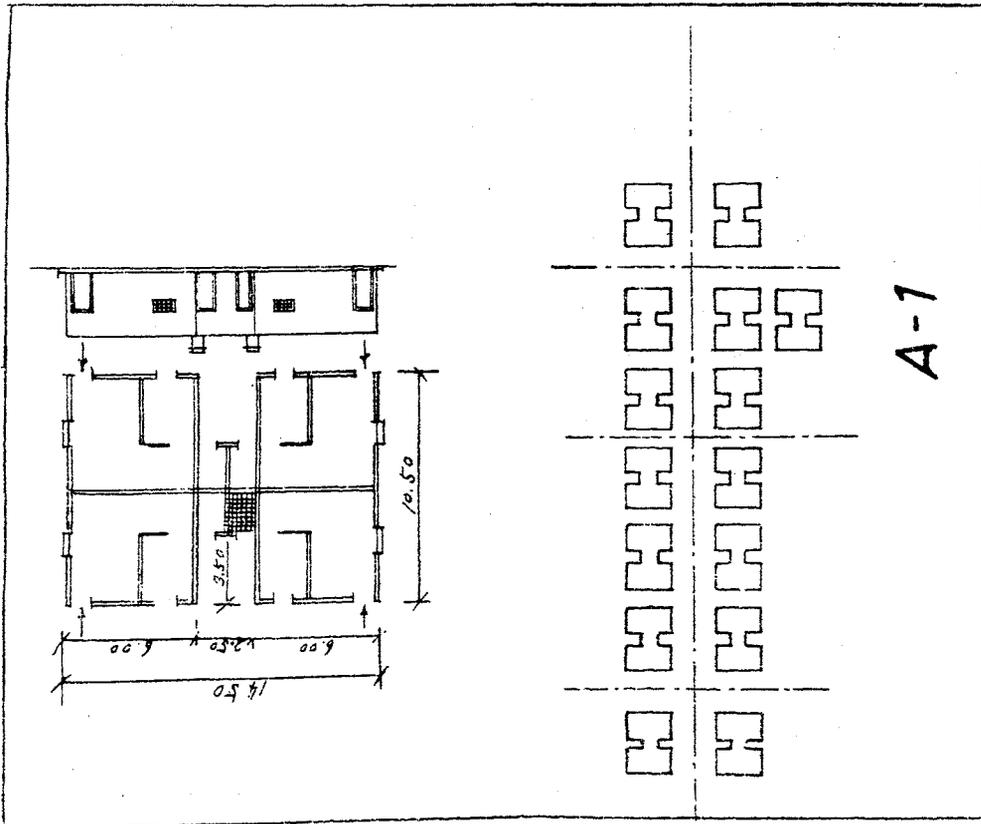
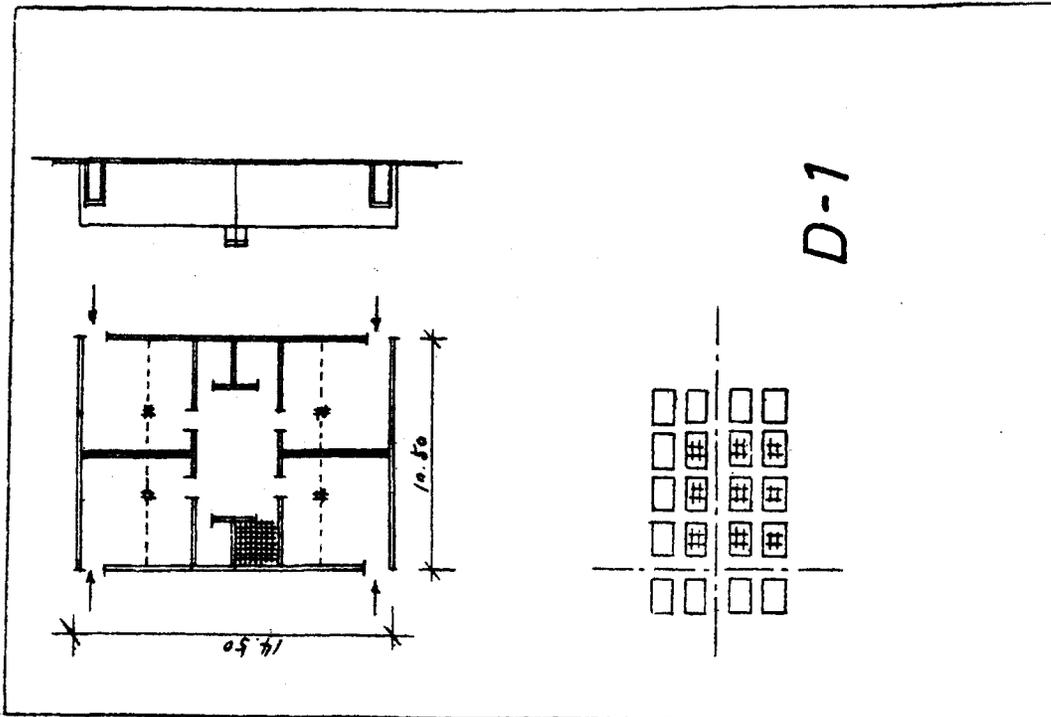
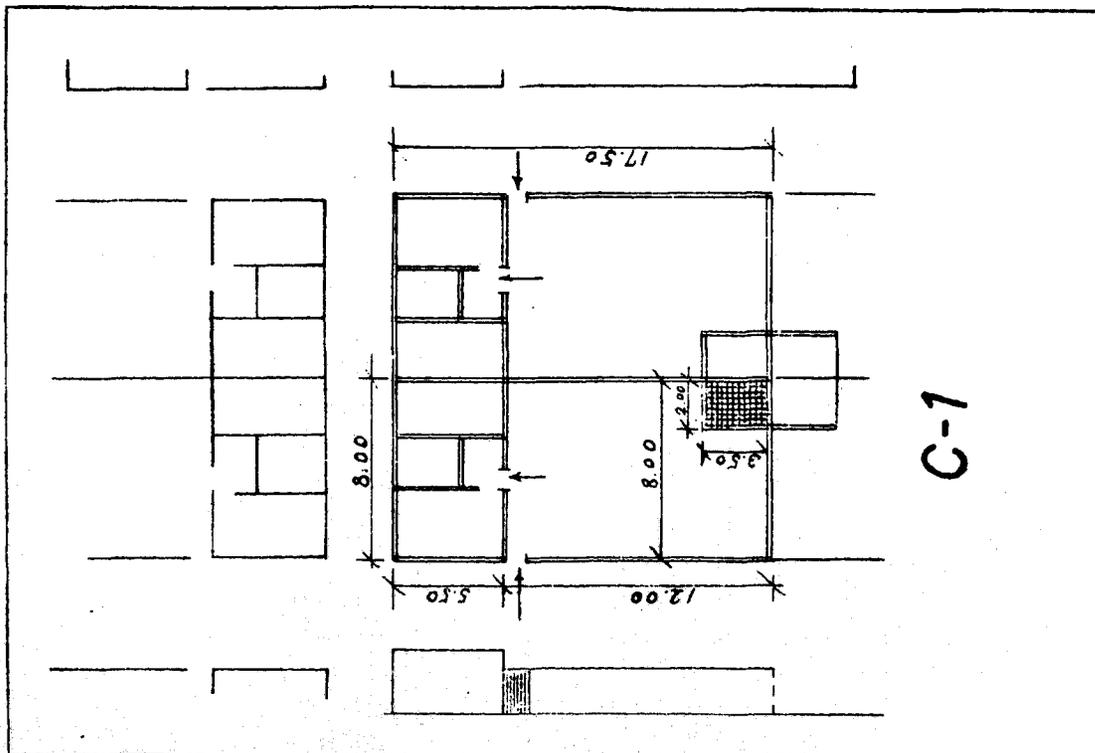
The following types of buildings as indicated by the corresponding plan and elevation drawings have been proposed for the reconstruction of the residential units of the city of Lar.

A-1. This is an open type of dwelling for medium size families of 4 persons. The construction is so designed that, if necessary, another story could be added, and they are designed for the inner ring of the

town. The surface occupied by this type of building is 34.m².

B-1. This type is designed for the minimum size families of 2 persons and could be constructed in any region of the town. The surface occupied by this type is 24.m².

C-1. This is the largest unit for families of 7 persons having an independent court yard with the possibility of an additional story.

This type is designed for the outer ring of the town and the area occupied by this type is 51.m².

D-1. This type is a closed system for medium size families of 3 persons and designed for the central region of the town. The area occupied by this unit is 34.m².

In order to provide sufficient rigidity and resistance against deformation and twist, the following points in the designs have been taken into consideration.

1- Walls are solidly jointed together and uniformly continuous.

2- The minimum height of 2.67 meters provides the optimum connecting strength between the walls and the reinforced concrete roofs.

3- The connecting walls are by necessity either in the form of T, U, or L.
