ENGINEERING ASPECTS OF EARTHQUAKES IN RUMANIA  
IN THE LIGHT OF MODERN INVESTIGATIONS

Aurel A. Beleş<sup>x)</sup> and Mihail Ifrim<sup>xx)</sup>

## II. ENGINEERING ANALYSIS OF THE EARTHQUAKE IN RUMANIA OF NOVEMBER 10, 1940

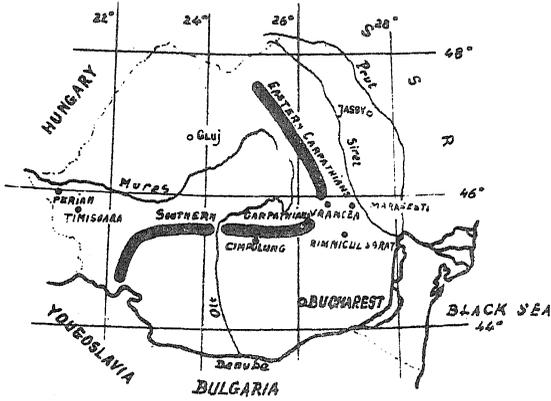
Fig. 1 Centers of seismicity

Several earthquakes centers have been identified till now, but the most important which has produced also the earthquake of November 10, 1940 is situated in the Vrancea Mountains. This center is defined by the geographic coordinates  $45.9^{\circ}$ , northern latitude and  $26.5^{\circ}$  eastern longitude, being situated at the depth of nearly 150 km (fig.1). Because of this depth, its effects are felt on a large zone.

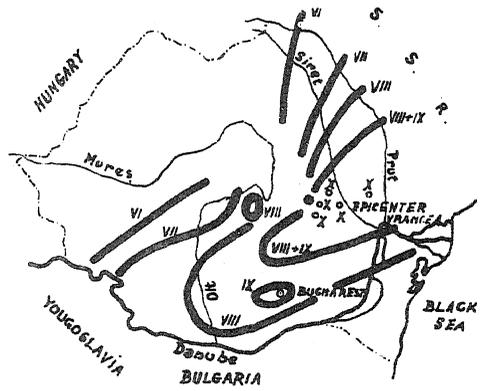
Fig. 2 Isoseismics of Rumania

The medium degree of earthquake was 8 and it affected nearly 80,000 km<sup>2</sup>. In Bucharest it was estimated at 8-9 degree, and within the epicentral region and other isolated points, at degree 10. According to Gutenberg-Richter scale, this earthquake had the magnitude 7, being of class B. The Carpathian Chain protected, in a certain measure, the Transylvanian Plateau, and the northern, north-western and south-western regions of the country (fig.2).

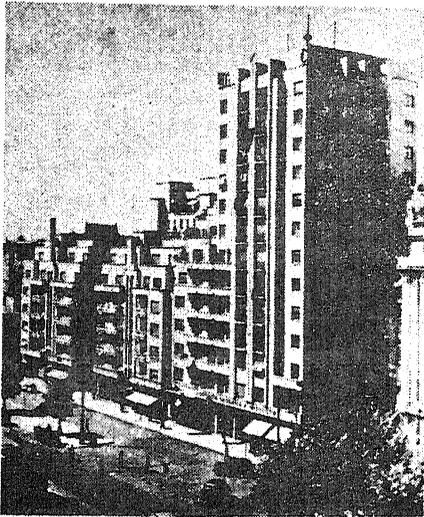
Fig. 3 Building Carlton

In connection with the complete collapse of the Carlton building, the essential cause was the conception on which the design of the reinforced concrete frame had been based. As there were shops at the ground-floor, in order to get as big shop-windows as possible, some of the columns were reduced to transversal reinforced concrete walls only 22 cm in width, but 200 m in length.

The Column having the heating element still attached can be seen in the figure (fig. 3 - 7).

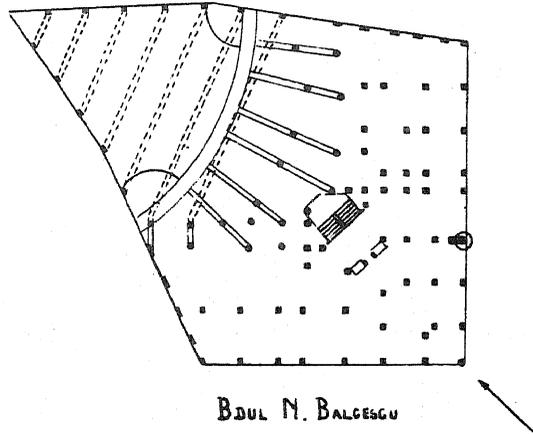
Fig. 4 Columns at the ground floor

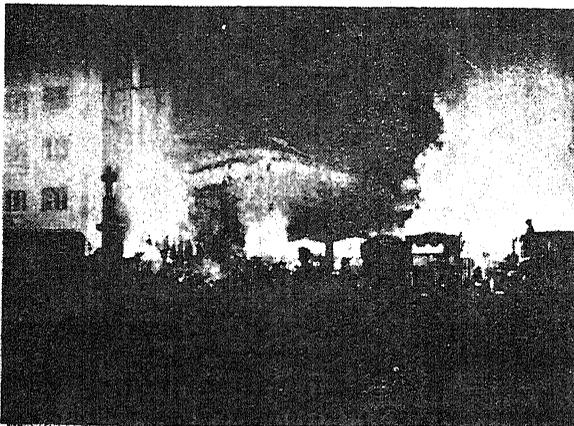
Fig. 5 Building Carlton in fire

The most important discussions which followed the earthquake of Nov. 10, 1940 were caused by the collapse of the Carlton building. The real causes of the collapse could not be established on account of the complete destruction of the reinforced concrete resistant frame followed by a big fire, but some assumptions could be made as is shown later.

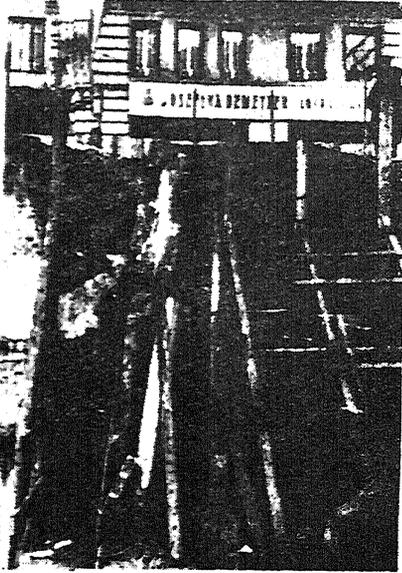
Fig. 6 Building Carlton  
The column that collapsed

After clearing away the ruins of the building in the cellar of the building, one of these concrete columns was found intact. It seems that by the earthquake shock, the column was cut at its base and on account of insufficient connection of the reinforcement the column was removed on the reinforced plate, perforated it and fell in the cellar, drawing the whole building after it.

Consequently, the failure of the Carlton building may be attributed to the shear caused by the seismic shock which produced the section of columns and afterwards the complete failure of the building. To the complete destruction also contributed the imperfect mode of transmitting the loads to the foundation due to the lack of continuity of all the columns.

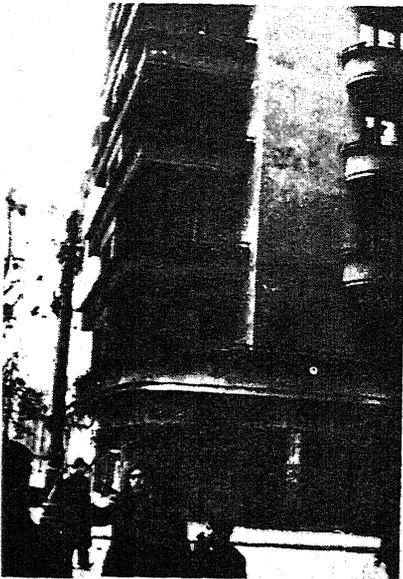
Fig. 8 Column with non corresponding bars

Generally, for structures resting on a concrete skeleton, it was stated a series of faults due to some execution defects. For instance, there were found columns whose reinforcement bars were bound in unfitted places (fig. 8, 9) other columns with too thin and too distanced ties (fig. 10, 11), some with non-corresponding structural joints, and insufficient reinforcement or with a diameter (fig. 12, 13) too small - at same columns - relative to the importance of forces they had to support. On that account, many local yields have been recorded, which caused only local ruptures without collapse.

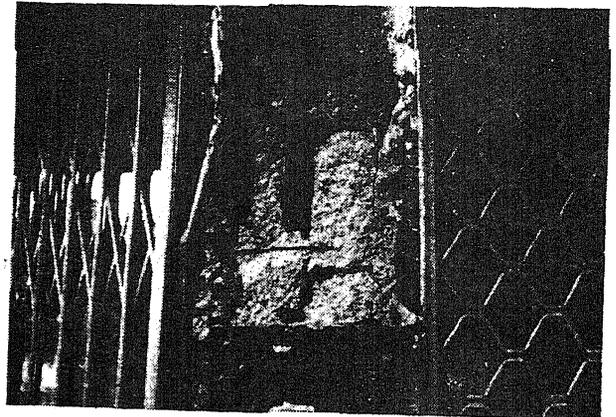
Fig. 9 Details for Fig. 8

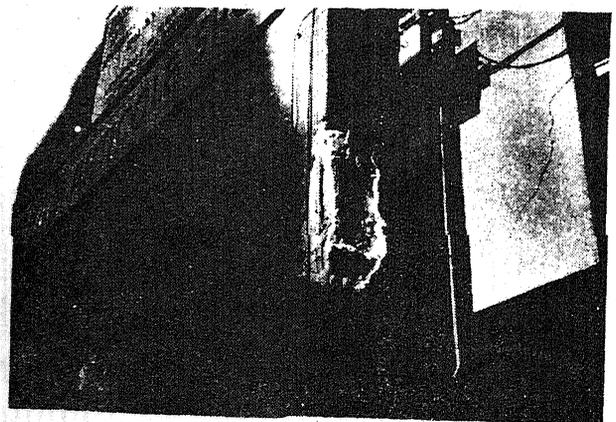
Fig. 10 Too distanced ties

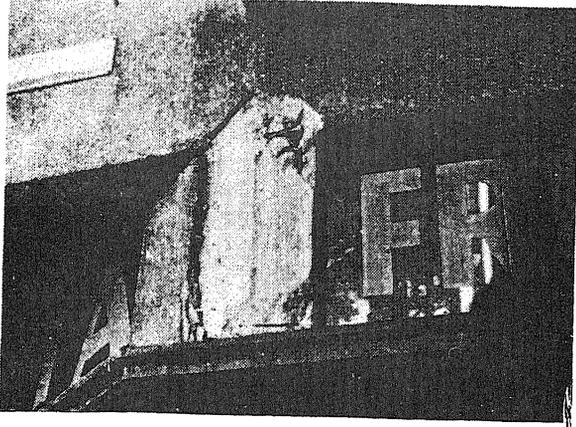
Fig. 11 Non corresponding structural joints

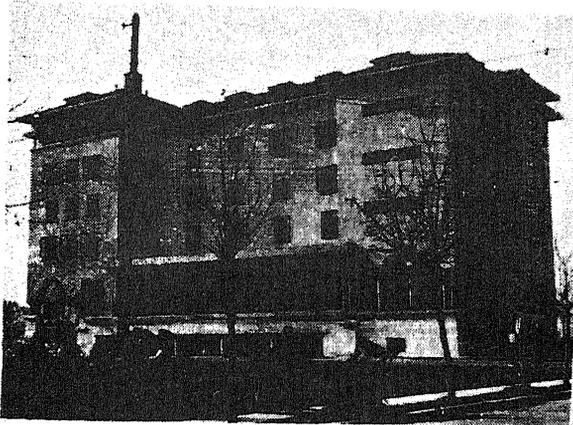
Fig. 12 Non corresponding columns

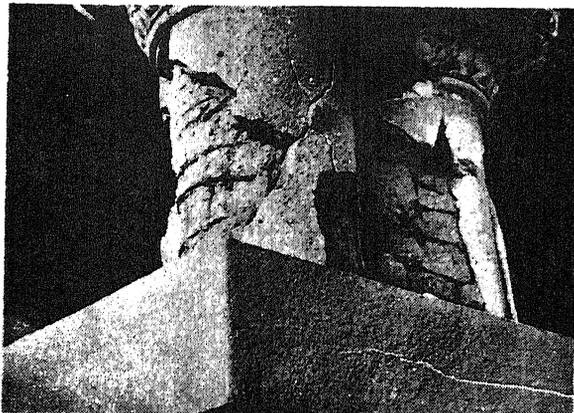
Fig. 13 Details of columns Fig. 12

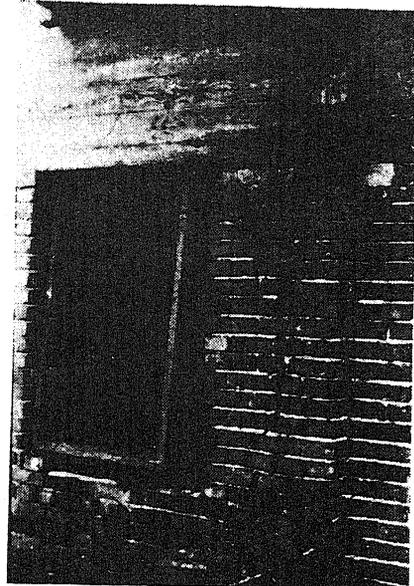
Fig. 14 Non corresponding masonry

In case of structures consisting of load-bearing masonry, important faults were recorded in those constructions where the mortar was insufficiently hardened or where the vertical brick joints were not filled. These were the causes that a series of modern buildings although tied with concrete floors showed strong degradations of the masonry (fig. 14, 15). The presence of wooden floors producing by the supports of the beams a discontinuity in the masonry,

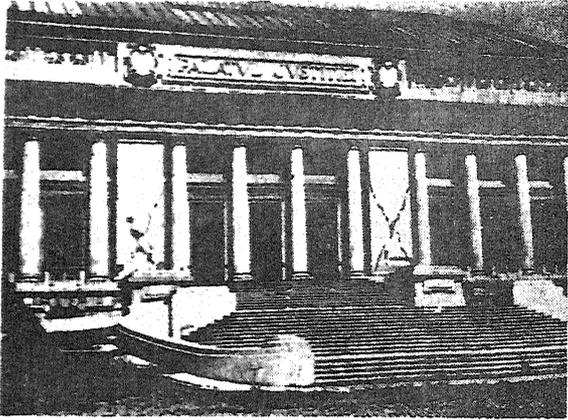
Fig. 16 X-shaped ruptures

caused the rupture of walls, In general, the apparition of the classical X-shaped ruptures as a consequence of strong shear forces was noticed (fig. 16 - 19).

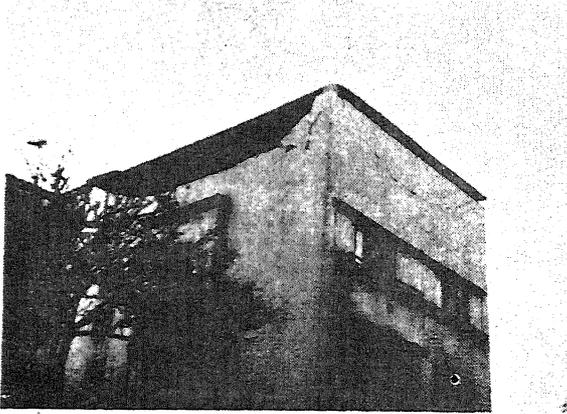
Fig. 17 Non corresponding walls  
Lack of ties

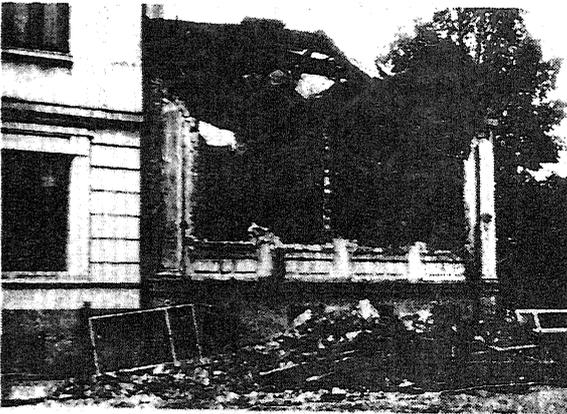
Fig. 18 Non corresponding gable

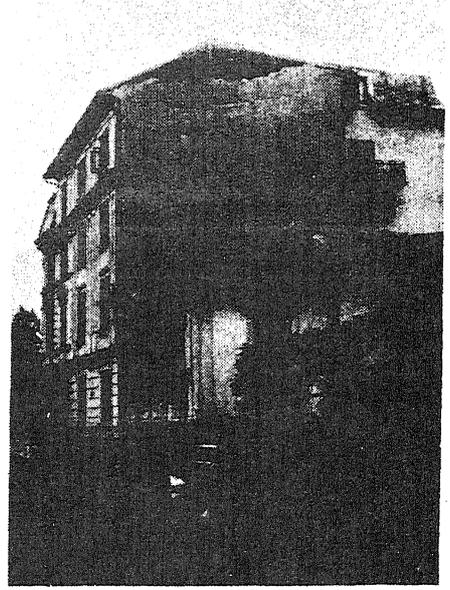
Fig. 19 Effects of gable Fig. 18

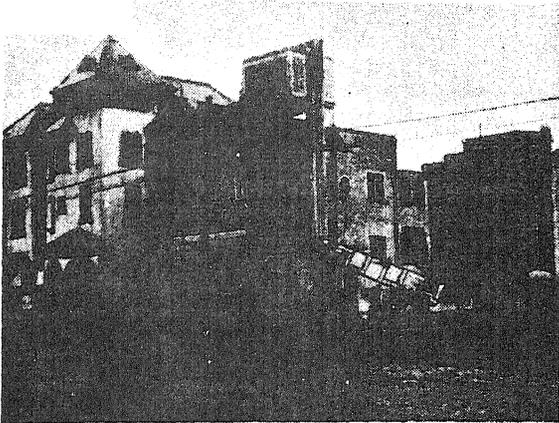
Fig. 20 Torsional effect

Another cause which brought destruction in many structure was the torsional effect. This was due to the difference between the center of rigidity and the center of mass (fig. 20). This produced the rupture of the small columns which were supporting the vault covering the amphitheater of the University in Bucharest. It is interesting to note that the rupture was stronger on the orthogonal directions of principal shear stresses (fig. 20 - 22).

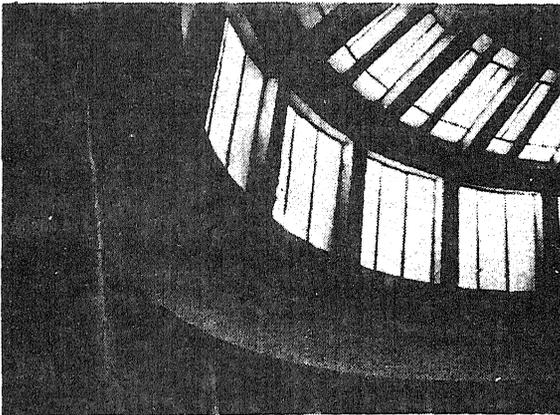
Fig. 21 University of Bucharest  
Rupture of the cupota columns

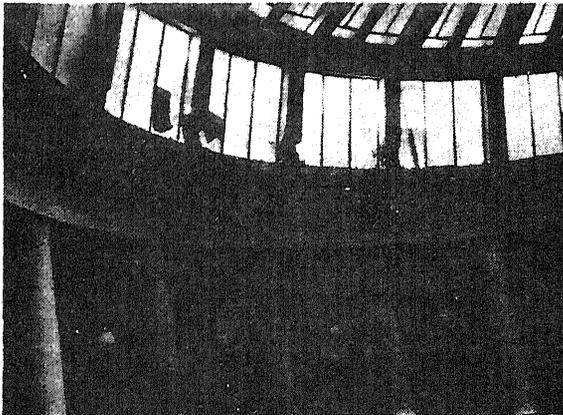
Fig. 22 University of Bucharest  
Details of the columns of  
the cupota
