PRESTRESSED CONCRETE EARTHQUAKE RESISTANT STRUCTURES -
DEVELOPMENT, PERFORMANCE AND CURRENT RESEARCH

by W. Morley Sutherland*

Presented on behalf of the N.Z. Prestressed Concrete Institute
Introduction

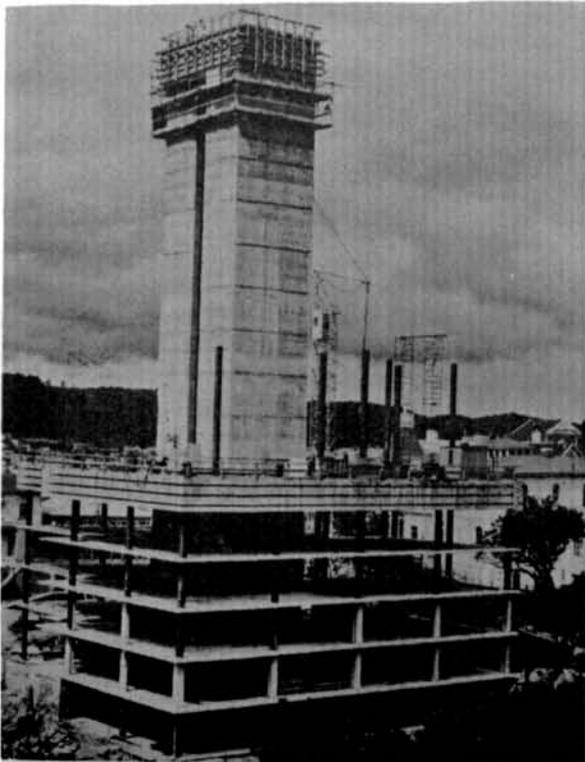
FIGURE No. 3 - HERBERT GARDENS, WELLINGTON

The "Herbert Gardens" building is a 14 storey structure of equivalent height of 132 feet from foundation to top floor slab. The floors are prestressed flat slabs disposed to be dynamically balanced about the main seismic resisting component, a prestressed concrete central core structure.

Seismic design loads at working stresses are base shear 15%g. applied as a triangular distribution and reduced to 40 per cent for overturning moments. The fundamental period of the structure was estimated to be in the vicinity of $1\frac{1}{2}$ seconds in the east-west direction and 1-1/8 seconds in the north-south direction. Prestressing the core was chosen to resist the uplift forces due to seismic action in the east-west direction. Design of core was checked for ultimate at factor of 1.5 and for first crack at 1.2. Design of slabs and slab to column connections were checked at working stresses for bending at a factor of 2.5 times working seismic loads. Torsion was calculated in the usual manner using the calculated lever arm increased by 1/20 the longest dimension of the building.

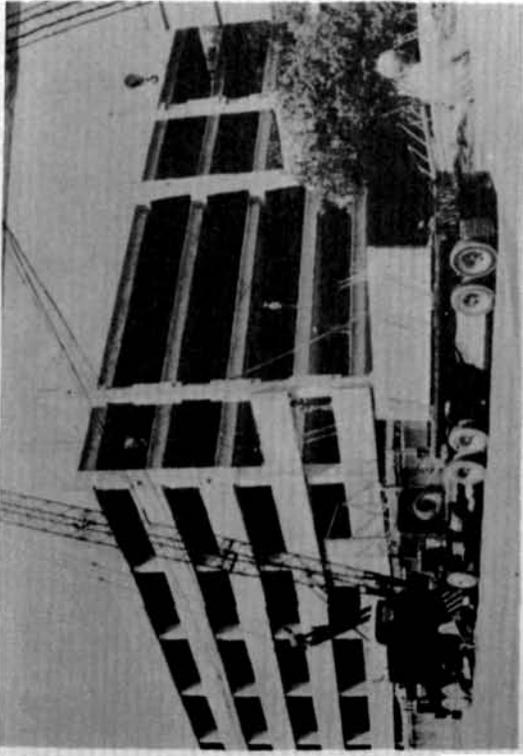
FIGURE No.9 - KAISER FOUNDATION HOSPITAL PARKING STRUCTURE,
CITY OF LOS ANGELES

Figure No.9 - Kaiser Foundation Hospital Parking Structure, City of Los Angeles
6 storey garage with over 200,000 square feet of precast, pretensioned double tees, girders and columns, designed for two additional future storeys.

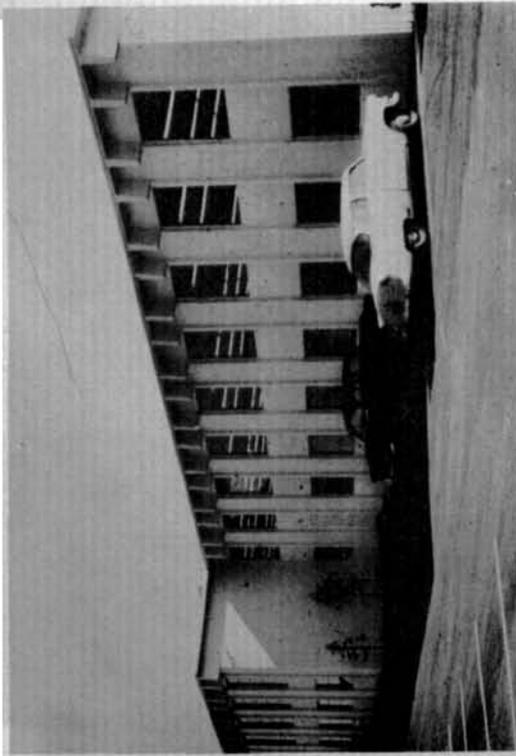
FIGURE No. 13 - COLLINS ELECTRONICS PLANT, LONG BEACH

Figure No.13 - Collins Electronics Plant, Long Beach
Precast walls, pretensioned 119 feet clear span, 8 feet wide double tees.

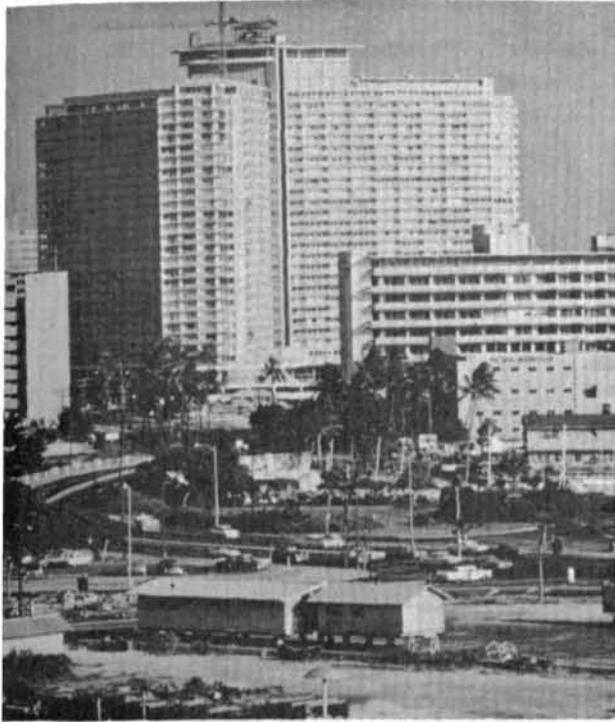
FIGURE No. 18 - ILIHAL HOTEL

Figure No.18 - Ilikai Hotel

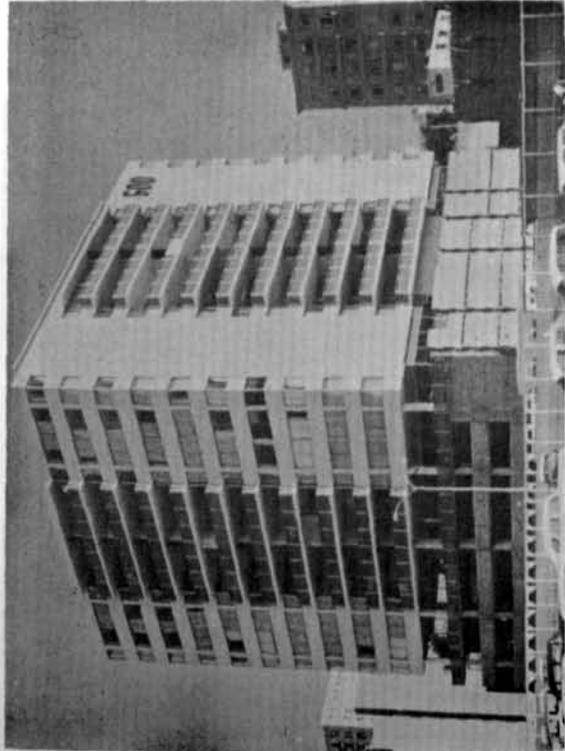
FIGURE No. 17 - 600 EAST OCEAN APARTMENTS, LONG BEACH

Figure No.17 - 600 East Ocean Apartments, Long Beach
15 storey, cast-in-place, post-tensioned flat slabs. Post-tensioned core walls for earthquake forces.

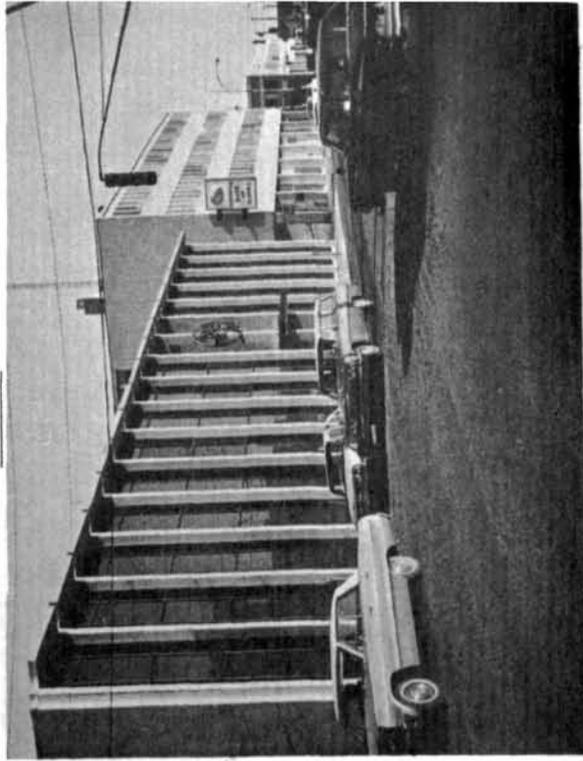
FIGURE No. 25 - NATIONAL BANK OF ALASKA

Of these, 13 suffered no damage other than very minor cracking of blockwork. Examples of these undamaged prestressed concrete buildings are the National Public Safety Building (Figure No.23) and the National Bank of Alaska (Figure No.24). Both these buildings utilised prestressed concrete tees and columns as frames.

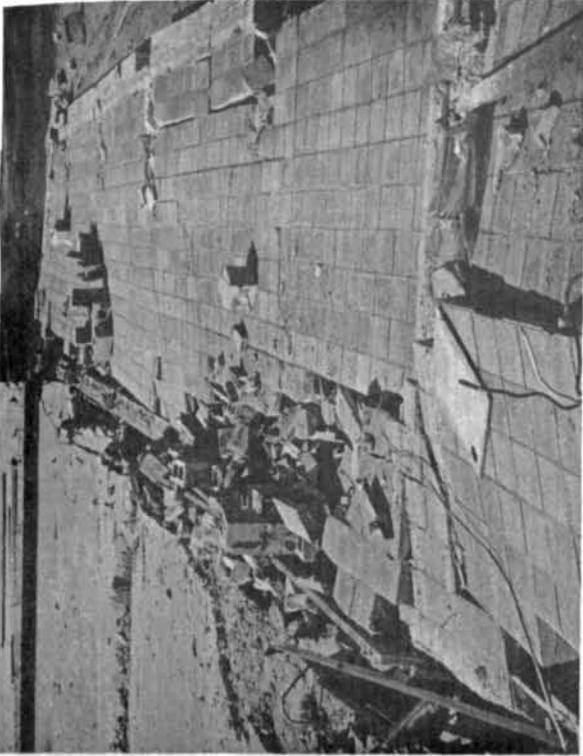
FIGURE No. 25 - FAILURE OF SUPPORTING STRUCTURES

However, there were a number of buildings which failed and which incorporated prestressed concrete. Apart from the Four Seasons Apartment building which I will refer to at greater length later, there were no failures of the prestressed concrete members themselves. In nearly every case the supporting structure, which was built of traditional materials, collapsed or connections and bearings were ineffective (see Figure No.25 and Figure No.26). Four buildings collapsed completely due to the failure of the supporting structure and three buildings suffered serious damage due to bad detailing of connections. One building under construction suffered partial collapse (bad connection details were evident). The main points which could be observed with regard to the functioning of the prestressed tees in these buildings were as follows.

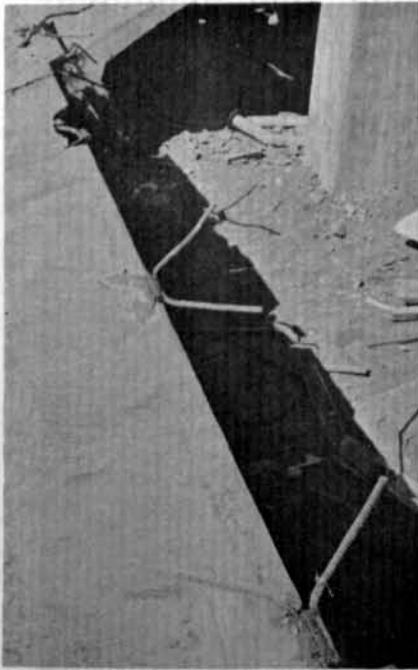
FIGURE No. 27A - FAILURE OF WELD PLATE CONNECTION

Unsatisfactory attachment of weld plates to the prestressed unit (See Figure No.27). The anchor rods holding the weld plates into the unit tended to pull out of the very thin flanges of many tee-sectioned units. These flanges were approximately $1\frac{1}{2}$ " thick and it would appear that this thickness is inadequate for good fixing of shear connections.

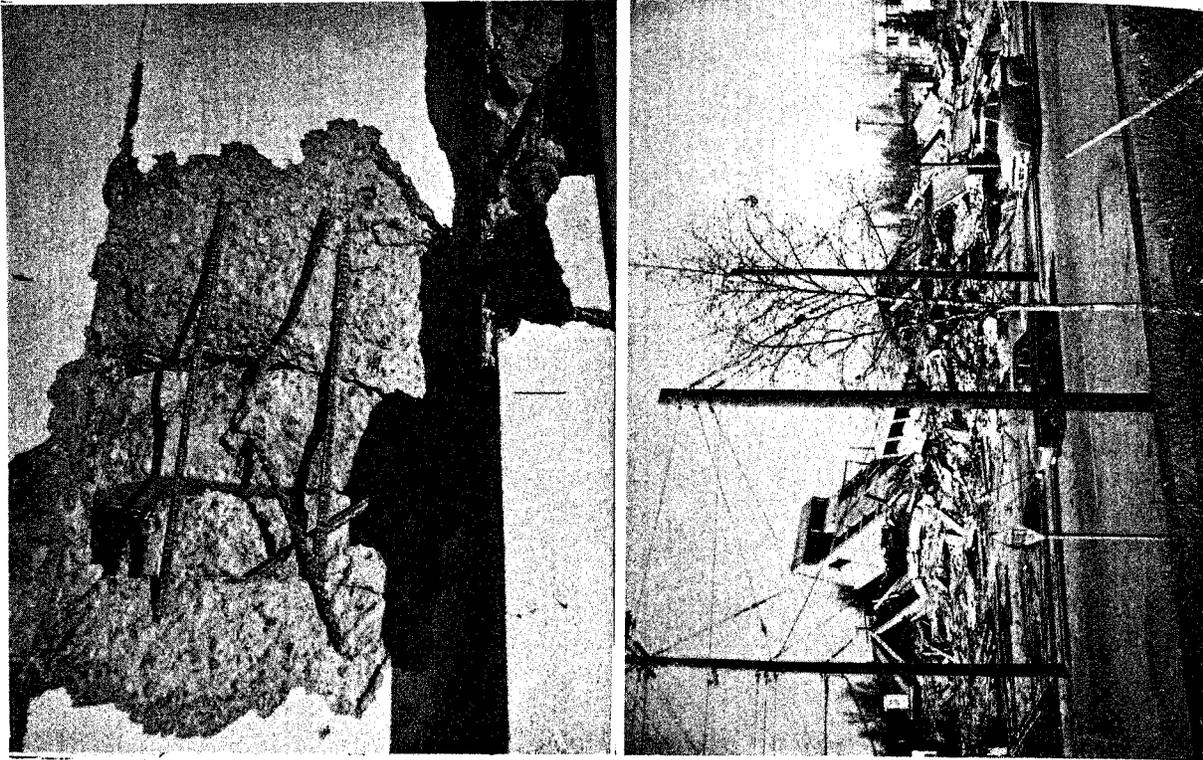
FIGURE No. 28 - INADEQUATE BEAM SEATING

(c) Inadequate provision for seating in connection of units to supporting structures (Figure No.28). Many failures in Alaska were attributed to inadequate seating.

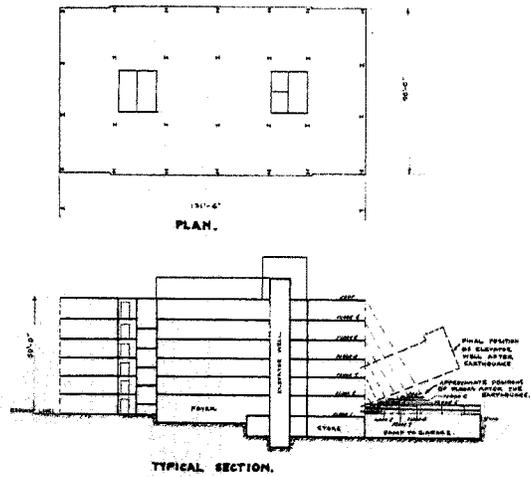
FIGURE No. 29 - FOUR SEASONS APARTMENT BUILDING.
GENERAL VIEW

4. Four Seasons Apartment Building; this structure consisted of six lifted prestressed slabs with horizontal seismic forces carried by lift and stairwell towers. Steel columns were encased in a lightweight fireproof material. The slabs were prestressed with $\frac{1}{2}$ " unbonded cables. The whole building collapsed completely during the earthquake. Whilst it is difficult to decide exactly how the structure first failed, the following are my personal observations (Figure No.29).

(i) The reinforced concrete shear towers appear to have crushed at their base on one side and thus allowed the whole structure to fall endwise under the effect of the horizontal forces. The towers were supported on a reinforced concrete foundation which also served as a basement car park. This part of the structure was still intact and was being used for storing materials. On examination of the shear towers which had collapsed, it appeared that there was insufficient mild steel and stirrups to restrain the concrete under the ultimate load. It was evident that the stiffness of the towers was not equal due to unsymmetrical placing of the door openings, and this no doubt caused one tower to draw extra load to it.

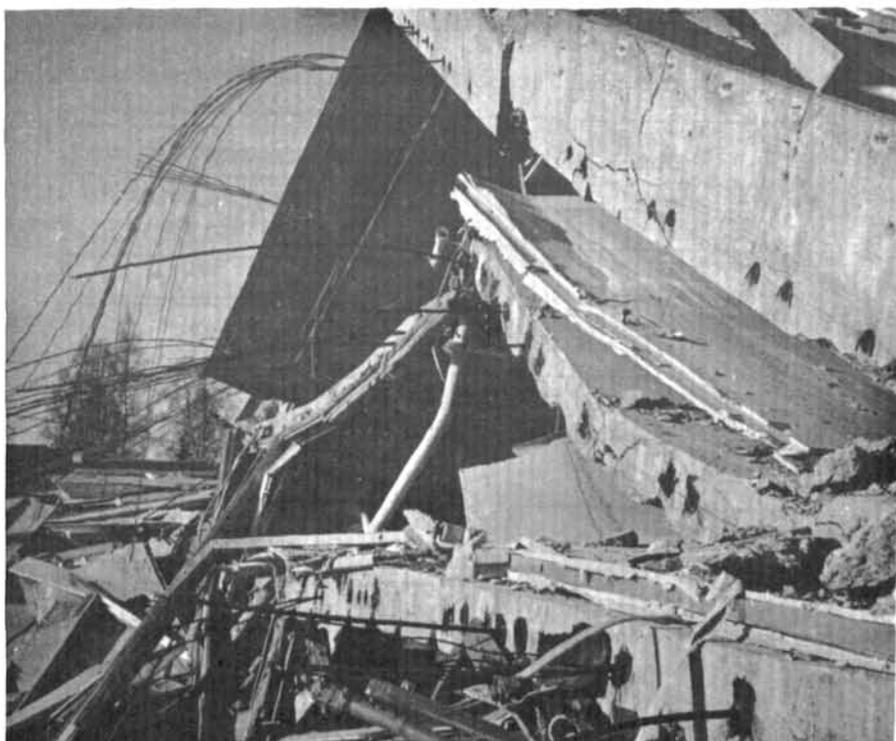
FIGURE No. 30 - FOUR SEASONS APARTMENT BUILDING
PLACEMENT OF SLABS

(ii) The prestressed slabs themselves appear to have failed before the complete structure collapsed to the ground, and this could be ascertained from the placement of the slabs as they lie (Figure No.30) and also from the fact that many of the prestressing tendons which are $\frac{1}{2}$ " unbonded cables flew out of the slabs while the structure was still in the air (Figure No.31). In fact, some of the strands actually penetrated the roof of an adjoining house, and this could only have occurred before the slabs had fallen to the ground.

The speculation that the slabs had failed first and slid down vertically before collapse of the shafts is not founded. If the slabs had fallen to the ground before the shafts failed, the reduction in elevated mass would have prevented collapse of the shafts.

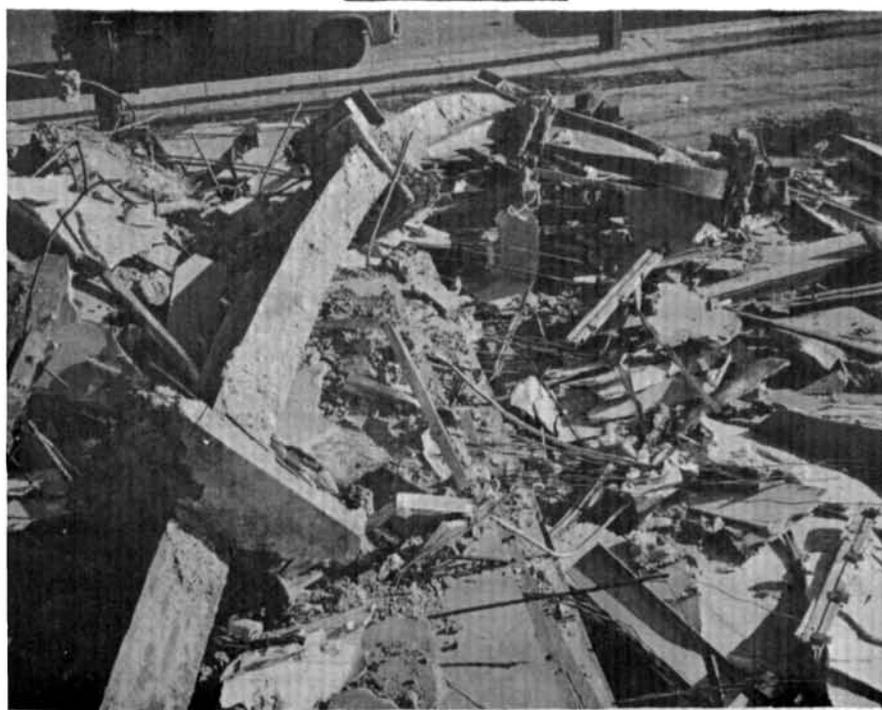
FIGURE No. 31 - FOUR SEASONS APARTMENT BUILDING,
FAILURE OF UNBONDED CABLES

There also appeared to be an absence of shear head reinforcement round the collars. It is possible that the reinforced concrete pour strip between the slabs may have failed causing the cable anchorages to be destroyed and the prestress thus released. However, this does not account for the fact that the transverse cables also failed and can be seen protruding from the sides of the slabs. Many of the anchorages became detached from the concrete and it appears that the wedges failed at less than the ultimate strength of the wire. Wedges were found several blocks away and prestressing cables were thrown across the adjoining street. This would have been avoided had grouted cables been used. The failure of the connection of the prestressed slabs to the shear towers is most noticeable, and eyewitnesses report that the slabs were seen to slide down the columns and towers before the main structure collapsed. This again indicates the need for careful detailing of the connections of all units in a structure.

The lessons of the Alaskan earthquake are many. There is obviously a need for closer attention to connections and bearings and supporting structures, and the use of unbonded prestressing cables without doubt contributed to the failure of the Four Seasons Apartment Building.

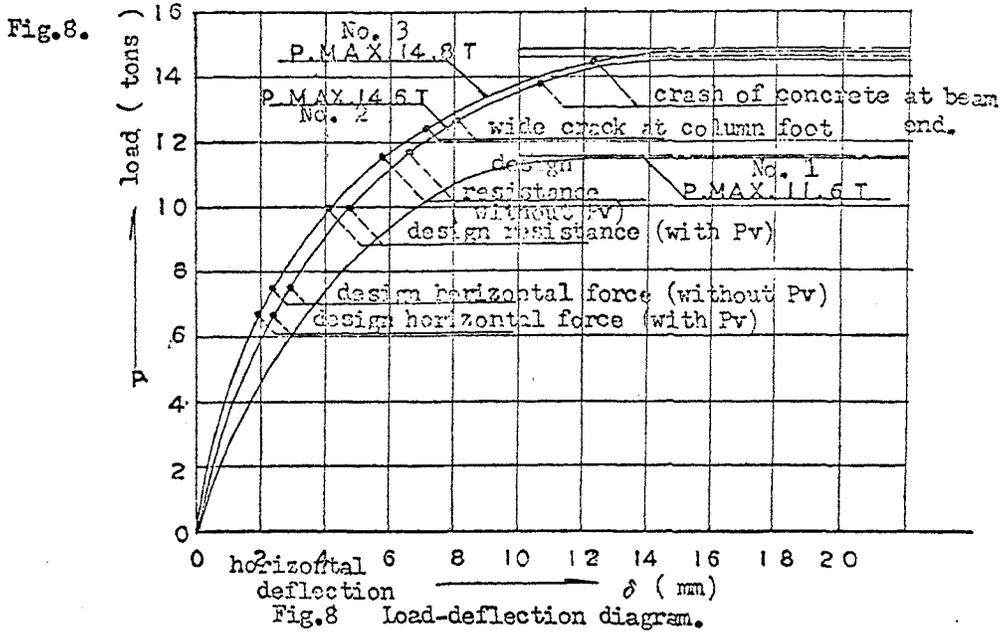
Diagrams of (horizontal force)-(horizontal deflection) are shown in

The following facts are induced from the above diagram.

- (i) All of the specimens show increment of load up to the moment when the last plastic hinge is formed.
- (ii) The shape of the diagram for No.2 specimen and that of No.3 specimen differs only slightly. The shape of the diagram for No.1 specimen differs considerably from that of No.2 & 3 specimen. That means rigidity of No.1 specimen is considerably less than that of No.2 & 3 specimen, due to the lack of grouting.
- (iii) Measured horizontal deflection of each specimens is more than 30 mm. That is, deformability of the specimens is more than 9,4 times of measured horizontal deflection corresponding to the design horizontal force for No.1 specimen, and 12.5 times for No.2. and No.3 specimen.

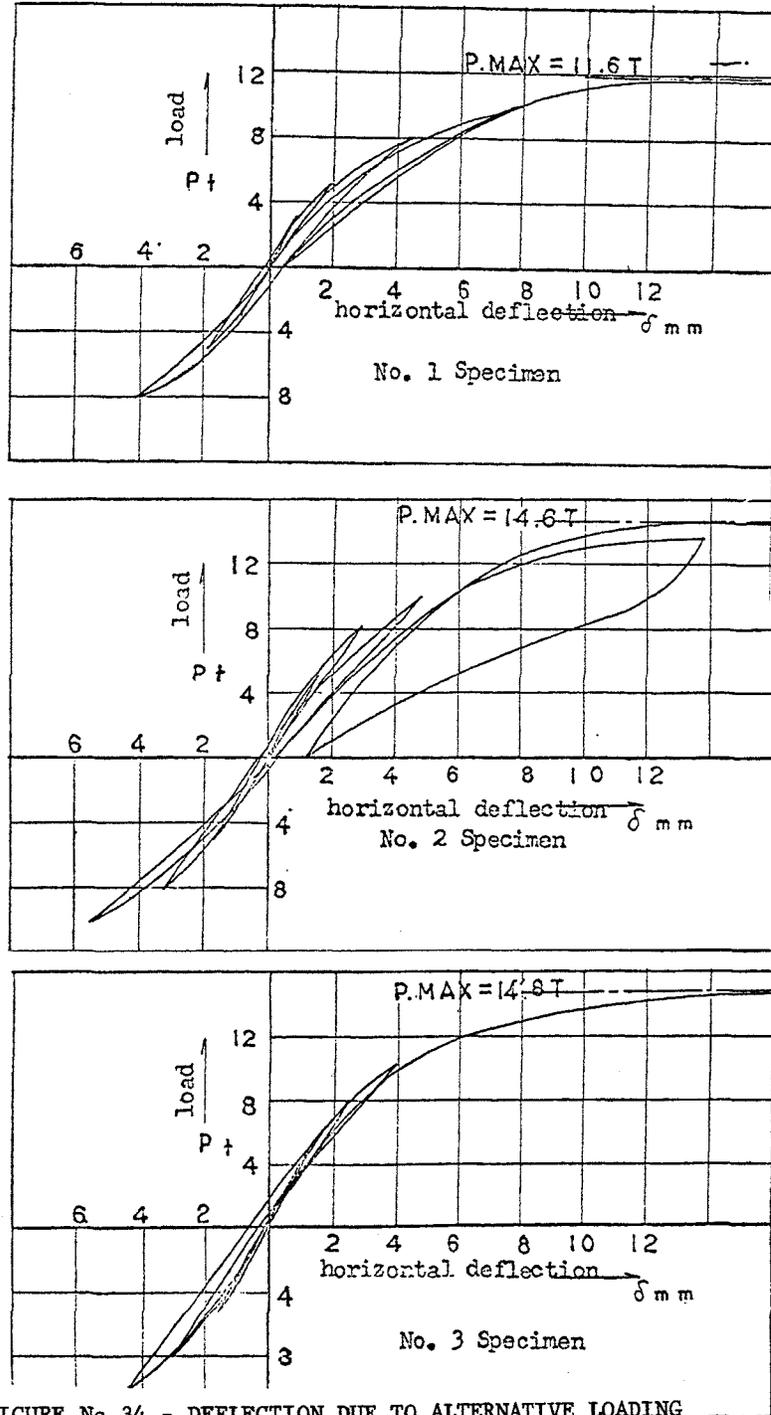
FIGURE No.34 - DEFLECTION DUE TO ALTERNATIVE LOADING

Load-deflection diagrams under alternative loading are shown in 1

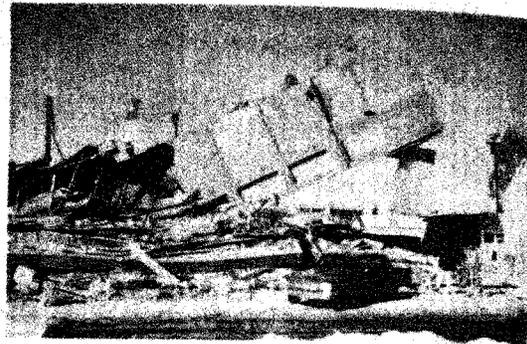
Figure 2. SHAFT B AND ROOF SLAB DISPLACED TO THE NORTH

As can be seen from the photographs of Figure 1 and Figure 2, the shafts were severed near their base (level 1, Figure A) and overturned to the north, carrying the slabs with them. The photograph of Figure 2 shows the corner of the roof overhang (see column line 6, Figure A) displaced northward about 35 feet. This northward movement would have been greater (about 52 feet) if the slabs completely followed the shafts to the ground, describing an arc with the base of the shafts as the center. Apparently, some slabs began to slip downward as the shafts were turning over, hence a combination of overturning and vertical sliding movements took place.

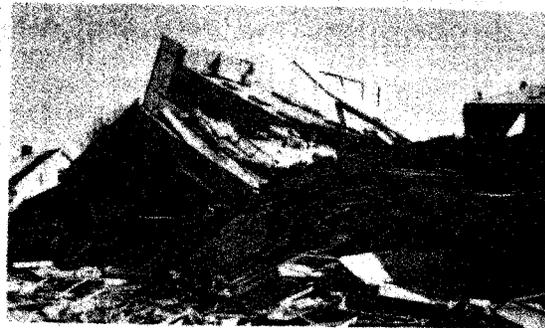
Figure 4. WEST EDGE OF ROOF SLAB

A rather spectacular secondary effect was the release of many prestressed cables ($\frac{1}{2}$ " greased and wrapped tendons) as the structure collapsed. The photograph of Figure 4 shows the severe twisting imparted to the slabs as the shafts rotated toward the north. Figure F describes how this twisting would deform the concrete around the anchorages located at the slab junction with the shaft outer wall. These wedge type anchorages were located in an area of maximum slab distortion and released the cable as soon as they were broken loose from the concrete.

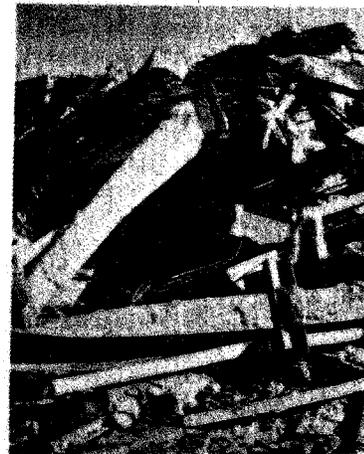
Figure 6. STEEL COLUMN

The slab concrete had varying degrees of prestress due to the progressive release of prestress cables as the shafts rotated northward. The photograph of Figure 6 shows a typical steel column, in a buckled configuration with shear heads in place.

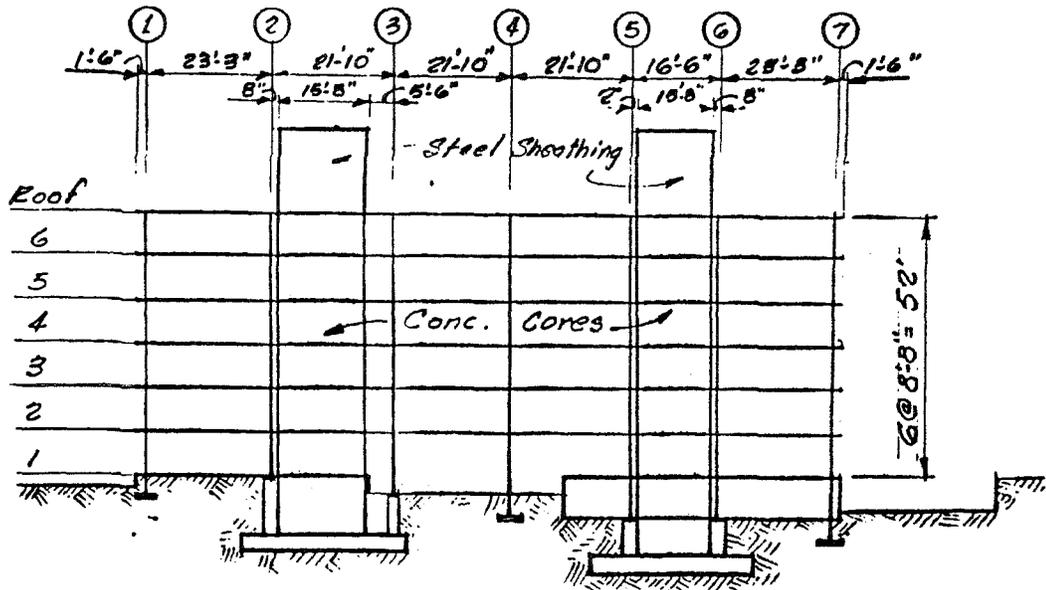
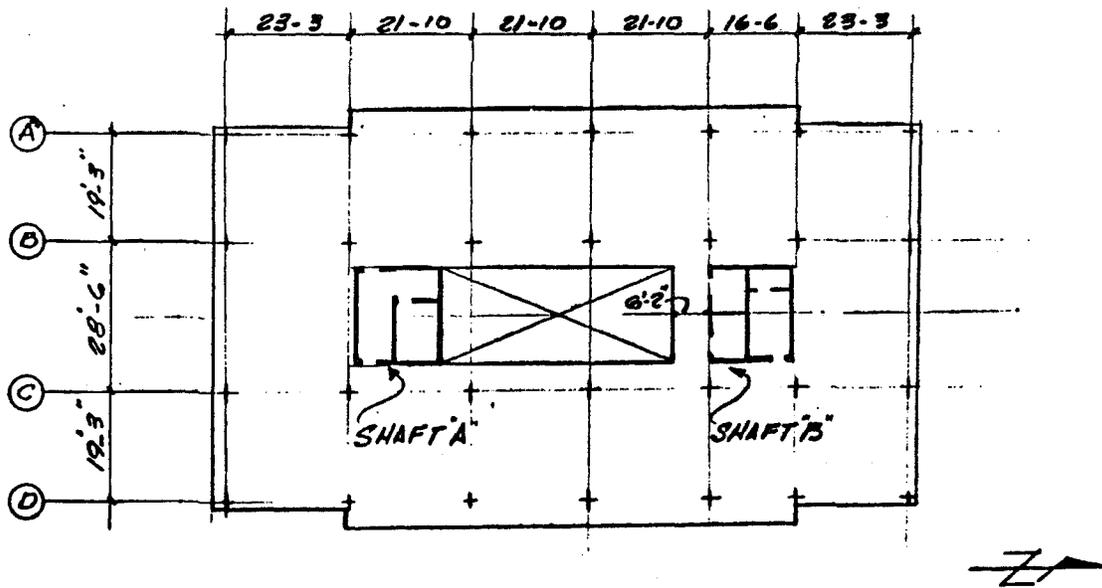
Figure A. FOUR SEASONS BUILDING

Longitudinal Section

Typical Floor

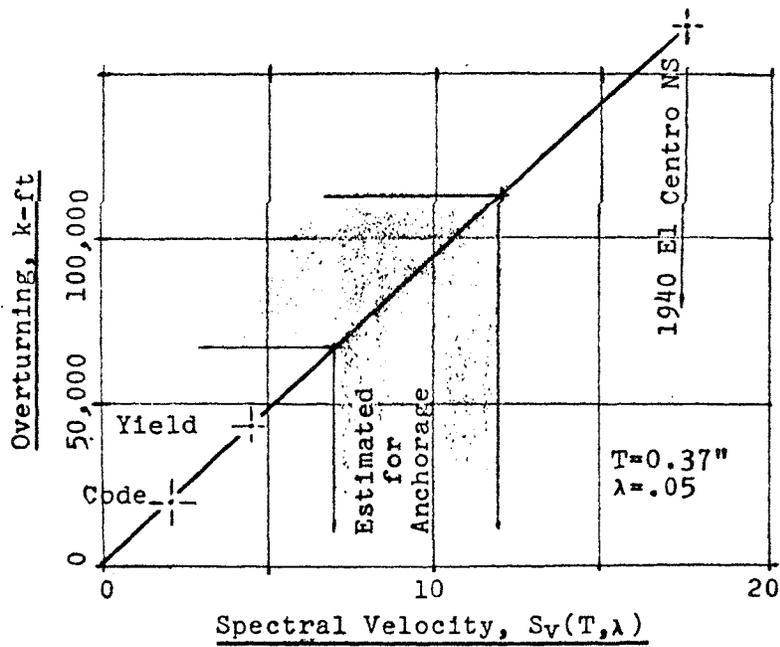
Figure B. ELASTIC RESPONSE vs EARTHQUAKE INTENSITY

By correlating observed damage trends with the velocity response spectrum description of earthquake effects, an elastic spectral velocity in the range of 7 to 12 inches per second is indicated for the Four Seasons structure ($T = 0.37$ sec., damping = 5%). This would indicate elastic lateral force levels of 3 to 5 times the design values.

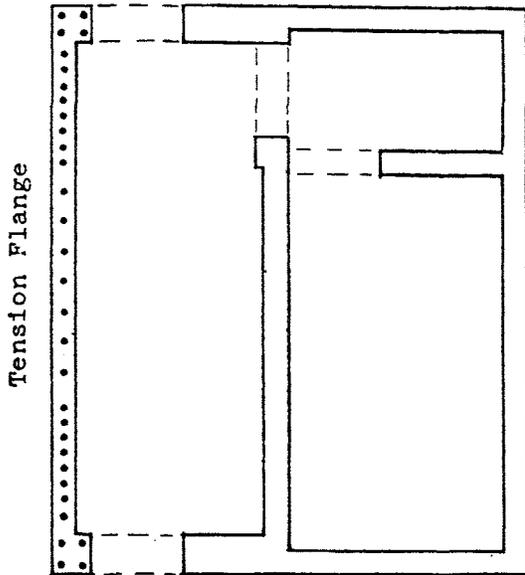
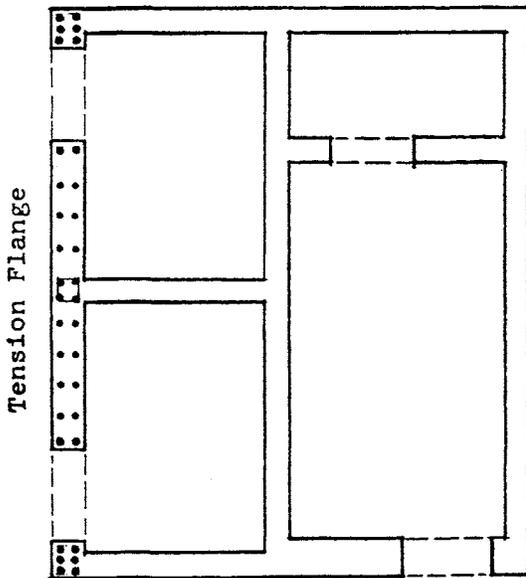
Figure D.
 SHAFT PROPERTIES

The actual collapse of the building, resulted from the failure of the shafts near their base (Figure D). All bars were spliced with a 20-bar diameter lap at one level. It was noted by a number of observers, including investigators of the Portland Cement Association who were there shortly after the earthquake, that the large bars, # 8s and # 11s, all failed at the splice, while the # 4 bars were broken with a ductile rupture. The failure of the splice of the large bars can be explained. The 20-bar diameter splice would have resulted in an average bond stress of 560 psi (Figure E) when the steel was stressed to the yield point. This stress exceeds the ultimate strength values given in ACI 318-63 (Section 805 (b) and Chapter 18) for large bars.

Moment of Inertia = 2290 ft.⁴
 Shear Area = 25 ft.²
 Yield Moment = 19,500k-ft.

TENSION BARS
 7-#5 = 2.1 sq.in.
 16-#8 = 12.6
 8-#10 = 10.2

Moment of Inertia = 2010 ft.⁴
 Shear Area = 25 ft.²
 Yield Moment = 24,600k-ft.

TENSION BARS
 14-#4 = 2.8 sq.in.
 4-#6 = 1.8
 4-#8 = 3.2
 12-#11 = 18.7

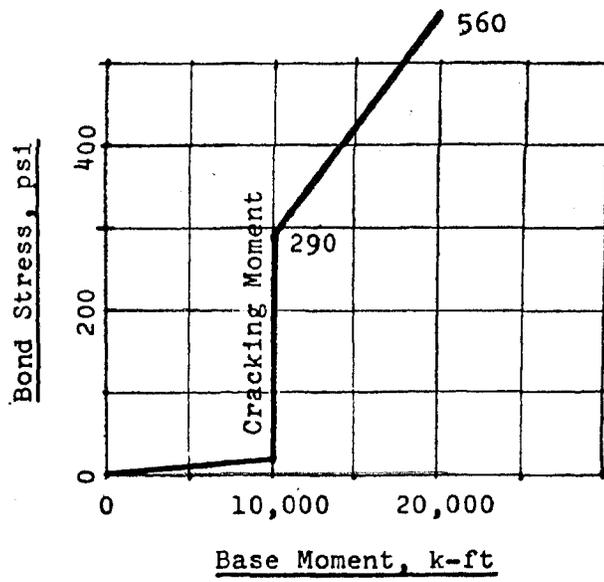
Figure E. BOND STRESS AT
BASE OF SHAFT A

The collapse of the Four Seasons building under the Alaskan Earthquake resulted from the overturning of the shafts which, in turn, was attributed to the bond failure of the main bars in the shafts. Bond failure with all bars spliced at one joint was brittle and could not supply the ductility necessary to absorb the energy imparted by the serious earthquake. The loosening of the tendons was an after-effect resulting from the severe twisting movement between the shafts and the slabs and was not the cause of the collapse.

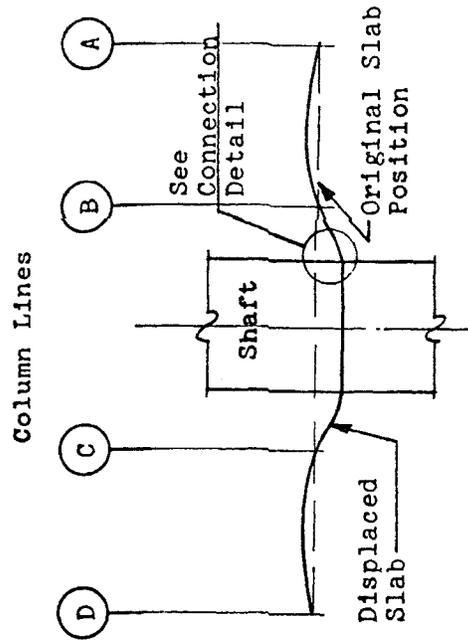
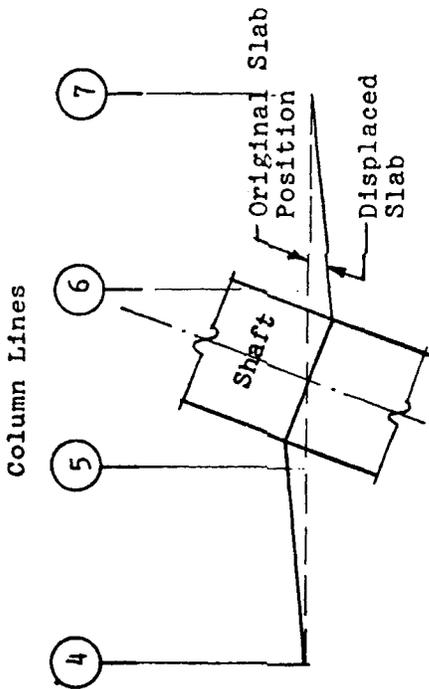
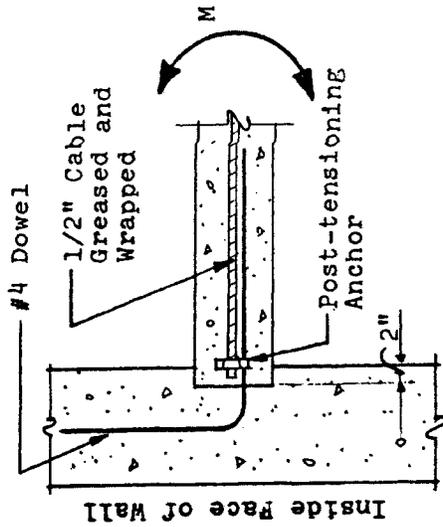
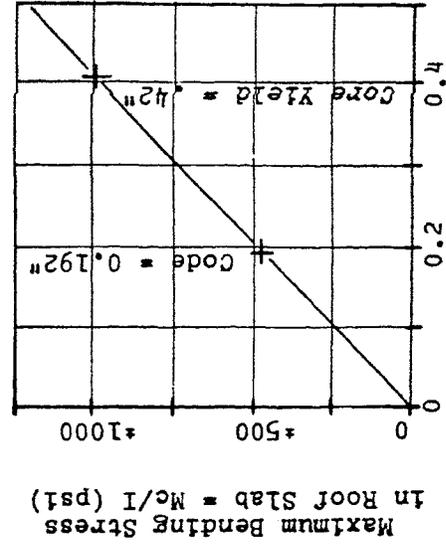
Figure F. SECONDARY SLAB STRESSES AT JUNCTION WITH SHAFT WALL

a. East Elevation

c. Connection Detail

b. North Elevation

d. Roof Sidesway, (in.)
