AN EARTHQUAKE ENGINEERING VIEWPOINT OF THE SKOPJE EARTHQUAKE

26th JULY, 1963.

BY N.N. AMBRASEYS *

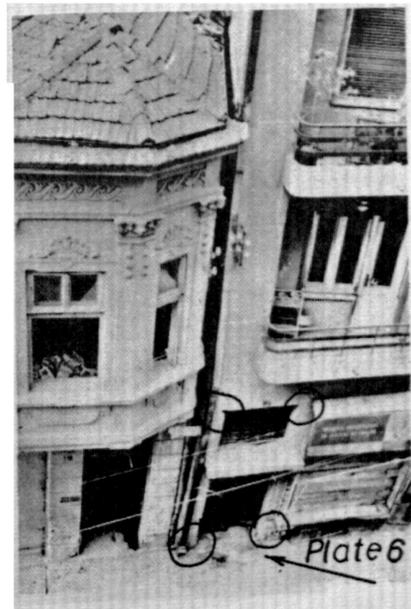
- PLATE 6: A pair of rigid-flexible houses overlooking Tourist Hotel. Plastic joints developed in columns (circles). No sign of pounding; tiles that fell into the gap were not crushed. Upper storeys of skeleton building slightly damaged.

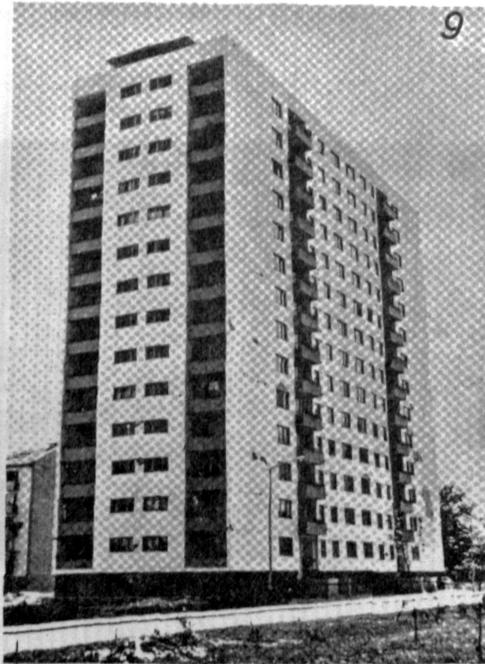
- PLATE 9: Karposh district. (Kula Brj. 1). 15-storey reinforced concrete skeleton building with central concrete core designed to withstand wind forces suffered minor damage.
