STRENGTHENING EXISTING RC COLUMNS
FOR EARTHQUAKE RESISTANCE

Lawrence F. Kahn[I]

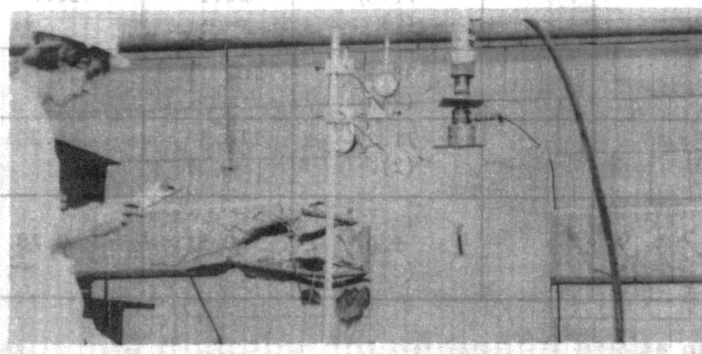
Figures 8 through 11 show the shear force–deflection response for Specimens 1 through 4, respectively. The hysteresis curve for Specimen 1R was identical to that for Specimen 4. Specimen 1 collapsed (lost axial load capacity) at a deflection of 38 mm, which represented a ductility ratio, Δ/Δy, of 1.9. Retesting showed that the repaired section of Specimen 1R cracked slightly only at the maximum shear load; the main reinforcement yielded on the other side of the center block which had been previously cracked but not severely damaged. This area of Specimen 1R was strengthened with U-clamps. Plastic hinge formation and cracking of Specimen 1R were identical to Specimen 4, also strengthened with U-clamps.

Figure 3. Specimen 1 after collapse.

Specimen 1 was not strengthened prior to testing (Figure 2). After testing, Specimen 1, now termed Specimen 1R, was repaired by first hammering away all fractures concrete (Figure 3). Buckled reinforcement was cut and welded to straight pieces of 7.9 mm thick, 51 mm x 51 mm steel angle. Hoops of 9.5 mm reinforcing bars were bent around the repaired main reinforcement and were spaced 38 mm on centers as shown in Figure 4. The column on only one side of the block was damaged and, therefore, repaired; the remainder of Specimen 1R was strengthened using U-clamps identical to Specimen 4 described later.

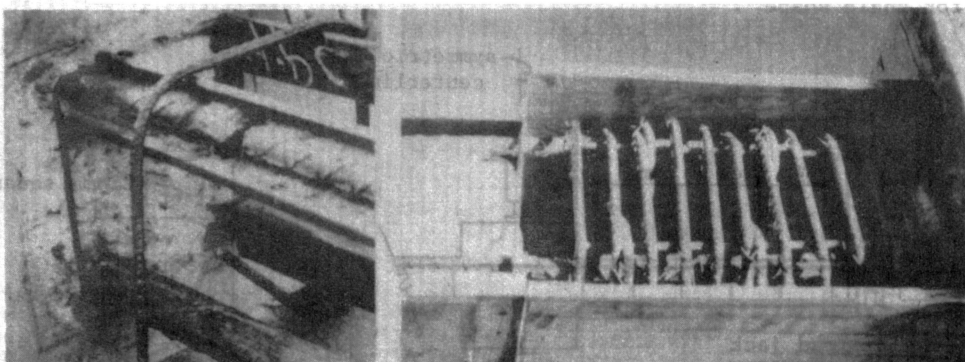
Figure 4. Repair for Specimen 1R: #7 bar welded to 50 mm angles (left), 9.5 mm hoops at 38 mm spacing (right).

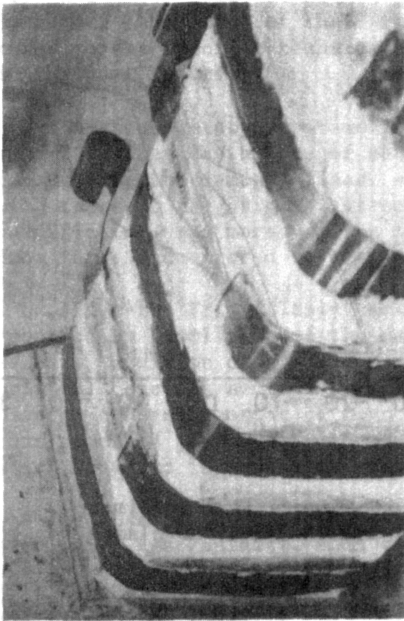
The hysteresis curves for Specimen 2, 3, and 4 were nearly identical in the inelastic region; the columns demonstrated ductile flexural response without shear deterioration. At the maximum deflection level, a ductility ratio of 4, each column showed slight diagonal X cracking near the center block and some concrete crushing failure beneath the strengthening hoop nearest the center block. For each column this hoop was about 25 mm from the face of the connection. The strains in the band, spiral and U-clamp nearest the connection were less than 14 mPa. Apparently each external strengthening technique confined the concrete so that the shear force was carried primarily by the concrete.

Figure 7. Specimen 4, U-clamps; cracking at maximum deflection.

Figure 7 shows the U shaped clamps used to strengthen Specimen 4. These U-clamps were fabricated by welding 7.9 mm x 50.8 mm bar to 79.4 mm thick steel angle (76 mm x 127 mm x 63.5 mm wide). A325-19 mm bolts held two U-clamps together to form a hoop; hoops were spaced 108 mm on centers.

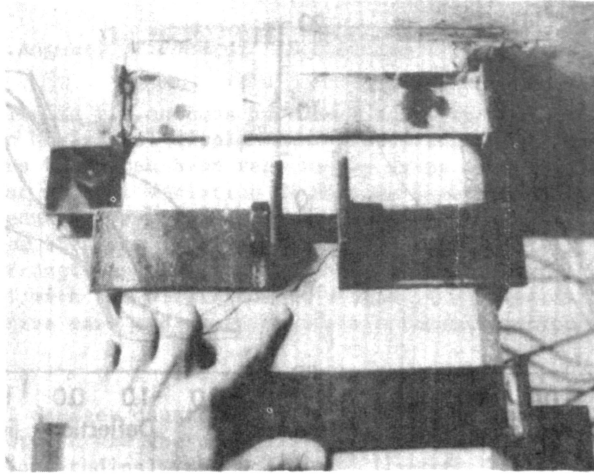
Figure 5. Specimen 2, packaging bands.

Specimen 2 was strengthened by tensioning 50.8 mm wide packaging bands around the column. The band hoops were spaced 102 mm on center and were secured with pressed clips (Figure 5). Tension tests showed that the clipped bands started to slip at a stress of 614 mPa, 5 percent less than the f_y given in Table 1. The 6 mm gap beneath the band hoops was packed with a non-shrink mortar.
