The collapse of the Struve Slough Bridge during the 1989 Loma Prieta earthquake in different seismic code perspectives

ABSTRACT: The collapse of the bridges on California Highway 1 near Watsonville, known as the Struve Slough Bridge during the 1989 Loma Prieta earthquake in Northern California is described. The Struve Slough Bridge consisted of two parallel structures erected in 1964. This paper describes both the structural and the geotechnical aspects of the damage, and presents a comparison of the American and the Canadian codes. Reference is made to the American seismic design code practice at the time of the bridge design and construction.

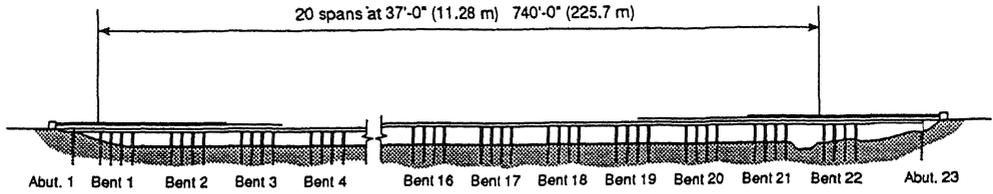
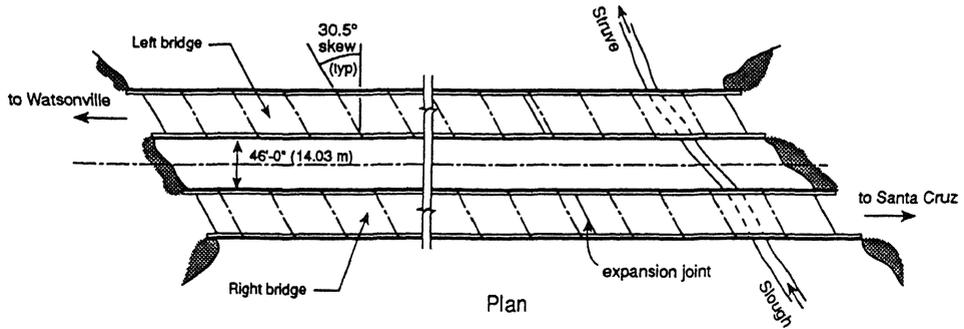
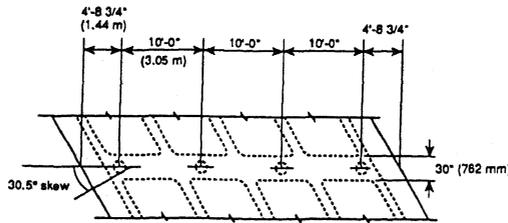
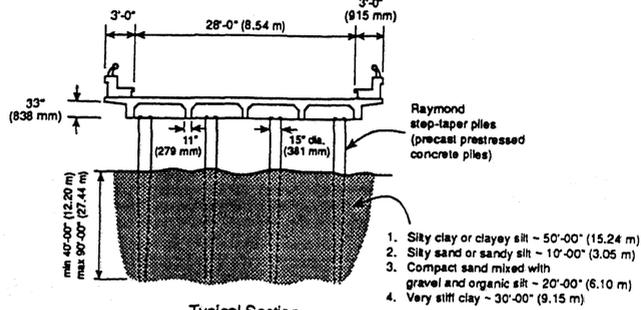
Figure 1. Elevation, plan view, bent plan and cross section of the Struve Slough Bridge (courtesy of CALTRANS)

is followed by a 14 ft. (4.3 m) thick layer of compact to dense sand that is underlain by a very stiff grey silt to silty clay. The subsoil at the north abutment appears to be similar to that of the south abutment except that the thicknesses of different soil layers are different. Figure 1 shows the plan, elevation, typical bent of the bridge and typical soil layers for its vicinity.
