March 13, 1992 Erzincan (Turkey) earthquake

M. Erdik, O. Yuzugullu & C. Karakoc

ABSTRACT: Erzincan City has been stricken by numerous earthquakes. That of 1939 ($M_s=7.8$) destroyed the entire city and killed thousands of people. The city was then relocated. The main shock of March 13, 1992 and its aftershocks killed about 500 people, injured 2800, damaged 11 000 houses and caused the collapse of 180 buildings. There were pronounced site effects and many instances of liquefaction and landslides. Damage to various types of construction, the good behavior of others and post-earthquakes experience underline lessons taught by earthquakes in other parts of the world, and teach us new lessons. Although plans existed for disaster response and mitigation, their implementation was hampered by lack of rehearsal.

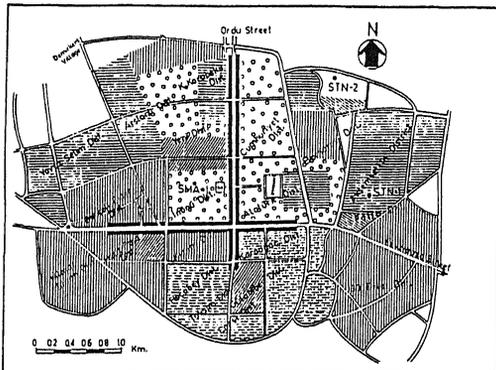
Fig 8. Erzurum City layout and building type distribution. Names correspond to districts.

1939 earthquake with imported material. These have wooden frames plastered on both sides with wire mesh. Group II prefabricated buildings were erected recently with lightweight panels. The small businesses in the south-east of the city occupy single story reinforced concrete constructions.
